The July 10 2000 Payatas Landfill Slope Failure

ABSTRACT: *This paper presents an investigation of the slope failure in the Payatas landfill in Quezon City, Philippines. This failure, which killed at least 330 persons, occurred July 10th 2000 after two weeks of heavy rain from two typhoons. Slope stability analyses indicate that the raised leachate level, existence of landfill gas created by natural aerobic and anaerobic degradation, and a significantly over-steepened slope contributed to the slope failure. The Hydrologic Evaluation of Landfill Performance (HELP) model was used to predict the location of the leachate level in the waste at the time of the slope failure for analysis purposes. This paper presents a description of the geological and environmental conditions, identification of the critical failure surface, and slope stability analyses to better understand the failure and present recommendations for other landfills in tropical areas. In addition, this case history is used to evaluate uncertainty in parameters used in back-analysis of a landfill slope failure.*

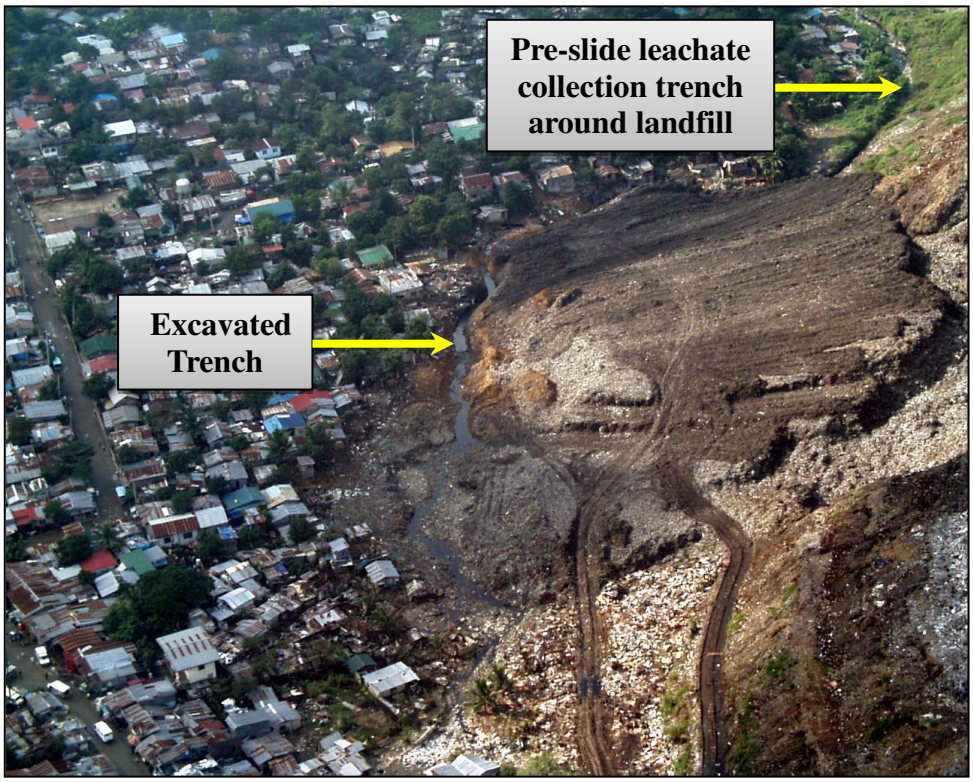
Figure 5 shows a close-up of the slope failure area and scarp in Payatas Landfill. Regrading of the slide mass had started shortly after the failure, which is shown in Figure 5. A leachate collection trench was excavated along the toe of the slide mass and is highlighted by the arrow and text box in Figure 5. The native brown soil underlying the waste and residential area is visible along the toe and sides of this excavated leachate collection trench. Leachate seepage existed prior to and shortly after the slope failure; however, the exact leachate level in the landfill just prior to failure is not known. A smaller landfill leachate collection trench was present along the slope toe prior to the slide and was similar to the trench shown in Figure 4. The leachate collection trench as it existed prior to the slide was covered by the slide mass and hence, is not visible (see the central portion of Figure 5). However, it was visible along the toe of the north-facing slope of the landfill east of the slide mass (see the top of Figure 5 where a small trench separates homes from the landfill toe and is highlighted by an arrow and text box). In summary, Figure 5 indicates that the leachate trench in front of the slide mass was constructed after the slide to collect leachate exiting the slide mass and a considerable volume of leachate existed in the landfill prior to failure but the exact leachate level at failure is not known.

Figure 5. Slope failure showing new and existing leachate trenches along slope toe (photo by S.M. Merry).

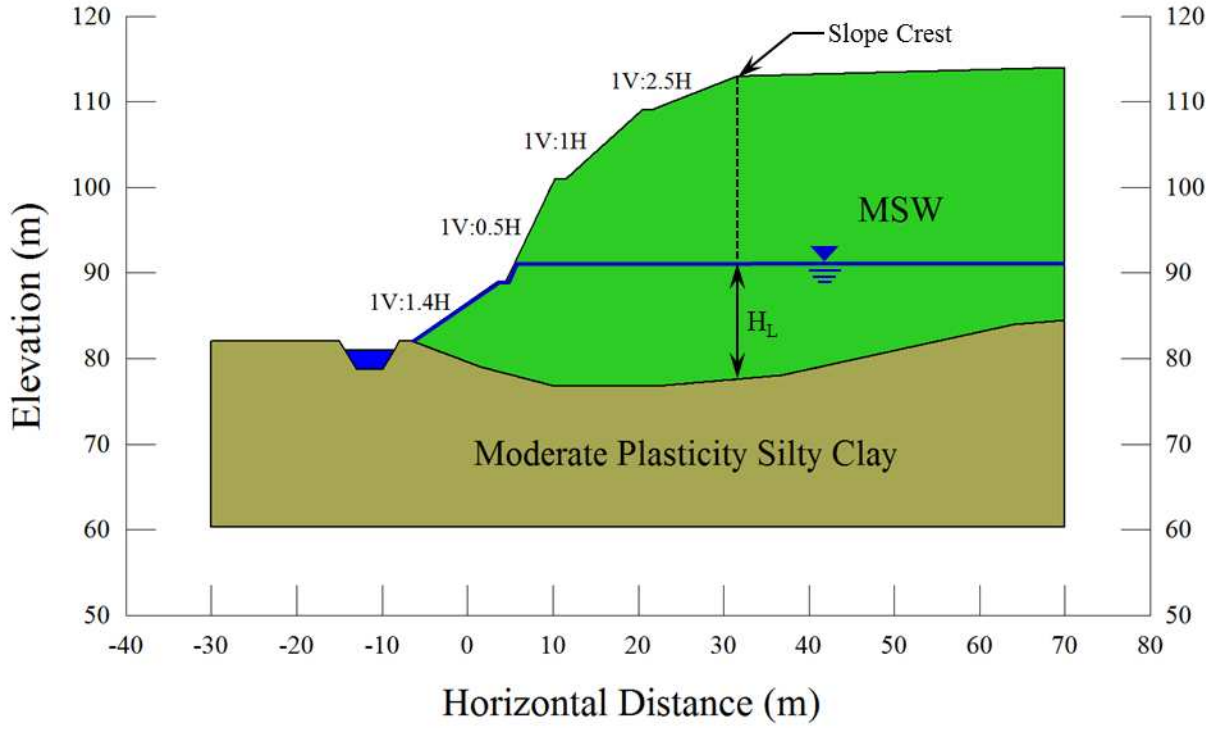
Figure 7. Two dimensional cross-section of failed waste slope.

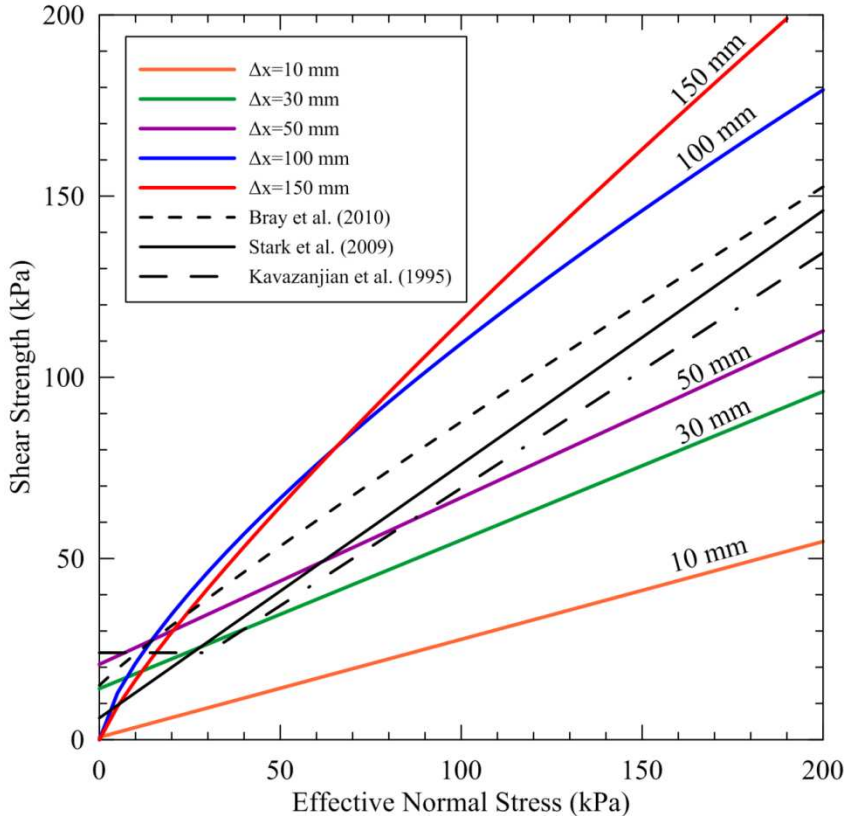
In addition to being dependent on the effective normal stress on the failure plane, the shear strength of MSW is also shear displacement or axial strain dependent and tends to increase with increasing deformation (Eid et al., 2000). Review of existing laboratory data show that most of the laboratory shear tests investigated are not continued to sufficient displacement or strain to mobilize the peak shear strength of the MSW. As a result, Stark et al. (2009) provide MSW shear strength envelopes mobilized at horizontal displacements of 10, 30, 50, 100, and 150 mm. Table 3 shows equations for each strength envelope estimated from direct shear tests, where R^2 values are all above 0.90. Figure 10 compares the shear strength envelopes in Table 2 to envelopes recommended by others (e.g., Stark et al., 2009; Bray et al., 2009; Kavazanjian et al., 1995). As highlighted in Figure 10, all of the recommended envelopes fall between the 50 and 100 mm of shear displacement strength envelopes.

In fact, for effective stresses lower than 200 kPa, recommended strength envelopes are about average of these two displacements. For horizontal displacements of 10, 30, and 50 mm, the strength envelopes are linear and can be described by Mohr-Coulomb cohesion and friction angle parameters. As the displacement increases to 100 mm, the strength envelopes are stress dependent and described by a power trend with no apparent cohesion. Based on preliminary stability analyses, the 50 mm envelope in Table 3 is assumed to represent the average mobilized MSW strength at the time of the slide. The section "Inverse-Analysis of Wasteslide" describes the rationale for using the 50 mm envelope.

Figure 10. MSW shear strength envelopes.

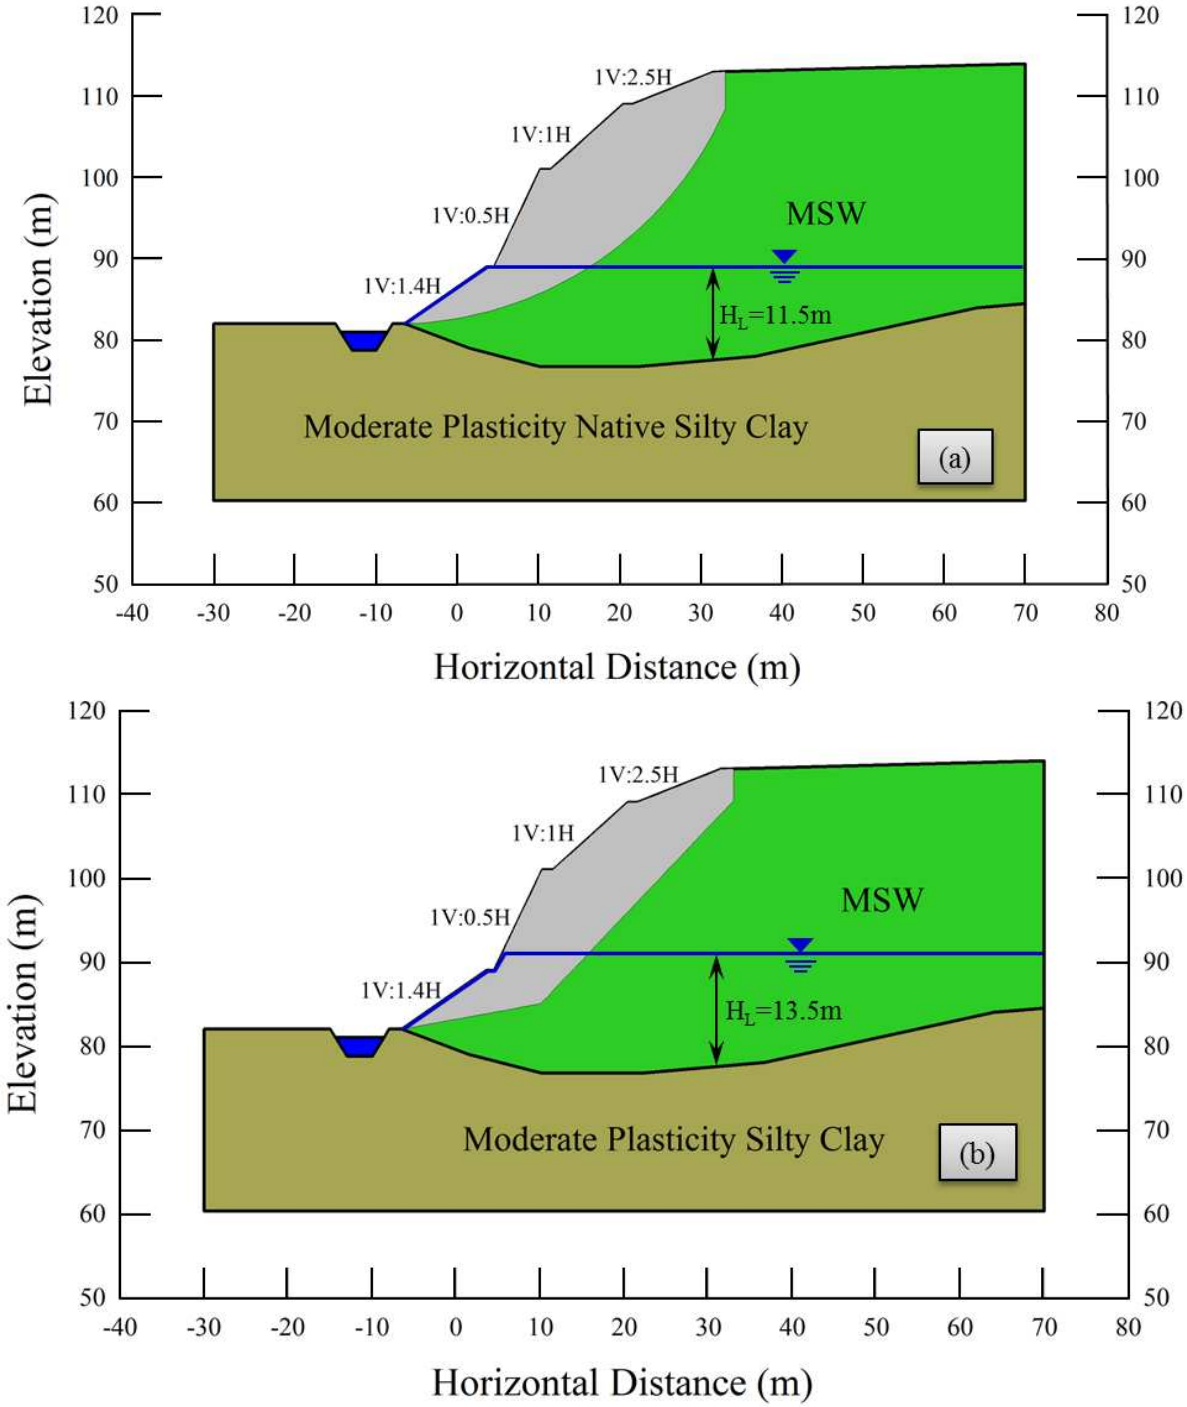
Figure 11. Cross- sections showing location of (a) circular and (b) planar failure surfaces.

The failure surfaces shown in Figure 11 were estimated from photographs in Figures 2, 3, 5, and 6 and consist of a shallow circular and shallow planar failure surface through only the MSW. From Figure 3, the authors surmise that the failure surface is shallow in nature, and the waste mass slid down the side slope as a mass, i.e., a slab or sliver slide. Subsequently, ledges developed along the main scarp formed from vertical blocks toppling over or sliding down (see Figure 3). Therefore, it was concluded that the failure surface passed from the crest of the slope through the MSW, and exited at the slope toe without entering the underlying brown native clayey silt.

Although a circular failure surface indicates a homogenous material, a planar failure surface starting at the toe and daylighting at the top of the landfill was also analyzed. Because the exact location of the failure surface at the crest is not known, the scarp of the waste slide was used to estimate the location of the failure surface at the top of slope that yielded the lowest factor of safety. Furthermore, after the waste slide, the waste was regraded (see Figures 2 and 5) such that the actual slide mass geometry does not represent the possible progression of failure. A helicopter video from a news report (http://www.abs-cbnnews.com/video/nation/metro-manila/07/10/11/payatas-tragedy-commemorated) shows an aerial view of the landfill prior to regrading, which was also helpful in estimating the location and geometry or the failure surface. From this video, the failure progresses from the main slide mass and regressing from the initial head scarp to a final scarp that is about 5 m behind the slope crest. Then, an ensuing block of waste toppled from the scarp creating the final geometry shown in Figure 2. Merry et al. (2005) report that a steep (vertical at the top) head scarp remained above the area where heavy machinery had reworked the waste mass.

In the inverse analysis described below, the piezometric surface required to reduce the FS to unity is about 11.5 m and 13.5 m for circular and planar failure surfaces, respectively, using the Δx=50 mm MSW shear strength in Table 3. A leachate level (H_L) of 11.5 m is greater than usually associated with engineered landfills but it is deemed plausible for the Payatas landfill because no soil cover was present, two recent typhoons impacted the site, limited waste compaction or grading occurred, a precipitation collection trench was excavated at the top of slope, no leachate collection system was installed, and the facility is located in a depressed area. In addition, ponded water/leachate was observed at the top of the landfill during the site reconnaissance which occurred several weeks after the failure (Merry et al., 2005). Finally, Figure 6(a) shows leachate present at the first bench of the landfill several weeks after the failure.

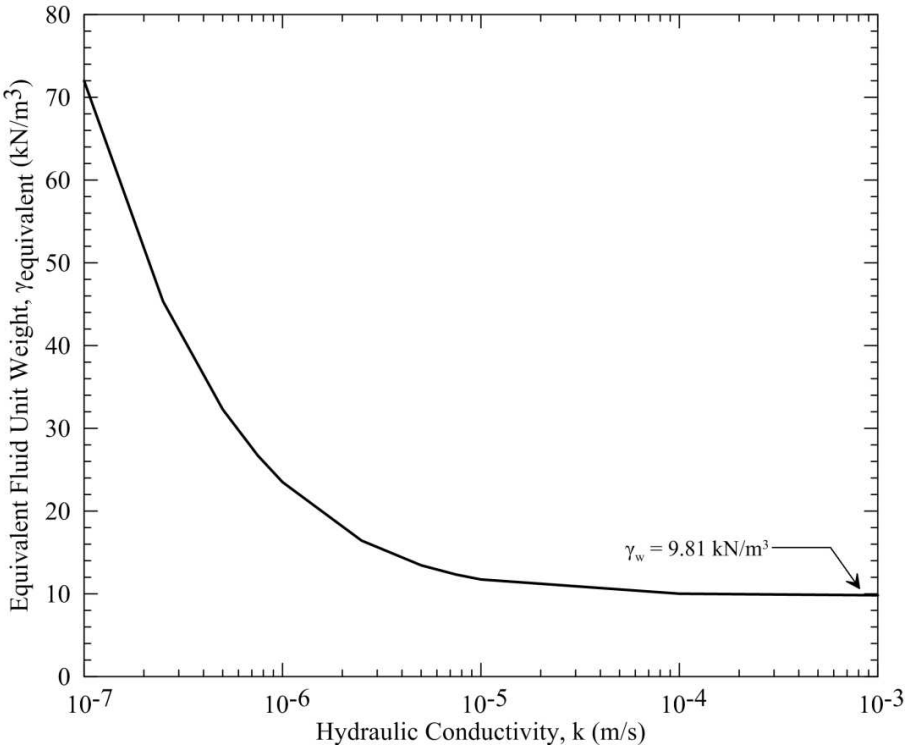
Figure 12. Dependence of equivalent fluid unit weight, $\gamma_{equivalent}$, on MSW saturated hydraulic conductivity, $K_{waste,sat}$

Using Table 5, the equivalent fluid unit weight of the pore fluid, $\gamma_{equivalent}$, that accounts for both hydrostatic water pressure and gas pore pressure is 11.7 kN/m^3. Due to the inclusion of gas pressure in the inverse analysis, the piezometric surface that gives a FS of unity is lowered by 1 m for both the circular and planar failure surfaces in Figure 11.

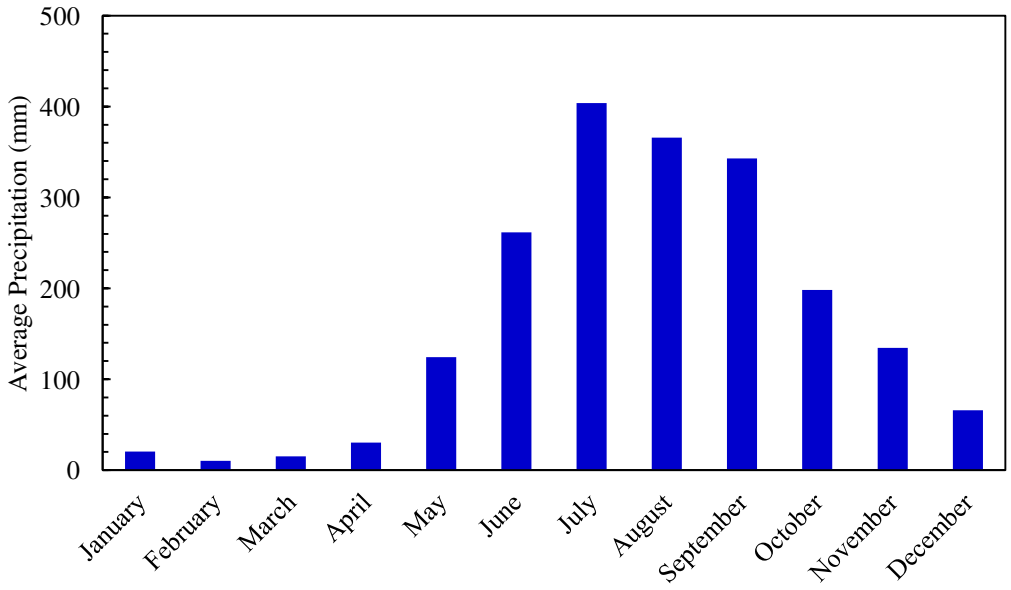
The precipitation database in the HELP model does not provide historical precipitation data for Quezon City, so recorded rainfall data from 1 May through 31 July 2000, was obtained from the Quezon City weather station and imported into HELP. This provides a reasonable simulation of the two months of precipitation immediately preceding the slope failure. Replicating approximate initial moisture conditions before May 1st 2000 involved executing the HELP model for several years prior to the failure. As a result, weather and climate conditions similar to Quezon City were required because this data is not available from the Quezon City weather station. Quezon City, located at 14° latitude, is closer to the equator than the United States and hence, has different climate conditions. Quezon City weather is dominated by high humidity, precipitation, and warm conditions year round. Table 7 presents a summary of the key weather conditions for Quezon City. The HELP program can also generate daily precipitation data using a synthetic weather generator. By entering the normal mean monthly precipitation values of Manila, Philippines shown in Figure 13, HELP generated synthetic precipitation records for 10 years preceding the failure. This synthetic record was used until May 1st of the 10th year, so that the water content and saturation levels reached a reasonable steady state value before applying the recorded data from the Quezon City weather station. From May 1st to July 31st, recorded precipitation values from the Quezon City station (Canty and Associates LLC, 2004) were input to HELP.

Figure 13. Average monthly precipitation for Manila, Philippines from Quezon City weather station *(data from www.weather.com).*

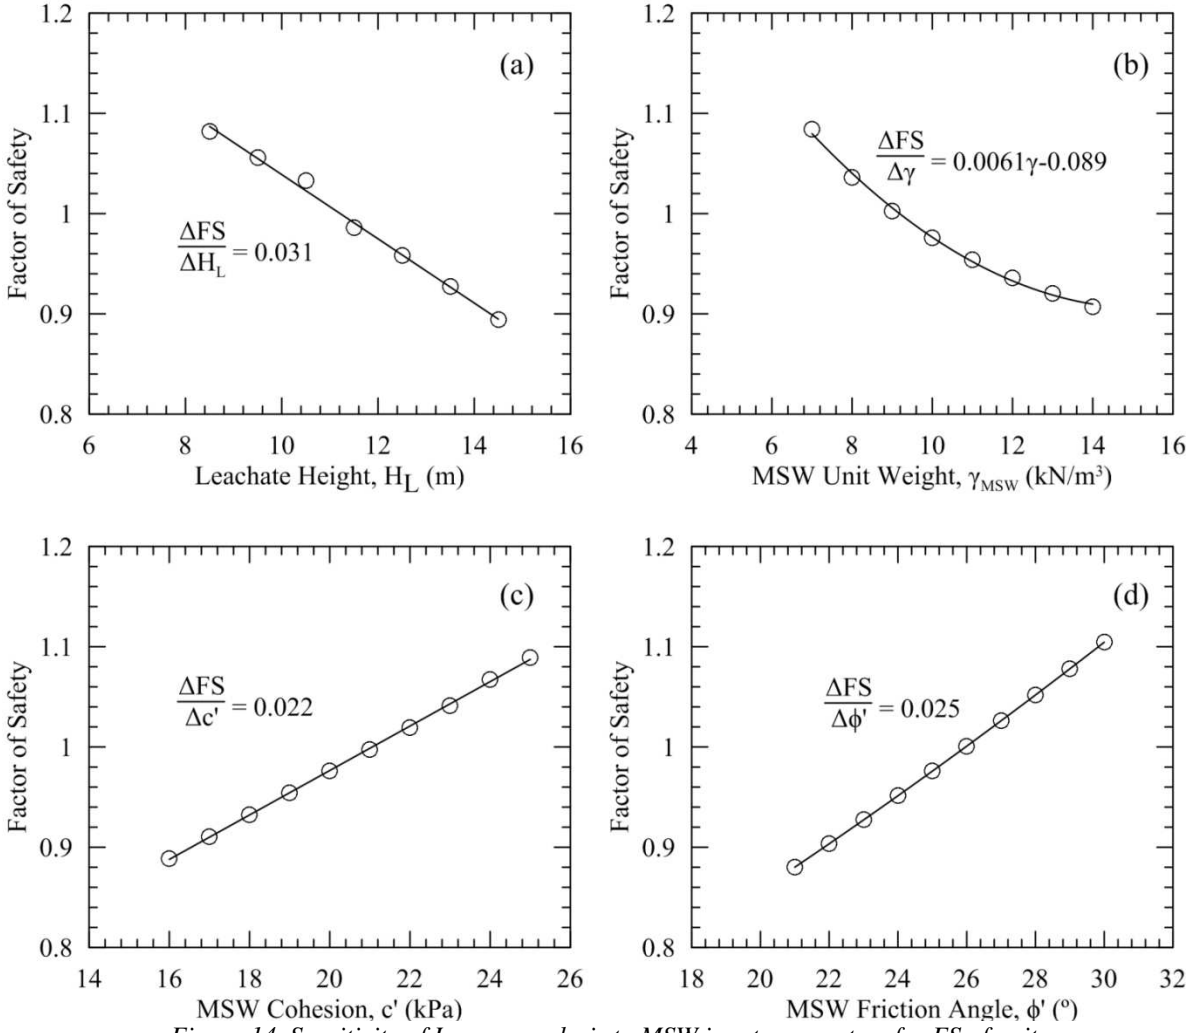
Using site reconnaissance information, pictures, and reports of the wasteslide, an inverse analysis was conducted to estimate the piezometric level at the time of failure. Figures 14(a), 14(b), 14(c), and 14(d) show the sensitivity of the factor of safety for a range of MSW shear strength parameters, MSW unit weight, and leachate level. For each sensitivity parameter, the factor of safety was computed using the circular failure surface in Figure 11(a). In Figure 14, the trend line slope is used to capture the sensitivity of FS to each parameter. For example, Figure 14(a) shows that FS decreases by 0.031 for a 1 m increase in leachate level. Using the trend line slopes for each parameter, the contributing factors leading to failure can be compared. MSW unit weight can increase when rain infiltrates into the waste mass and increases moisture content. The sensitivity of MSW unit weight is a nonlinear relationship shown in Figure 14(b). Figures 14(c) and 14(d) indicate that reducing MSW cohesion and friction, i.e., slopes equal to 0.022 and 0.025, respectively, contributes less to failure than increasing the leachate height (slope=0.031). Thus, Figure 14 suggests that leachate height has the greatest influence to reduce the FS.

Figure 14. Sensitivity of Inverse analysis to MSW input parameters for FS of unity.
