Collapse of Showa Bridge Revisited

Subhamoy Bhattacharya, *Professor and Chair in Geomechanics, University of Surrey, U.K; email: S.Bhattacharya@surrey.ac.uk*
Kohji Tokimatsu, *Professor, Tokyo Institute of Technology, Japan; email: kohji@o.cc.titech.ac.jp*

KEYWORDS: Showa Bridge, Niigata earthquake, collapse, liquefaction.

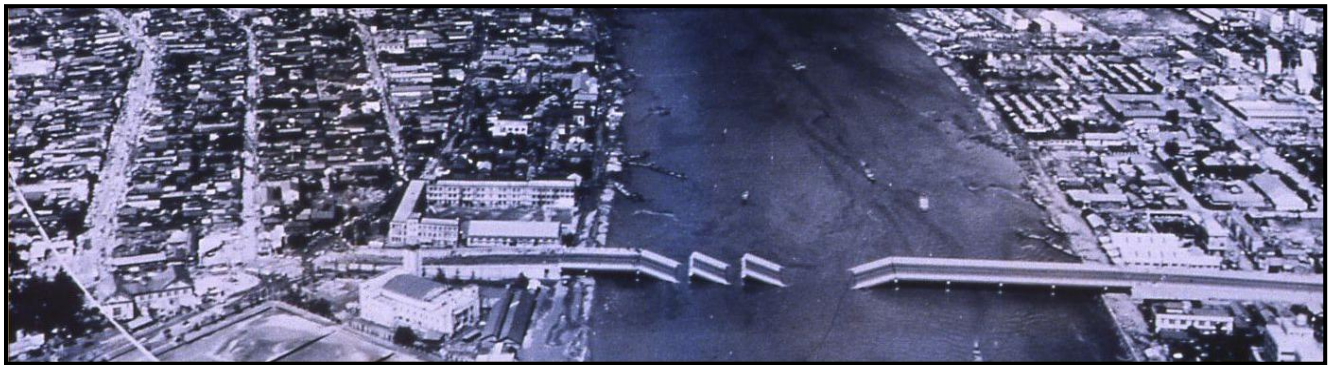
Figure 1. Collapse of Showa Bridge.

It is interesting to observe that the middle of the bridge i.e. the bridge piers collapsed while the abutments (end piers) remained stable. Figure 2 shows the ground profile along the longitudinal direction of the bridge following Hamada and

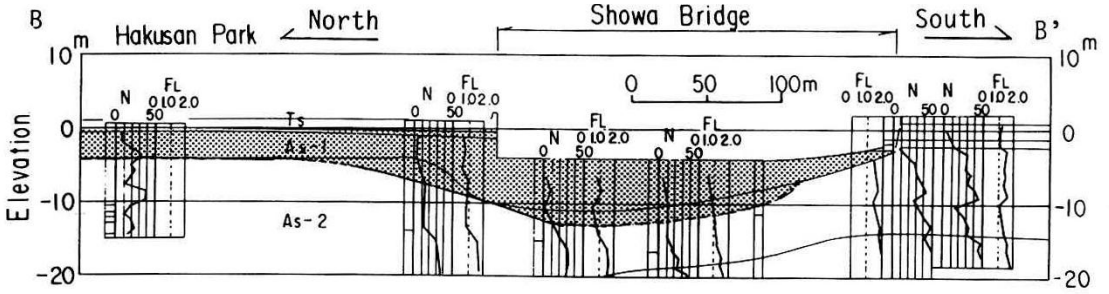
O'Rourke (1992). It was generally believed that lateral spreading was the cause of failure of the bridge (see for example the seminal work of Hamada and O'Rourke (1992) collating the performances of infrastructures following the major earthquakes in United States and Japan). In other words, the hypothesis was based on the fact that lateral pressure of the liquefied soil pushed the pile sideways to cause the pile to fail in bending. This hypothesis is based on the reliable eye witness that the bridge failed 1 to 2 minutes after the earthquake started which clearly ruled out the possibility that inertia (during the initial strong shaking) was the contributor to the collapse. Figure 3 shows the longitudinal section of the river along with the pile displacement profile following the earthquake.

Figure 2. Soil liquefaction profile (in grey), Hamada and O'Rourke (1992).

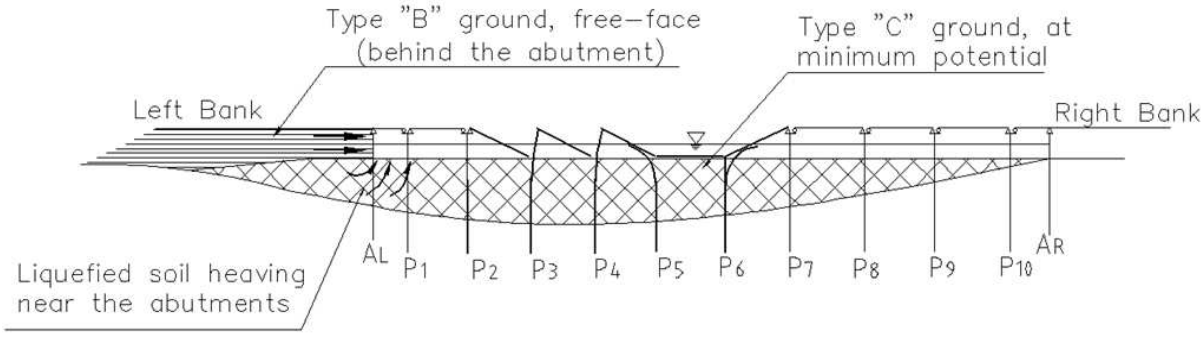
Bhattacharya (2003), Bhattacharya and Bolton (2004), Bhattacharya *et al* (2005) reanalysed the bridge and showed that the lateral spreading hypothesis cannot explain the failure of the bridge. It was argued that had the cause of failure been due to lateral spreading, as suggested, the piers (see Pier P5 and Pier P6 in Figure 3) should have displaced identically in the direction of the slope. Also the piers close to the riverbanks did not fail, where the lateral spreading was observed to be severe.

Figure 3. Liquefaction profile at Showa Bridge divided into ground types as defined by Hamada et al. (1986) cases (B) and (C). The soil profile has been adapted from Hamada (1992).

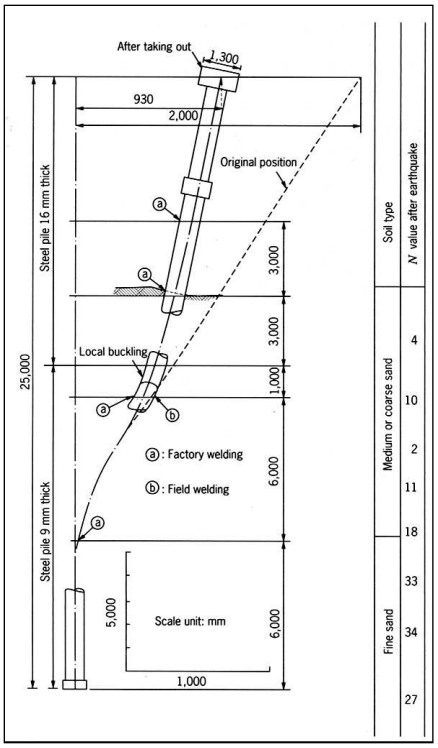
Figure 4. Deformed shape of a recovered pile (P4 as shown in Figure 3) after the earthquake. The original shape refers to the position just after the earthquake, Fukuoka (1966).

From the shape of the deformed pile (Figure 4) of the bridge, Berrill and Yasuda (2002) inferred that the movement of the liquefied sand layer towards the river may have caused the deformation of the pile. Figure 9 shows a numerical model to study this effect to verify this aspect. A summary of the analysis is given below:

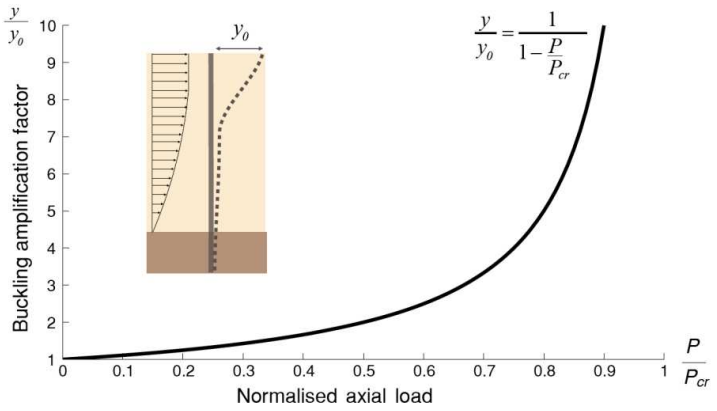
Figure 5. Buckling amplification factor for different ratios of P/Pcr.

The interaction between the axial and lateral load is generally referred to as P-delta effect. Stability analysis of elastic column (Timoshenko and Gere, 1961) shows that the lateral deflection (y_0) due to lateral loads is amplified in the presence of axial load (P) producing a final deflection of pile (y) as given in equation (2), which is also plotted in Figure 5.

The ratio y/y_0, commonly known as "Buckling Amplification Factor" (BAF), is a function of the critical buckling load, which depends on the boundary conditions of the pile.

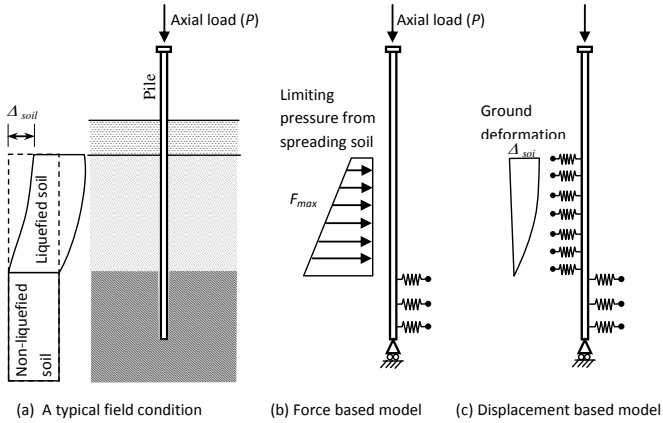
Figure 6. Force and displacement based models of pile-soil interaction in liquefiable soil.

For piles subjected to lateral spreading the value of y_0, due to the lateral load only, may be assessed considering two different methods: (a) Force based method; (b) Displacement based method. Figure 6 shows these two methods of representing a field condition. In force based method, the force from liquefied soil flow is represented by a limiting pressure (F_{max}) on pile. (see Figure 6b). Figure 6c illustrates displacement based method, where the lateral spreading is modelled by applying a displacement at the free ends of the soil springs. Typical results of pile response from these two methods with axial load are described in Figures 7 and 8.

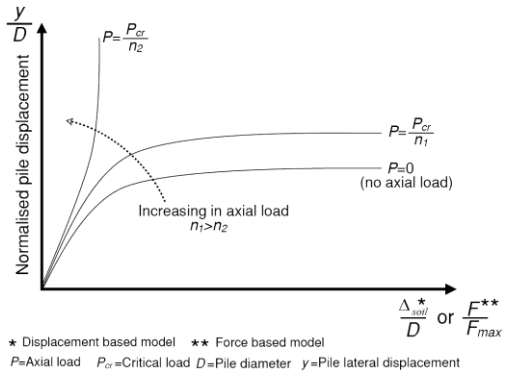
Figure 7. Pile head deflection response due to lateral and axial load.

Figure 7 shows the effect of the axial load on the bending response of a pile foundation, in terms of normalized pile displacement y/D (where y is the lateral displacement evaluated considering the effect of axial load) against either Δ_{soil}/D or F/F_{max} depending on the method of analysis (i.e., displacement based method or force based method). Clearly, Figures 7 and 8 show that when the axial load is higher with respect to critical buckling load, the pile head deflection (y) and maximum bending moment in pile get larger.

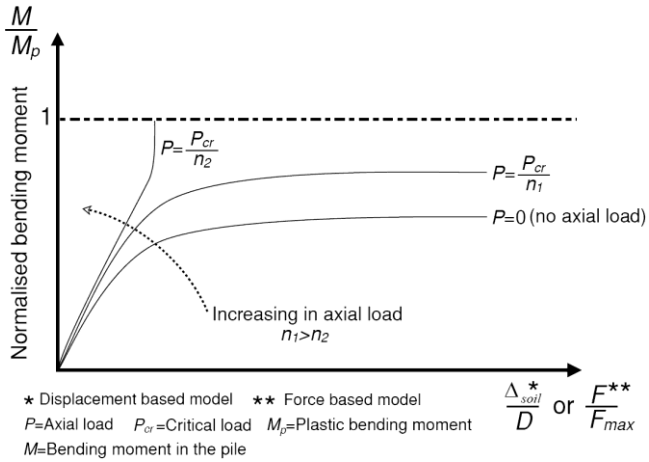
Figure 8. Pile bending moment response due to lateral and axial load.

During liquefaction, as the soil loses its stiffness, the elastic buckling load (P_{cr}) also reduces. Assuming a constant static axial load on pile, this also causes the P/P_{cr} ratio to increase. With the increasing P/P_{cr}, the pile head deflection and bending moment in pile also increase. When this ratio is close to 1, i.e., axial load is close to the buckling load, the bending moment amplification factor becomes very high, which leads the bending moment in pile to reach its plastic moment capacity, M_p, at a lower value of lateral load. The sudden rise in pile head deflection demonstrates the failure of the pile where bending moment reaches M_p and the pile continues to deflect without any additional loading. A similar behaviour can also be observed when the axially loaded piles in level liquefied ground are subjected to inertia loading.

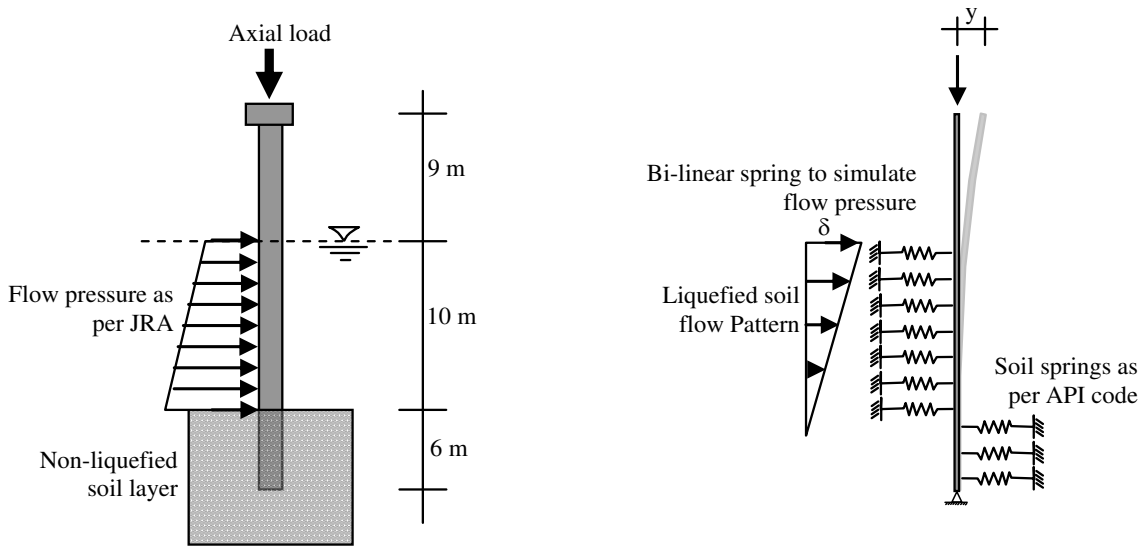
Figure 9. Analysis model for the Showa Bridge pile subjected to lateral soil flow and axial load. (a) Field condition. (b) Numerical model in SAP.

The axial load on each pile can be deduced from the configuration of the Showa Bridge deck. Bhattacharya *et al.* (2005) estimated the static dead load acting on each pile to be 740 kN. The length of the pile in the liquefiable soil zone is about 10 m and the underlying denser non-liquefied sand layer (6 m thick) can be assumed to provide restraint during lateral spreading. The 25 metre pile is therefore subjected to a combination of lateral and axial loads. The pile has been modelled as single standing frame element with lateral nonlinear soil springs at the bottom 6 m to simulate the restraint provided by

the non-liquefied soil layer. The spring constants were obtained from the API (2000) recommendation. The liquefied soil layer is modelled as bi-linear springs which simulate the maximum flow pressure of liquefied soil according to the JRA (Figure 9). Details of the finite element model are shown in Figure 9.

The pattern of the flow of the liquefied soil layer is assumed to have a triangular distribution. SAP2000 was used to perform a nonlinear static analysis for lateral soil flow under the axial loads given in Table 1. In these analyses the beam remains elastic. Figure 10 plots the pile head displacement (y) against the maximum ground deformation (δ) at the top of liquefied soil layer for the different axial loads. When the axial load is omitted (P=0), the pile is pushed over to give a pile tip displacement of about 0.6 m. If the axial load is included in the analysis, the pile tip suddenly becomes unstable (represented by the sharp increase in slope of the curve) at lower ground displacements. For an axial load of 370 kN, corresponding to half the weight of the deck, the pile becomes unstable with a surface lateral ground displacement of about 0.75 m. This figure falls to about 0.2 m when the full weight of the superstructure is applied to the pile. Thus this pile, that appears to be safe under the effect of lateral spreading alone, can fail under the combined action of axial load and lateral spreading.

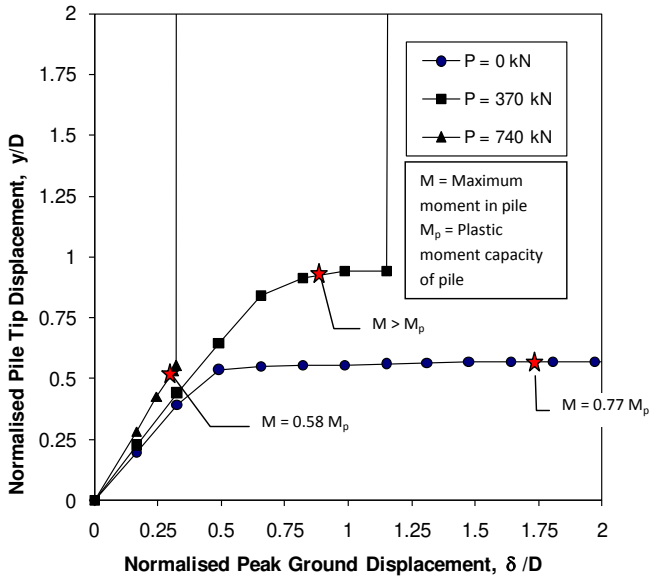
Figure 10. Influence of axial load on pile tip displacement

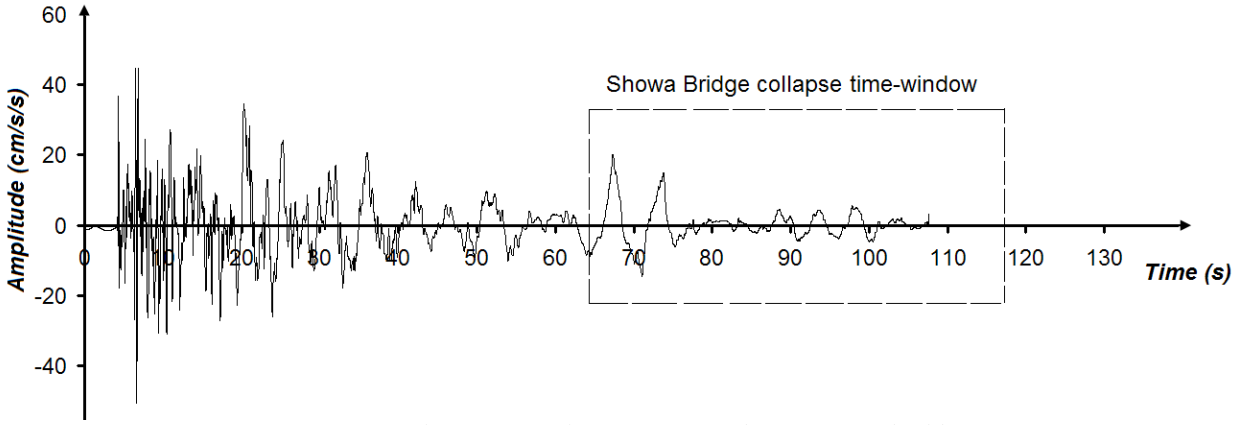
Figure 11 shows the acceleration information recorded from the basement of the Kawasgichi-Cho apartment which is about 2 km from Showa Bridge. This plot also shows the window when the Showa Bridge collapsed. It may be observed that there is slight increase in acceleration i.e. a shock wave or a jolt. It has been hypothesised, see Kudo *et al* (2000) and Yoshida *et al* (2007) that this shock wave or the jolt is from the same earthquake source and travelled the same path.

Figure 11. Acceleration time history at a nearby apartment building.

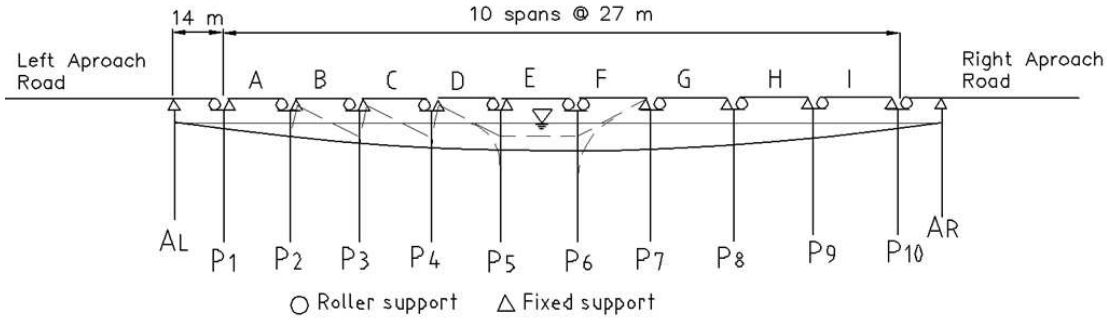
The numerical analysis carried out by Halder *et al* (2008) supports the study of Yoshida and Kudo (2000) that the liquefaction at the site occurred at about 12 seconds. After this instant, the pile can be considered to be unsupported in the liquefied zone i.e. the pile can be modelled as a long slender column. The superstructure of the Showa Bridge (i.e. the bridge decks) were composed of panels, each alternatively resting on roller and fixed supports, see Figure 12. The construction of the bridge was such that one end of the girders was locked and the other end was free to slide longitudinally off the piers except pier P6 which had both on roller supports. As discussed by Yoshida *et al* (2007), the predominant period of pier P6 would be different from the other such piers. It is reported that the seating length of the bridge pier was only 30 cm. The next section discusses two related issues:

Figure 12. Support of the bridge.

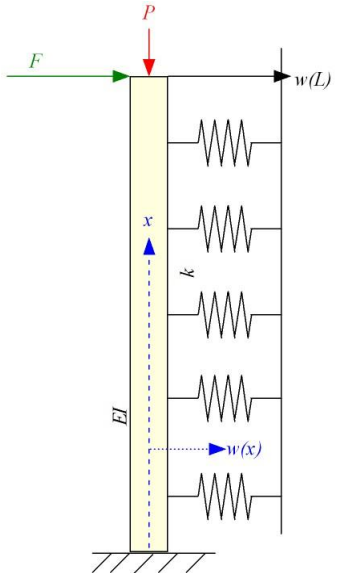
Figure 13. Combined pile-soil model using Euler Bernoulli beam with axial and lateral force resting against a distributed elastic support.

Figure 13 shows an Euler-Bernoulli beam having a bending stiffness of EI and resting against a linear uniform elastic support of stiffness k following Bhattacharya and Adhikari (2009), Bhattacharya *et al* (2009). A constant static lateral force F is applied at the top of the beam (x=L). The well known equation of static equilibrium can be expressed as:

It is assumed that the mechanical properties of the beam are constant along the length. Equation (3) is a fourth-order partial differential equation and requires four boundary conditions for its solution. To comment on the pile head deflection, it is necessary to find the deflection at the top of the beam (Δ) in terms of k (soil support), P and EI.

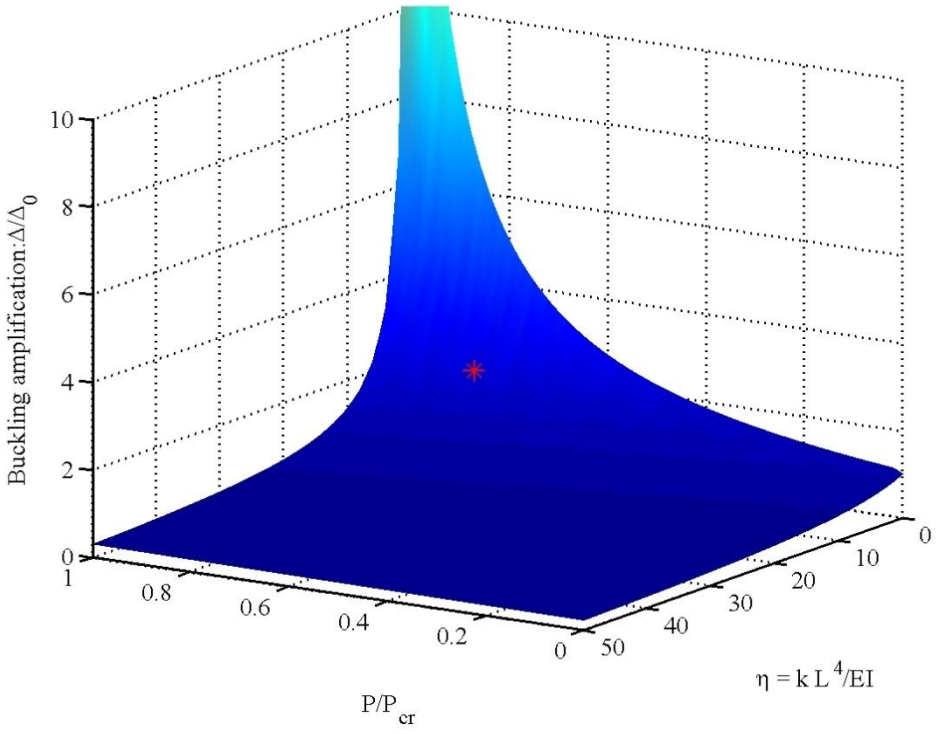
Figure 14. Variation of displacement amplification factor ($\frac{\Delta}{\Delta_0}$) due to support stiffness and axial load.

The first two parameters for the Showa Bridge case is presented in Table 2. Based on the above analysis, it can be estimated that the pile head deflection will increase by a factor of at least two times under the action of axial load. This enhanced deflection of the pile head may be adequate to dislodge the decks of the pier support. The star mark "*" in Figure 14 shows the point for Showa Bridge pile.

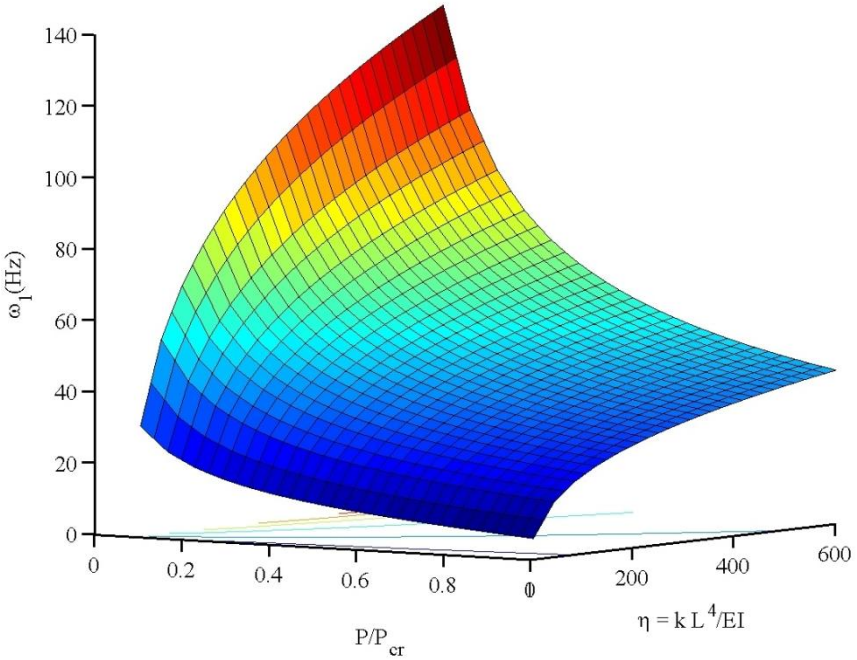
Figure 15: Variation of the first natural frequency of the cantilever pile with respect to the normalized support stiffness for different values of axial load.

In addition to the above, the frequency of a bridge deck-pile-soil system will change with the liquefaction-induced stiffness degradation of the soil surrounding the pile; see for example the analytical work carried out by Adhikari and Bhattacharya (2008), Bhattacharya *et al* (2009). Usually, the time period of vibration of a pile-supported structure is estimated based on formulas which are derived from internationally calibrated data; see Chopra and Goel (2000). This time period depends on the dimension of the superstructure without any consideration to the foundation. However, during and after liquefaction, as the pile loses its lateral confinement, it becomes an integral part of the superstructure. The frequency of the structure may alter substantially and in most cases will reduce. Reduction in fundamental frequency of the structure will increase its flexibility and the structure may suffer more lateral deformation. The bending moment in the piles may increase significantly if the altered natural frequency of structure comes close to the driving frequency of the earthquake. Figure 15 shows the results of the analysis of a cantilever pile where the variation of the first natural frequency (ω_1) is plotted with respect to the normalized support stiffness (η) and the normalized axial load (P/P_{cr}), where P_{cr} is the Euler's critical buckling load.

Fukuoka (1966) reports the time period of the bridge is about 2 seconds. A simple estimate shows that at full liquefaction, the time period of the bridge increases by about 3 times (i.e., about 6 seconds). As the bridge failed at about 70 seconds, it is more likely that the peak in the acceleration time history possibly due to aftershock triggered an increased pile head displacement which got amplified due to the P-delta effect resulting in dislodging of the deck of pier P_6. The other decks followed soon after.
