Preliminary Field Assessment of Sinkhole Damage in Pokhara, Nepal

KEYWORDS: sinkholes, site investigation, dynamic cone penetration test, surface wave method, Pokhara

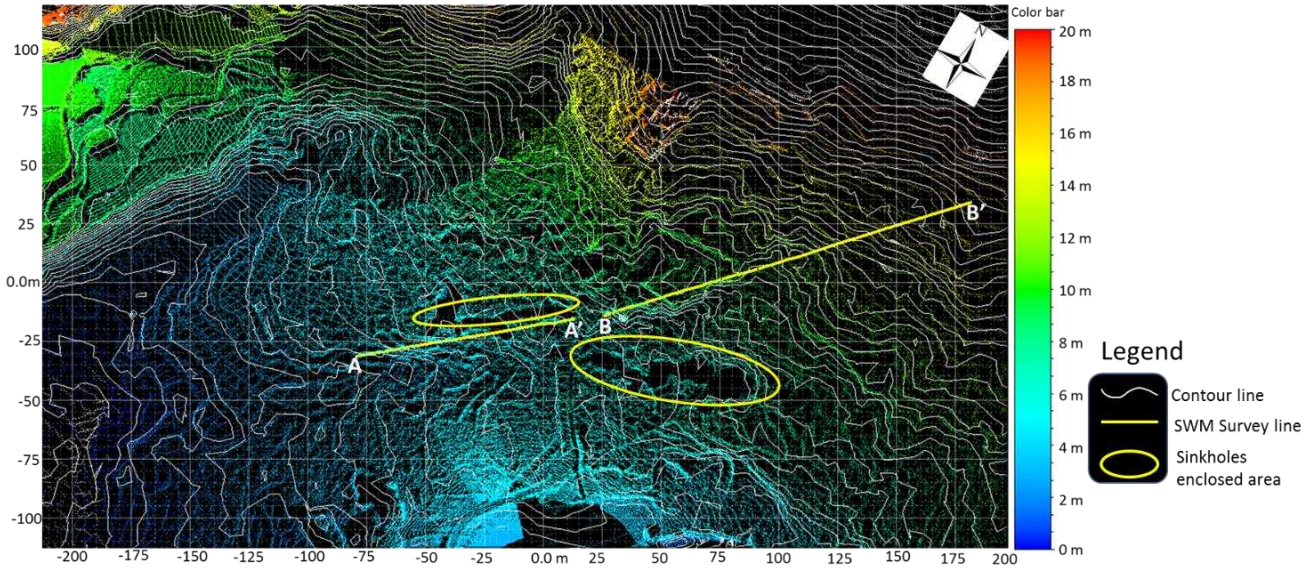
A detailed map of the study area reporting the location of sinkholes observed in June and November 2014, photo points and field investigations are shown in Figure 2. Topographically, the study area is a low-elevated zone as shown by the bird's eye view presented in Figure 3. This 3D image was obtained by overlapping LiDAR scanning carried out at three different locations (i.e. LS-1, LS-2 and LS-3 reported in Figure 2). There is a very gentle slope in the south-east direction, while a steep slope can be noticed in the north-west part. The black zones enclosed within circles are interconnected sinkholes as observed in November 2014.

Figure 3. Bird's eye view of the sinkhole effected area.
