Stability Analyses of the 1981 San Luis Dam Slide

Ashok K. Chugh, *Civil Engineer, U.S. Bureau of Reclamation, Denver, CO 80225, USA; email: achugh@usbr.gov*
D.V. Griffiths, *Professor, Colorado School of Mines, Golden, CO 80401, USA; email: d.v.griffiths@mines.edu*

KEYWORDS: analysis; case history; dams; failure; slope stability; two- and three- dimensional numerical analysis

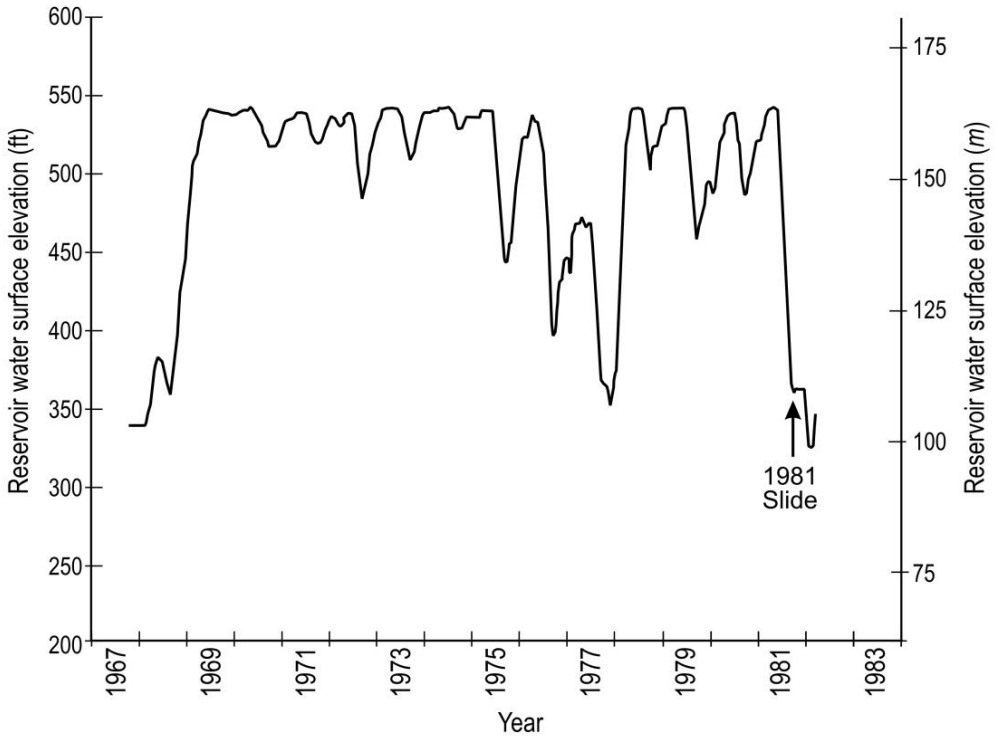
Figure 1. San Luis Dam site: (a) Elevation view of the 1981 slide; (b) Reservoir operational history.

2. Observations of the 1981 slide: The following field observations of the slide were noted by VonThun (1985) – see Figures 1(a), 2, and 3: First cracking occurred about 30 m (100 ft) down the u/s slope near the crest of an enveloped hill (near station 135) and progressed down the abutment towards more voluminous cross sections. The characteristics and progression of the slide mass are summarized as: (a) began as an arc-shaped crack, with ends of the arc parallel and perpendicular to the dam axis; (b) progressed from the initial length of about 150 m (500 ft) to an ultimate length of about 450 m (1475 ft); (c) took about two months to fully develop and stabilize; (d) formed a distinct pressure ridge at the toe moving over a portion of the toe of the dam for a distance of about 10 m (30 ft); and (e) moved on the order of 20 m (65 ft) with a 15 m (50 ft) vertical scarp. In view of the size of objects in Figure 1(a), the 15 m (50 ft) dimension for the vertical scarp seems to be in error (an over-estimate) – it is listed as 7.6 to 9.1 m high in Penman (1986) and 10 m high in Duncan and Wright (2005).

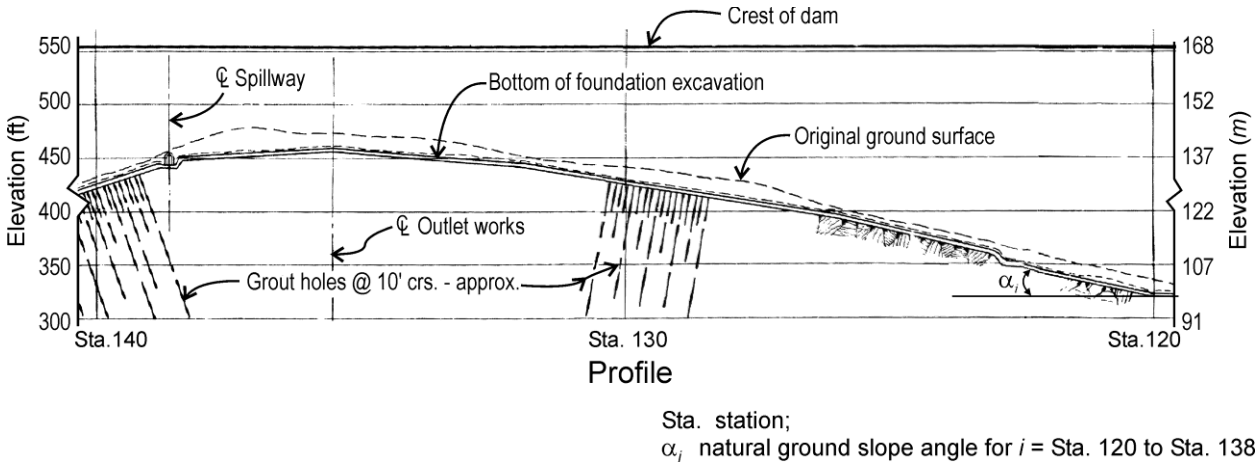
Figure 2. Profile view along the centerline of the San Luis Dam site between stations 120 and 140.

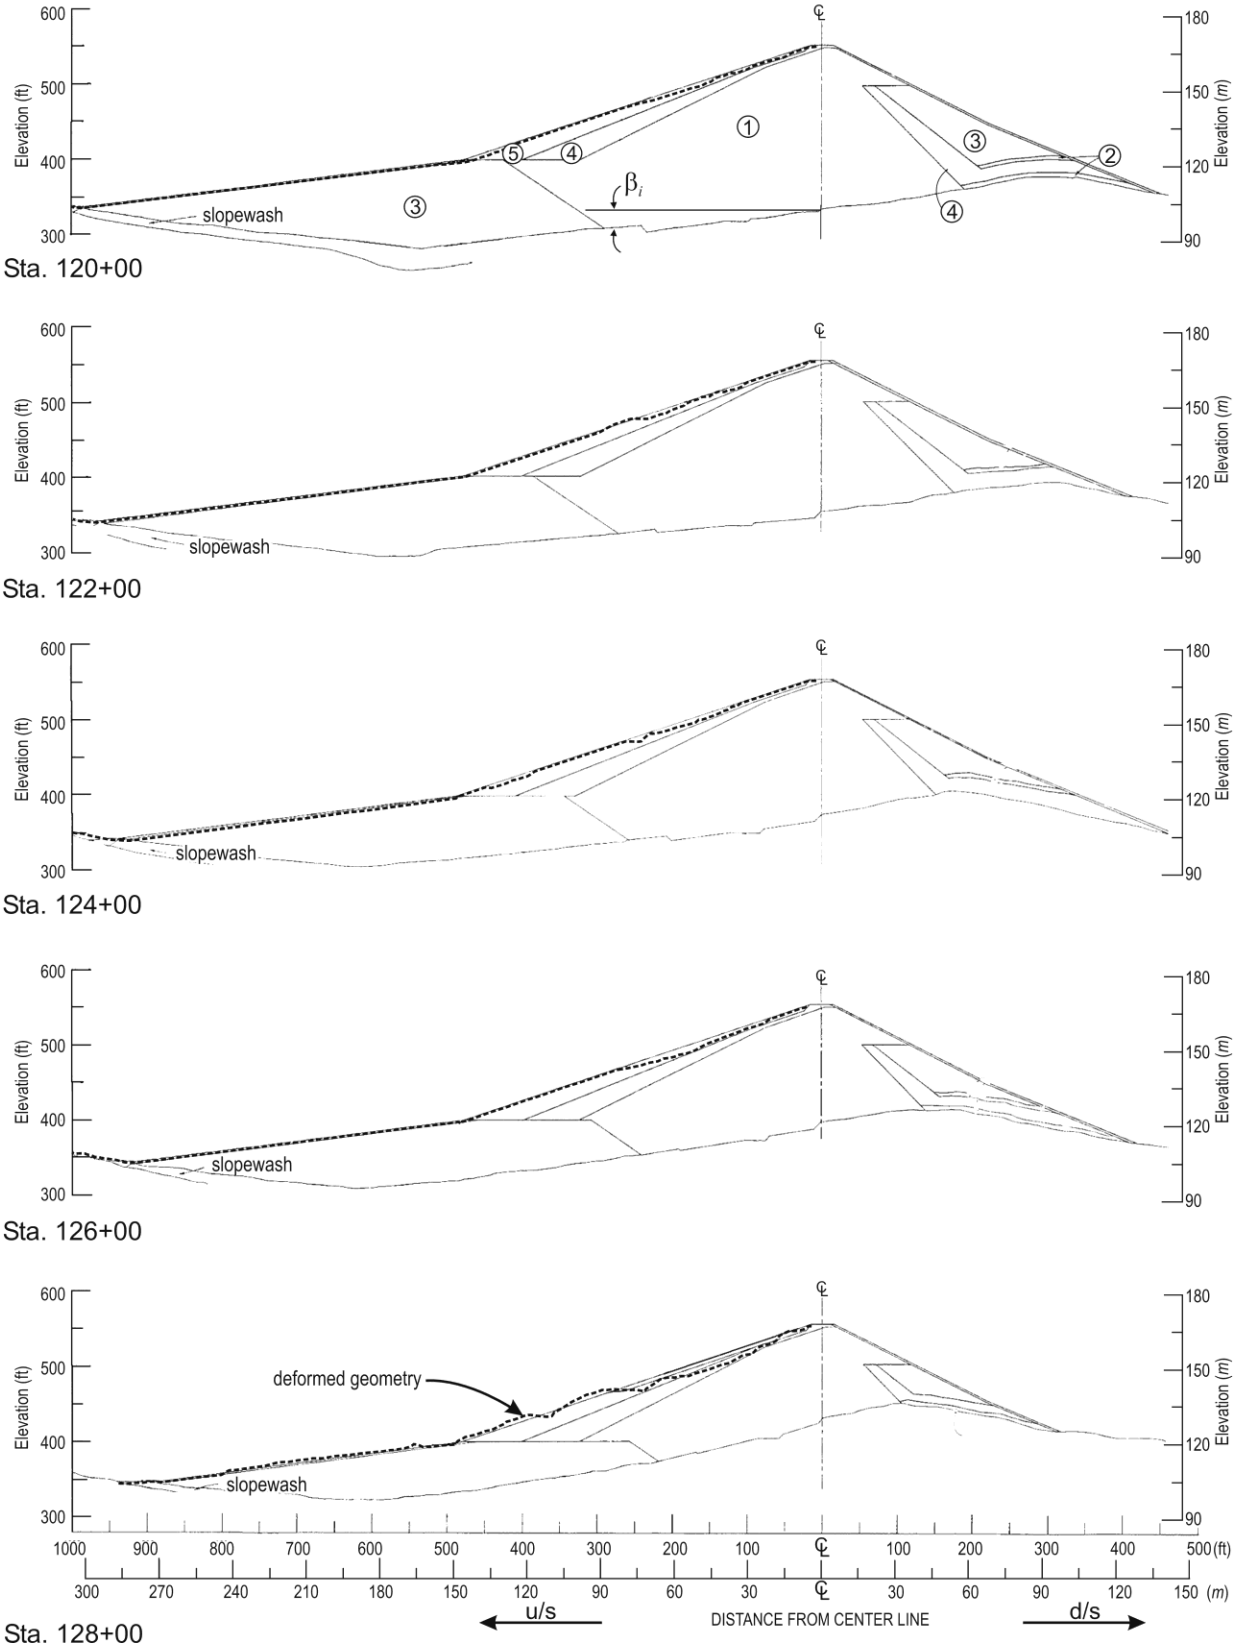
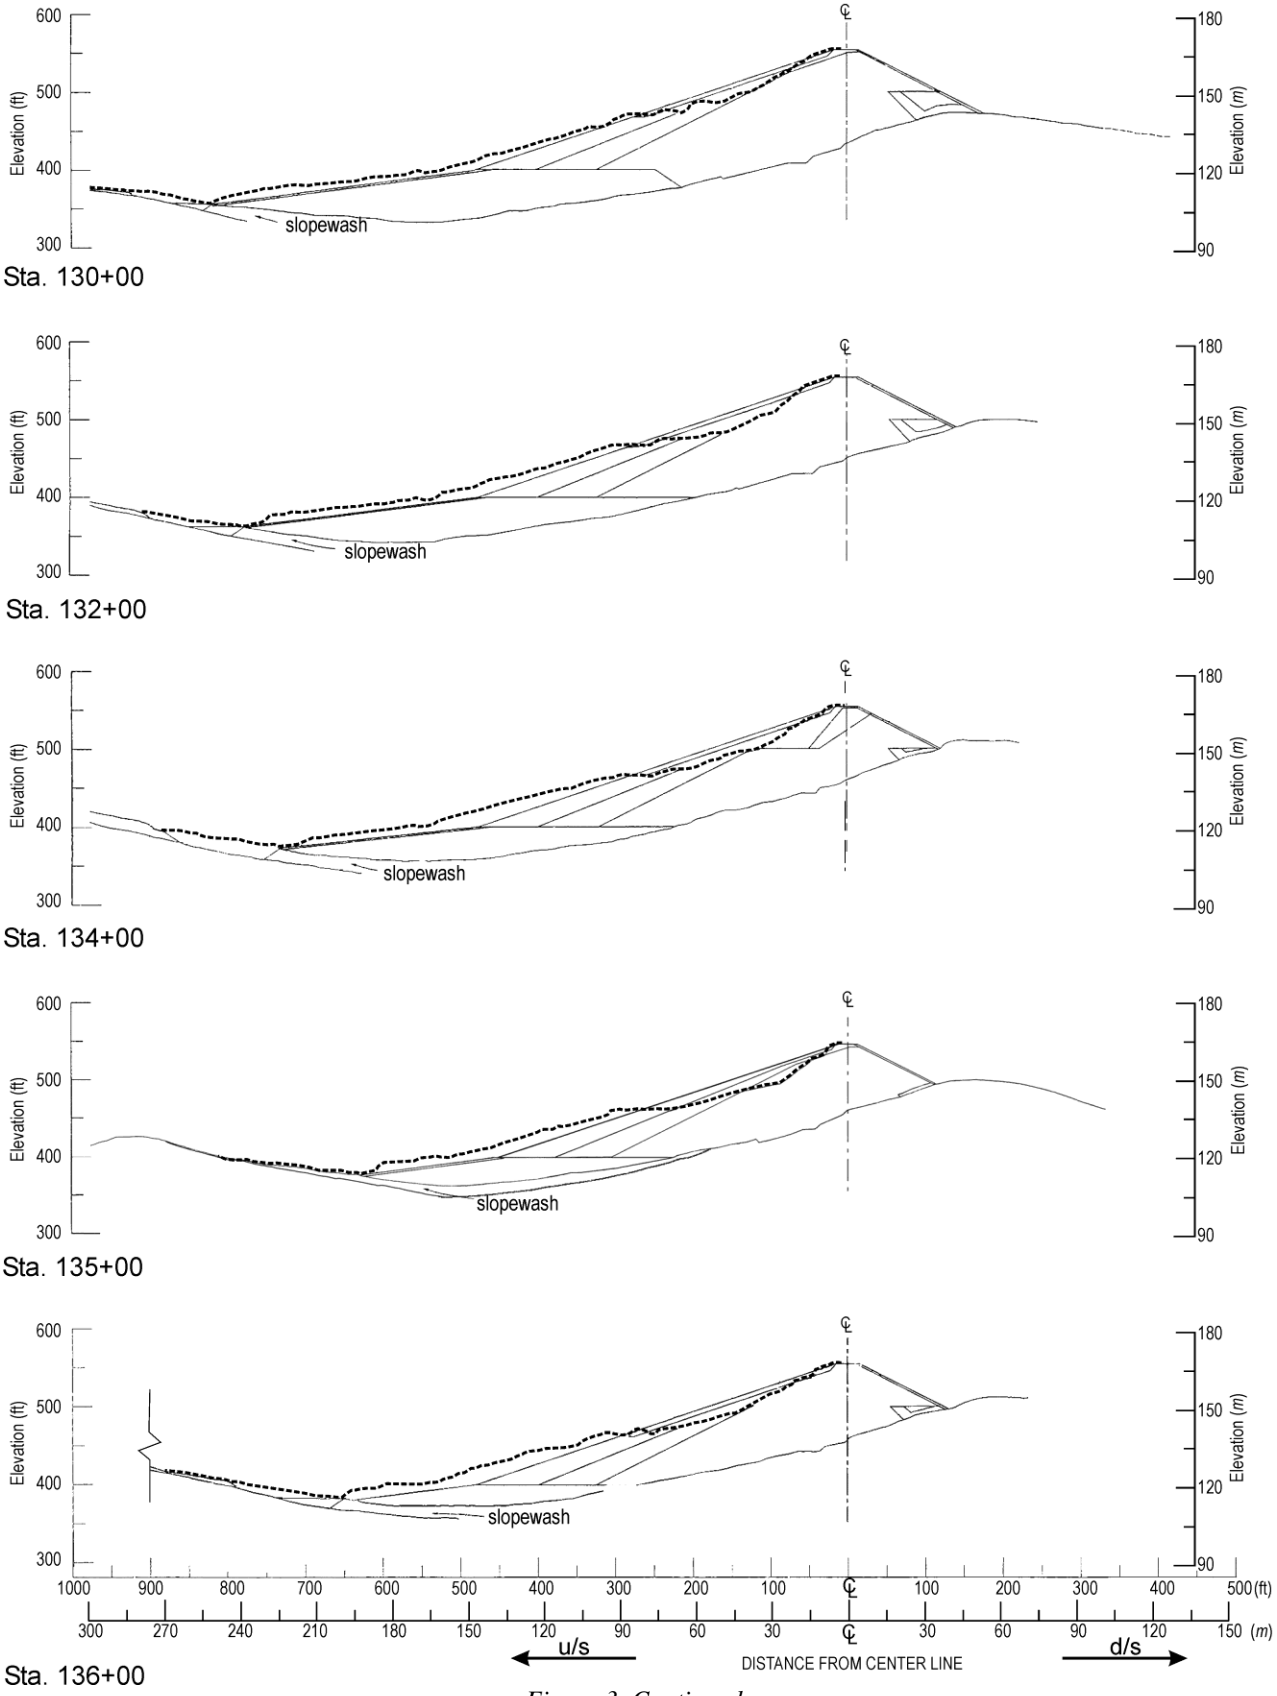
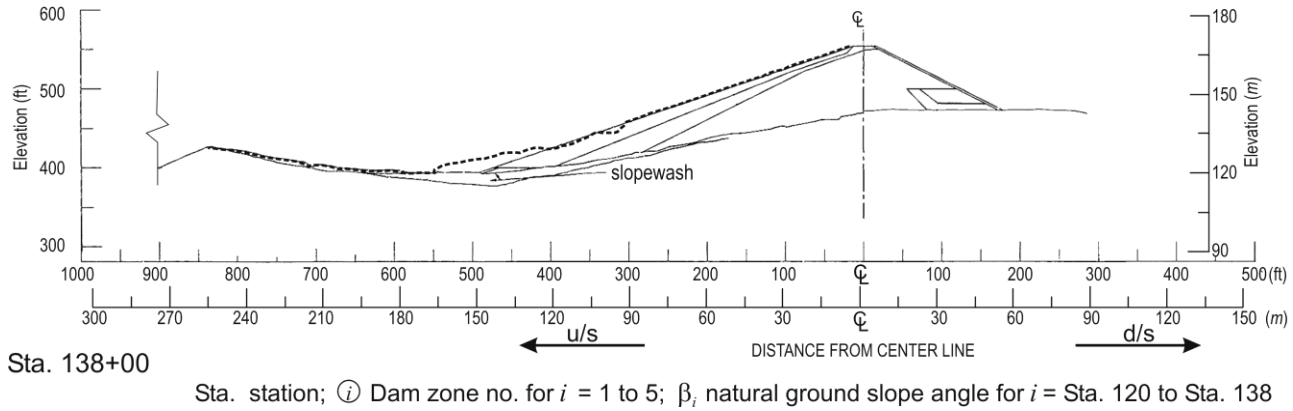
Figure 3. Cross section views of the San Luis Dam from station 120 to station 138 showing the original and deformed configuration of the dam.

The dam zones are identified on cross section at Station 120 in Figure 3, the same zoning identification applies to all cross sections included in this figure. All materials were placed in lifts and compacted with appropriate equipment typical of the period (1963 - 1967).

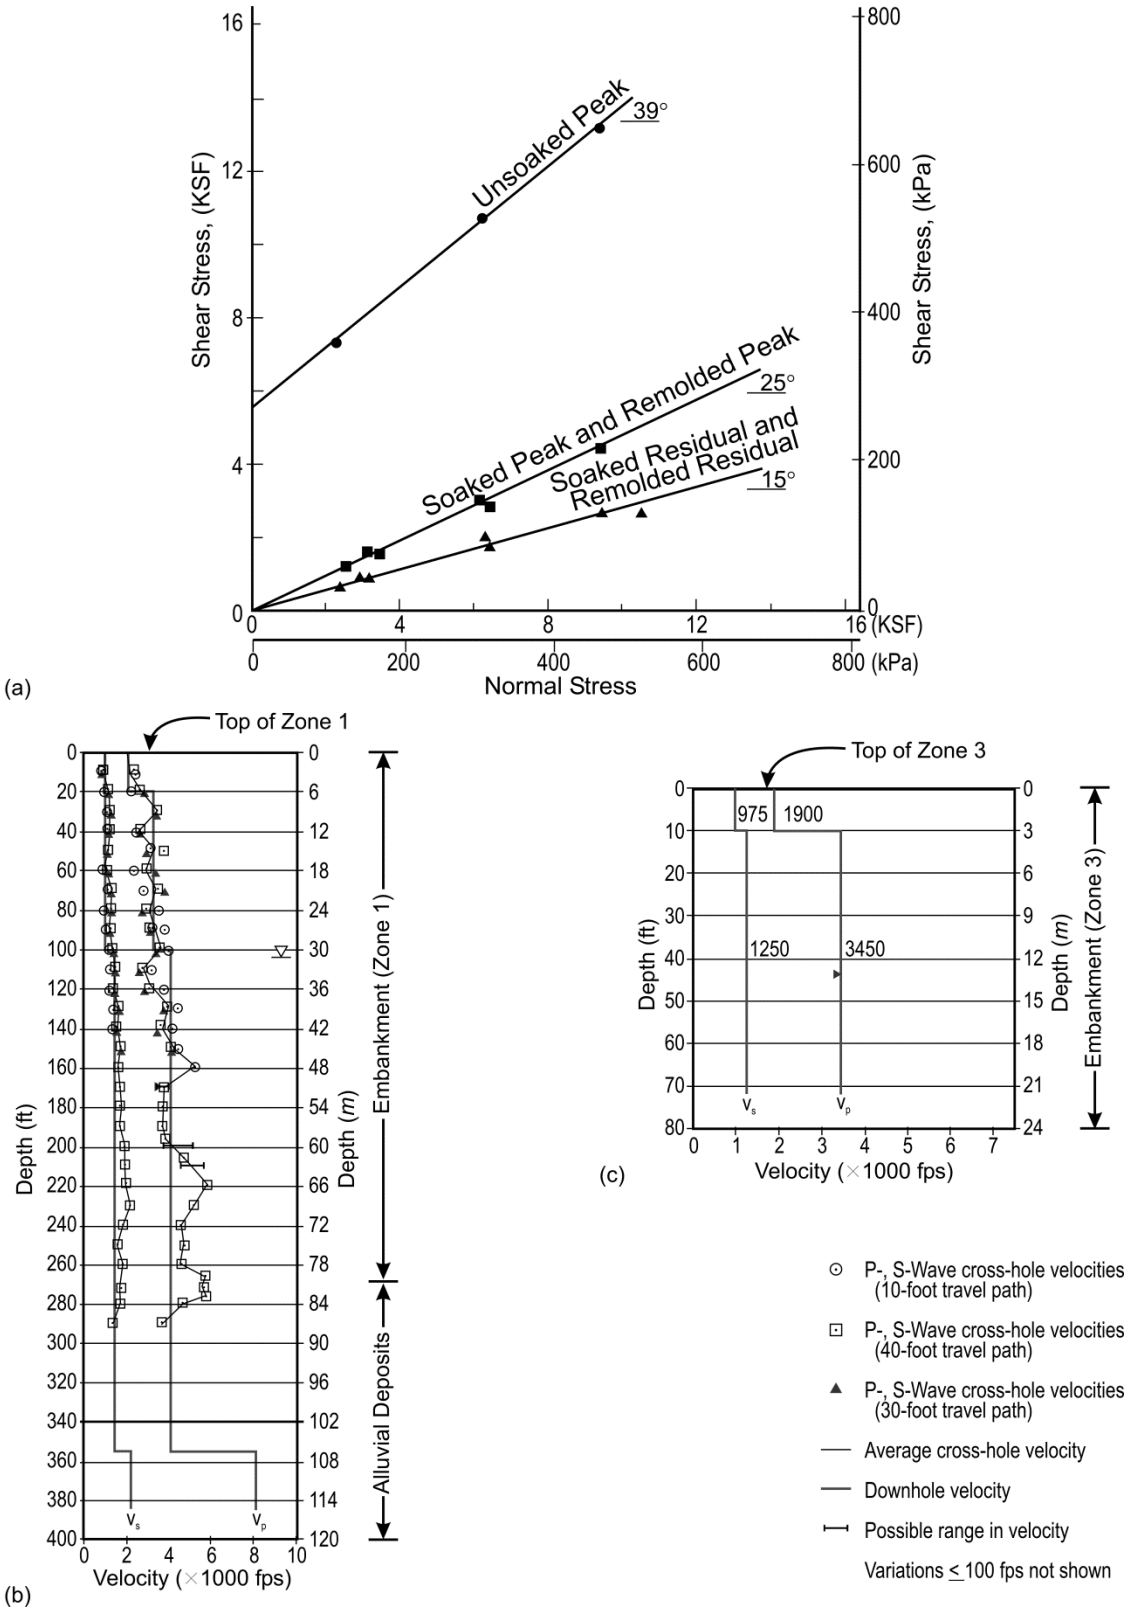
Laboratory tests of slopewash block samples from u/s and d/s resulted in the following index parameters: liquid limit ranging from 35 to 45, plastic limit ranging from 18 to 24; which yields the PI in the range 17 to 21. The preconsolidation pressure for the u/s (wetted) slopewash was estimated from oedometer tests to be in the range of 100 to 150 kPa (2 to 3 kip/ft^2); this results in an over-consolidation ratio in the range of 2 to 3 in the reach of the slide. Shear strength values from direct shear tests on the slopewash are shown in Figure 4. The drained peak shear strength is c' = 260 kPa (5500 psf), φ' = 39°; fully-softened shear strength is c' = 0, φ' = 25°; and residual shear strength is c' = 0, φ' = 15°. The shear strength envelopes show large difference in the peak, fully softened, and residual shear strengths. Details of the laboratory tests are included in Stark (1987) and Stark and Duncan (1991).

Figure 4. Material properties: (a) Shear strength descriptions of the slopewash material (Stark and Duncan 1991), reproduced with permission of ASCE; (b) and (c) Compression and shear wave profiles near the center of the dam at about station 85 (Black and Nelson, 1981), reproduced with permission of AMEC.

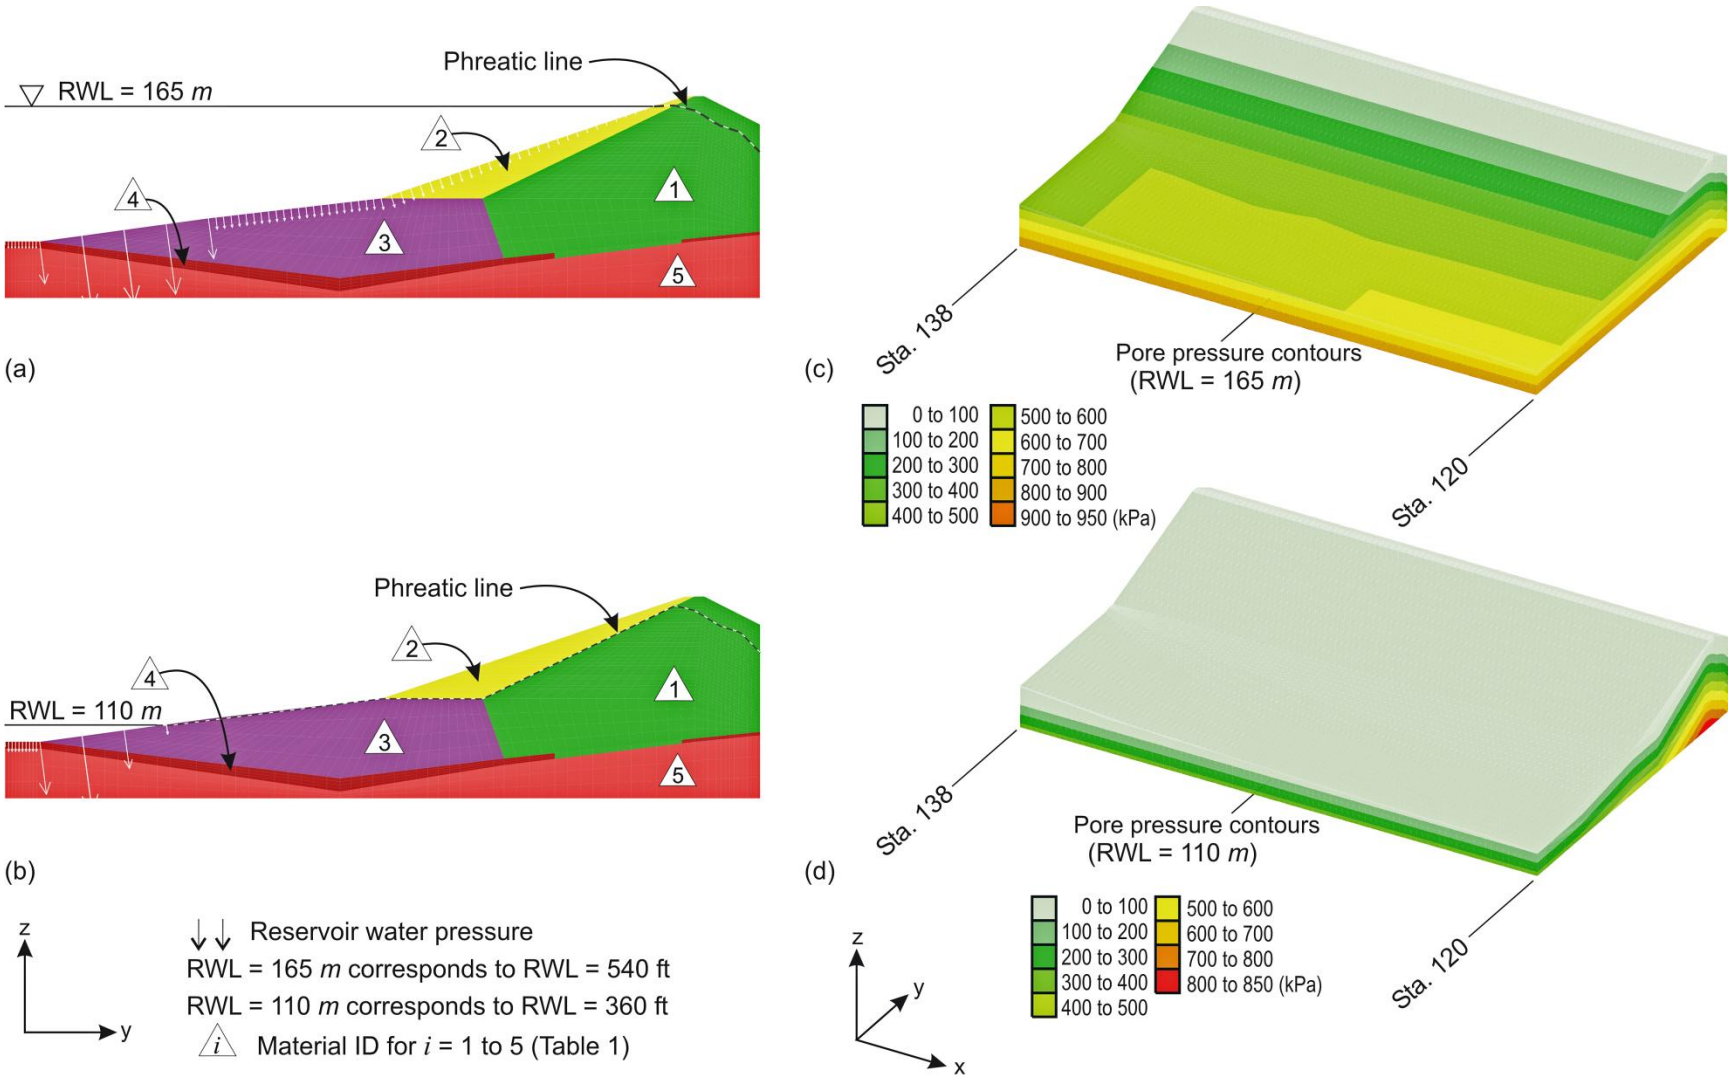
Two reservoir water level conditions of interest are (a) steady-state RWL = 165 m (540 ft) and (b) rapid-drawdown RWL = 110 m (360 ft). For RWL = 165 m, the phreatic surface was estimated from the available instrumentation data prior to the 1981 slide and calibrated 2-D finite-element-based seepage analyses of dam cross sections outside the reach of the 1981 slide (Mantei, 1982). For RWL = 110 m, the phreatic surface was assumed (due to lack of instrumented data) to rise from elevation 110 to elevation 165 along the interface between the shell and core and then follow the steady-state phreatic surface (Lamb and Whitman, 1969). Reservoir water pressure on the upstream face of the dam corresponds to the RWL condition being considered in the analysis. For illustration, Figure 5 shows the two reservoir water level conditions and associated phreatic surfaces for the cross section located at station 120; spatial layout of the reservoir and associated phreatic surface from station 120 to 138 are shown as pore pressure contours. Reservoir water loading conditions vary along the length of the slide due to changes in the ground elevations. For the RWL = 110 m condition, in locations where ground elevation is higher than elevation 110 m, there is no surface pressure due to the reservoir water.

Figure 5. Reservoir water level and associated phreatic surface/pore pressure contours in the reach of the slide (used in 2- and 3-D analyses): (a) RWL = 165 m (540 ft), cross section at station 120; (b) RWL = 110 m (360 ft), cross section at station 120; (c) RWL = 165 m (540 ft), perspective view from station 120 to Station 138; (d) RWL = 110 m (360 ft), perspective view from station 120 to Station 138.

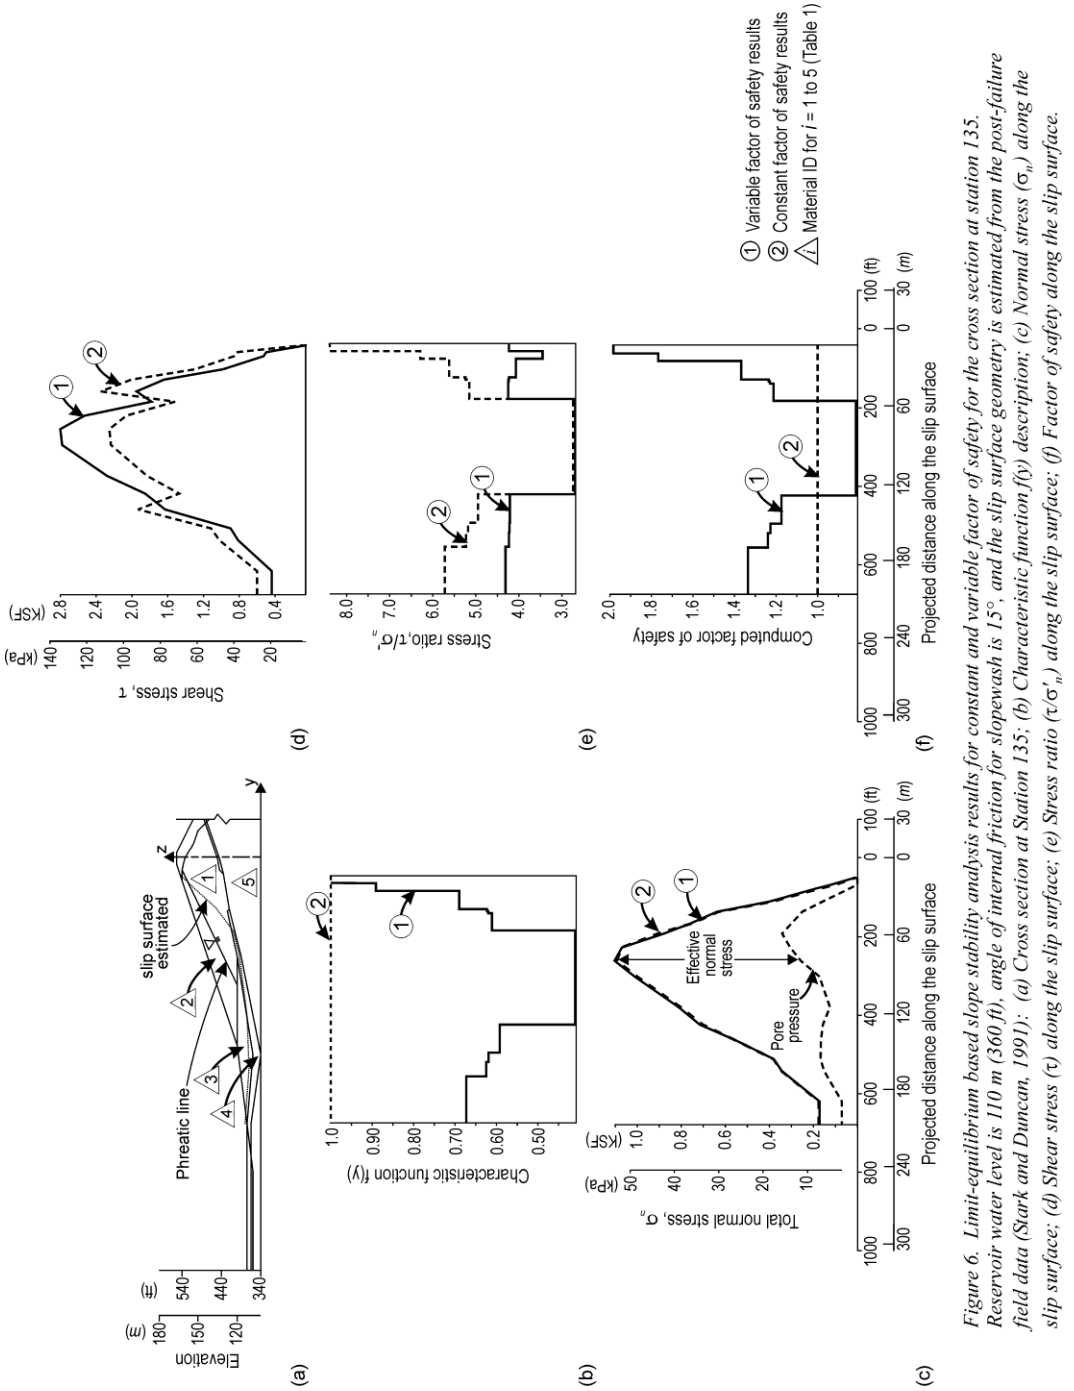
(a) For RWL = 110 m (360 ft), and residual shear strength (c' = 0 and φ' =15°), the computed factor of safety for the cross section at station 135 is 0.994. This result agrees well with the value of unity included in Stark and Duncan (1991) and the slope failing in 1981.

Figure 6. Limit-equilibrium based slope stability analysis results for constant and variable factor of safety for the cross section at station 135. Reservoir water level is 110 m (360 ft), angle of internal friction for slopewash is 15°, and the slip surface geometry is estimated from the post-failure field data (Stark and Duncan, 1991): (a) Cross section at Station 135; (b) Characteristic function f(y) description; (c) Normal stress (σ_n) along the slip surface; (d) Shear stress (τ) along the slip surface; (e) Stress ratio (τ/σ'_n) along the slip surface; (f) Factor of safety along the slip surface.

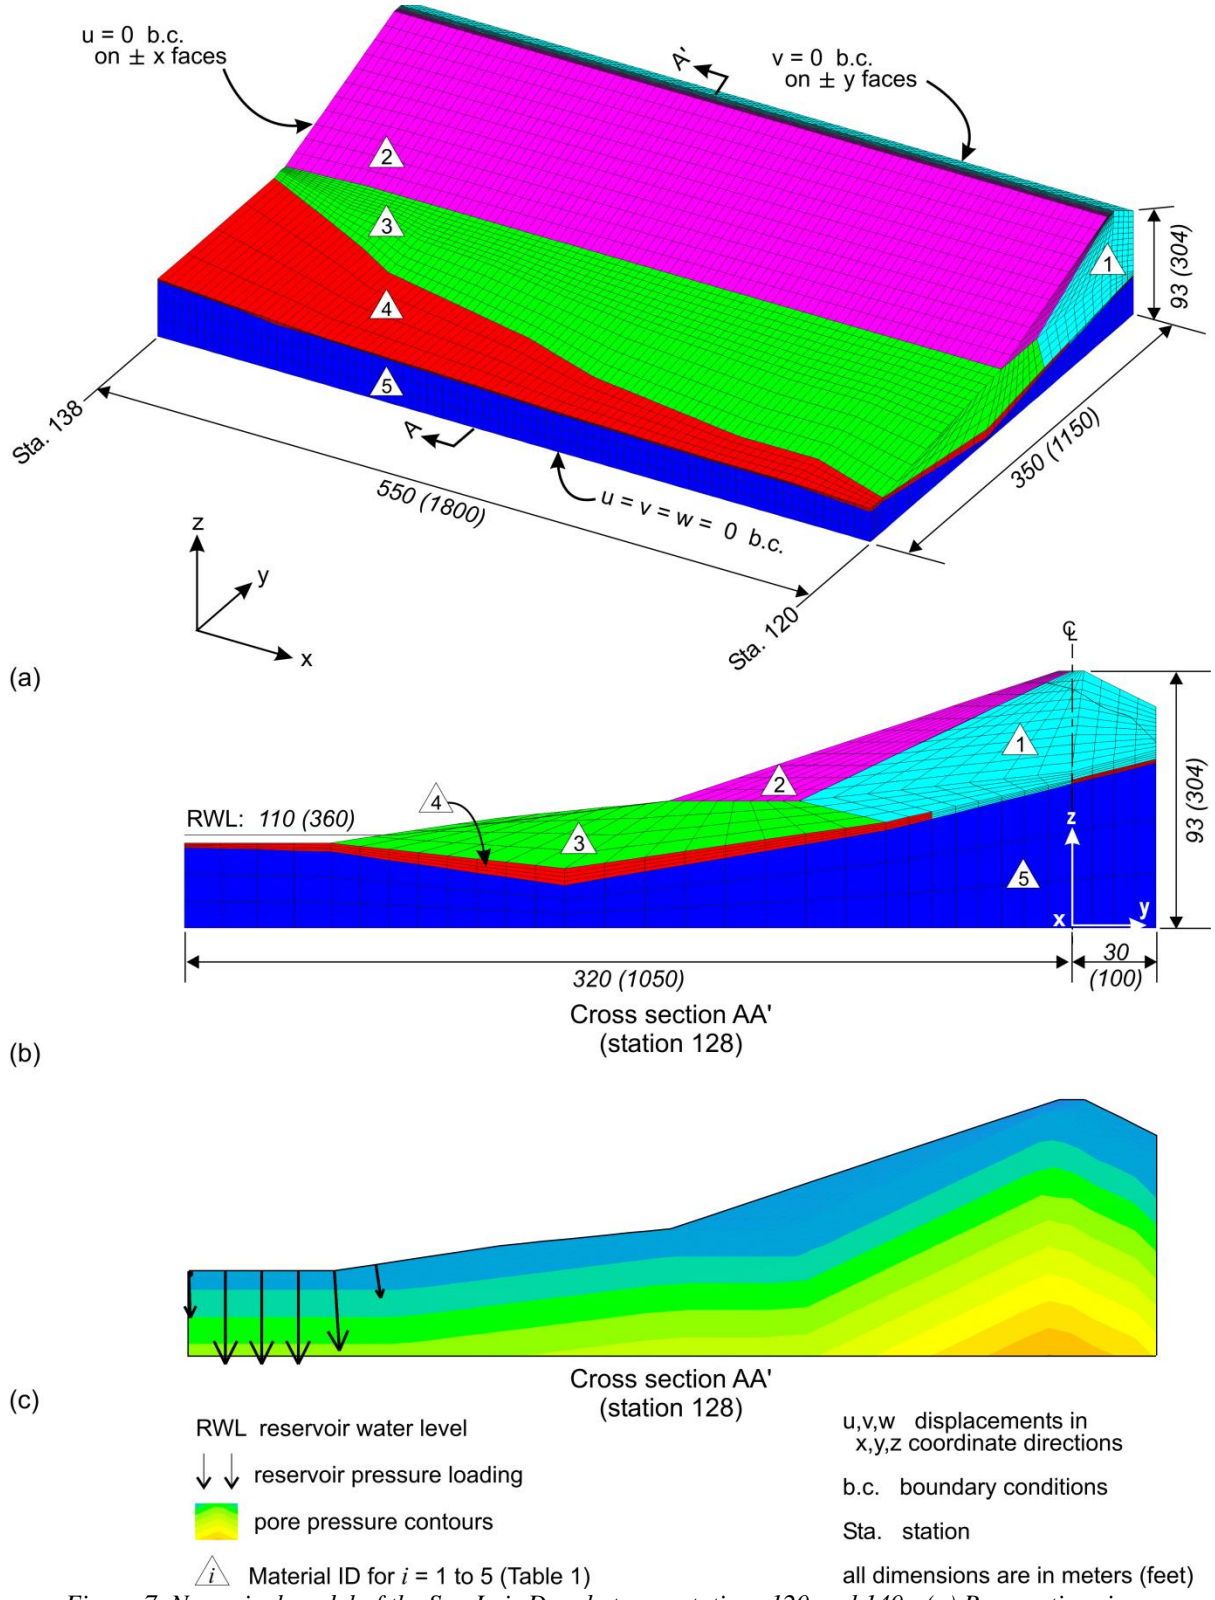
Figure 7. Numerical model of the San Luis Dam between stations 120 and 140: (a) Perspective view; (b) Cross section view at station 128; (c) Reservoir water and pore pressure for RWL = 110 m (360 ft) at station 128.

Figure 7(a) shows the perspective view of the 3-D numerical model of the San Luis Dam between stations 120 and 138. Figures 7(b and c) show the cross section view of the model, the reservoir pressure loading, and the pore pressure contours for a cross section located at station 128 for RWL = 110 m (360 ft). The reservoir pressures shown in Figure 7(c) are modeled as nodal forces. The force vectors for the end-nodes are half as big as for the central nodes because the contributing area is half as big. The boundary conditions for the 2- and 3-D analyses are shown on Figure 7(a).

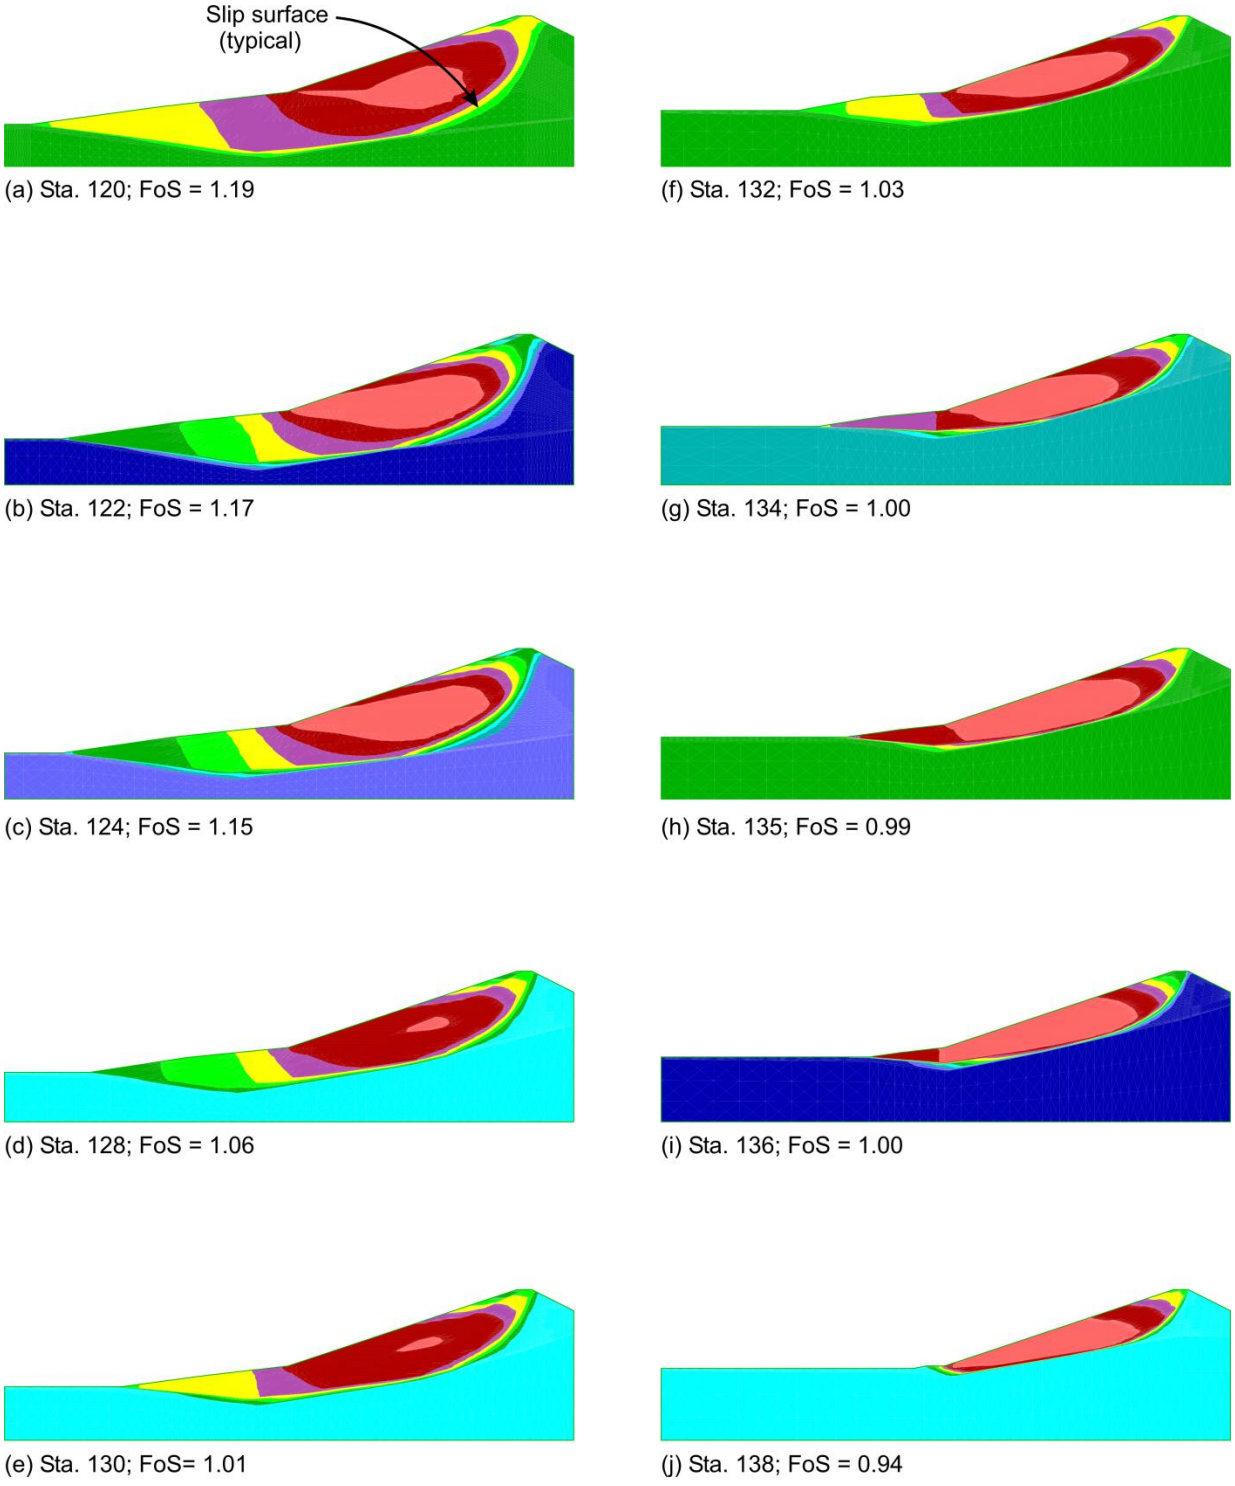
(b) For RWL = 110 m (360 ft), and residual shear strength (c' = 0 and φ' =15°), the computed factor of safety for the cross section at station 135 is 0.69. It is also significantly less than 1.0 for all other cross sections in the reach of the 1981 slide. These results do not agree with the field data which show the severity of the 1981 slide is intense between stations 128 and 136, and it diminishes outside this range, see Figure 3.

Figure 8. Slope stability analysis results of the two-dimensional continuum models from station 120 to station 138. Reservoir water level is 110 m (360 ft), angle of internal friction for slopewash is 22°, and the slip surface geometry is as determined by the continuum-mechanics-based computer program FLAC.

(c) For RWL = 110 m (360 ft) and an adjusted value of shear strength (c' = 0, φ' = 22°) for the slopewash, the factor of safety for the cross section at station 135 is 0.99. Also, the factor of safety for other cross sections located between stations 130 and 138 hovers around 1.0 (0.94 to 1.03) and is greater than 1.0 (1.06 to 1.19) for cross sections located between stations 120 and 128. These results agree well with the 1981 slide which had stretched between stations 120 and 138 with high intensity of distress between stations 128 and 136, and diminishing intensity outside this range – see Figure 3.

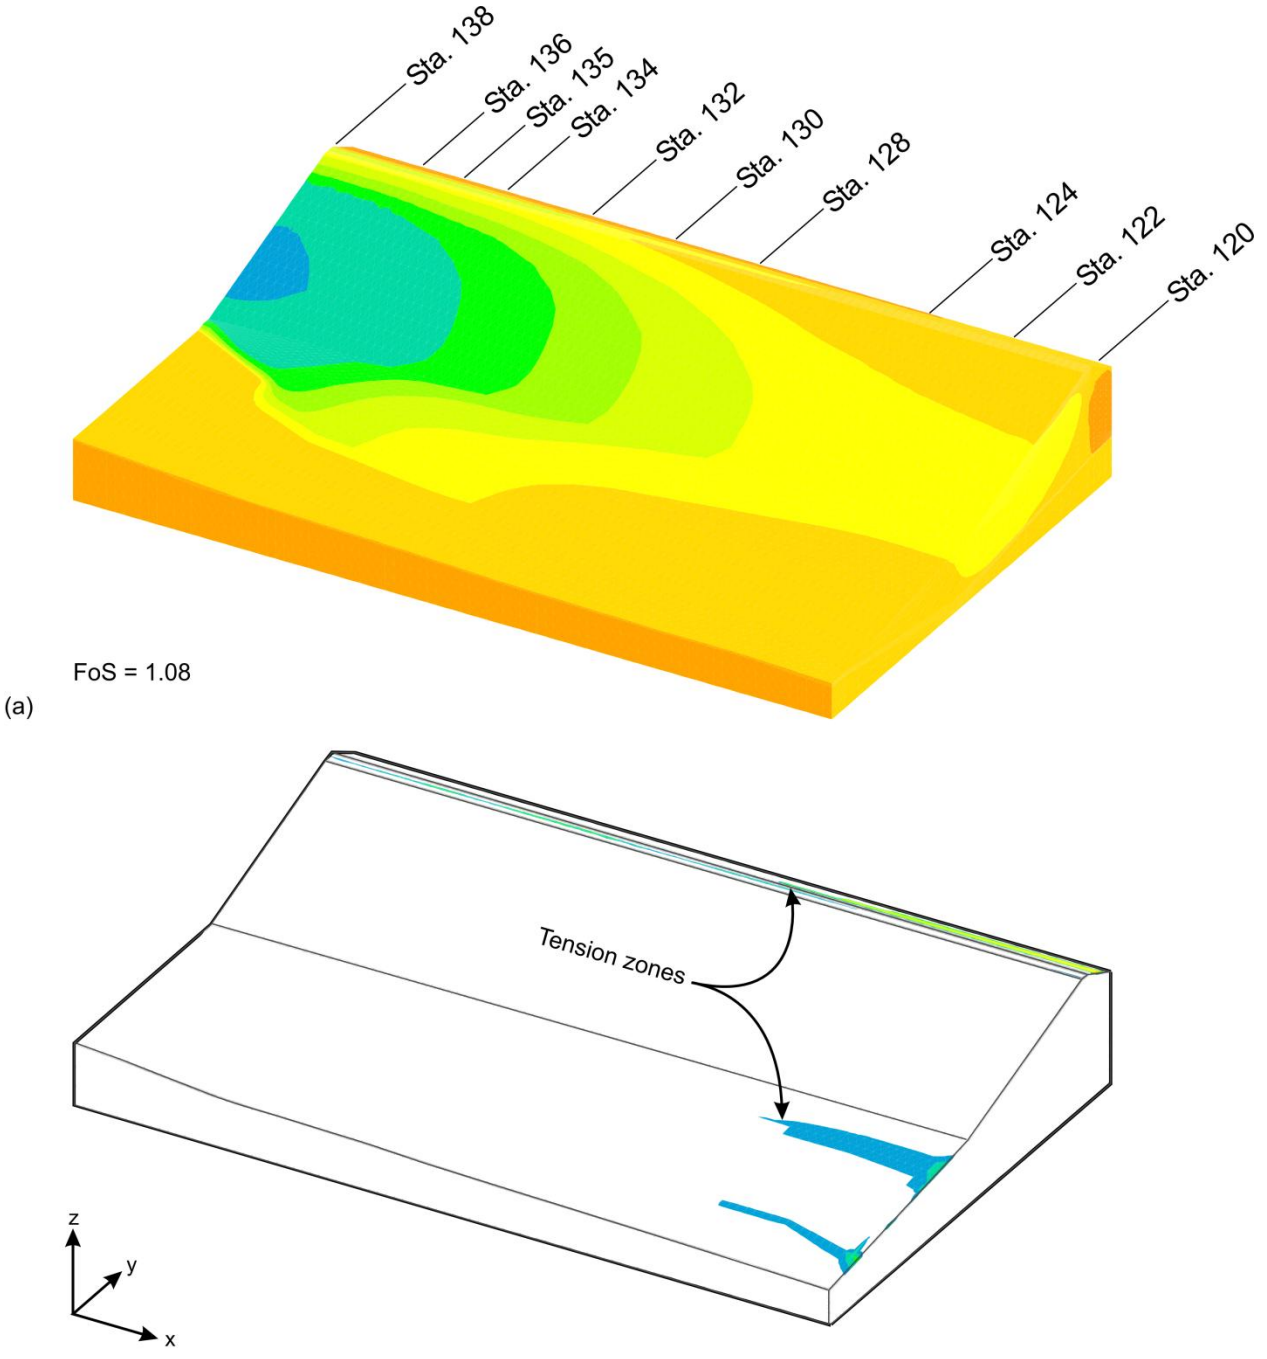
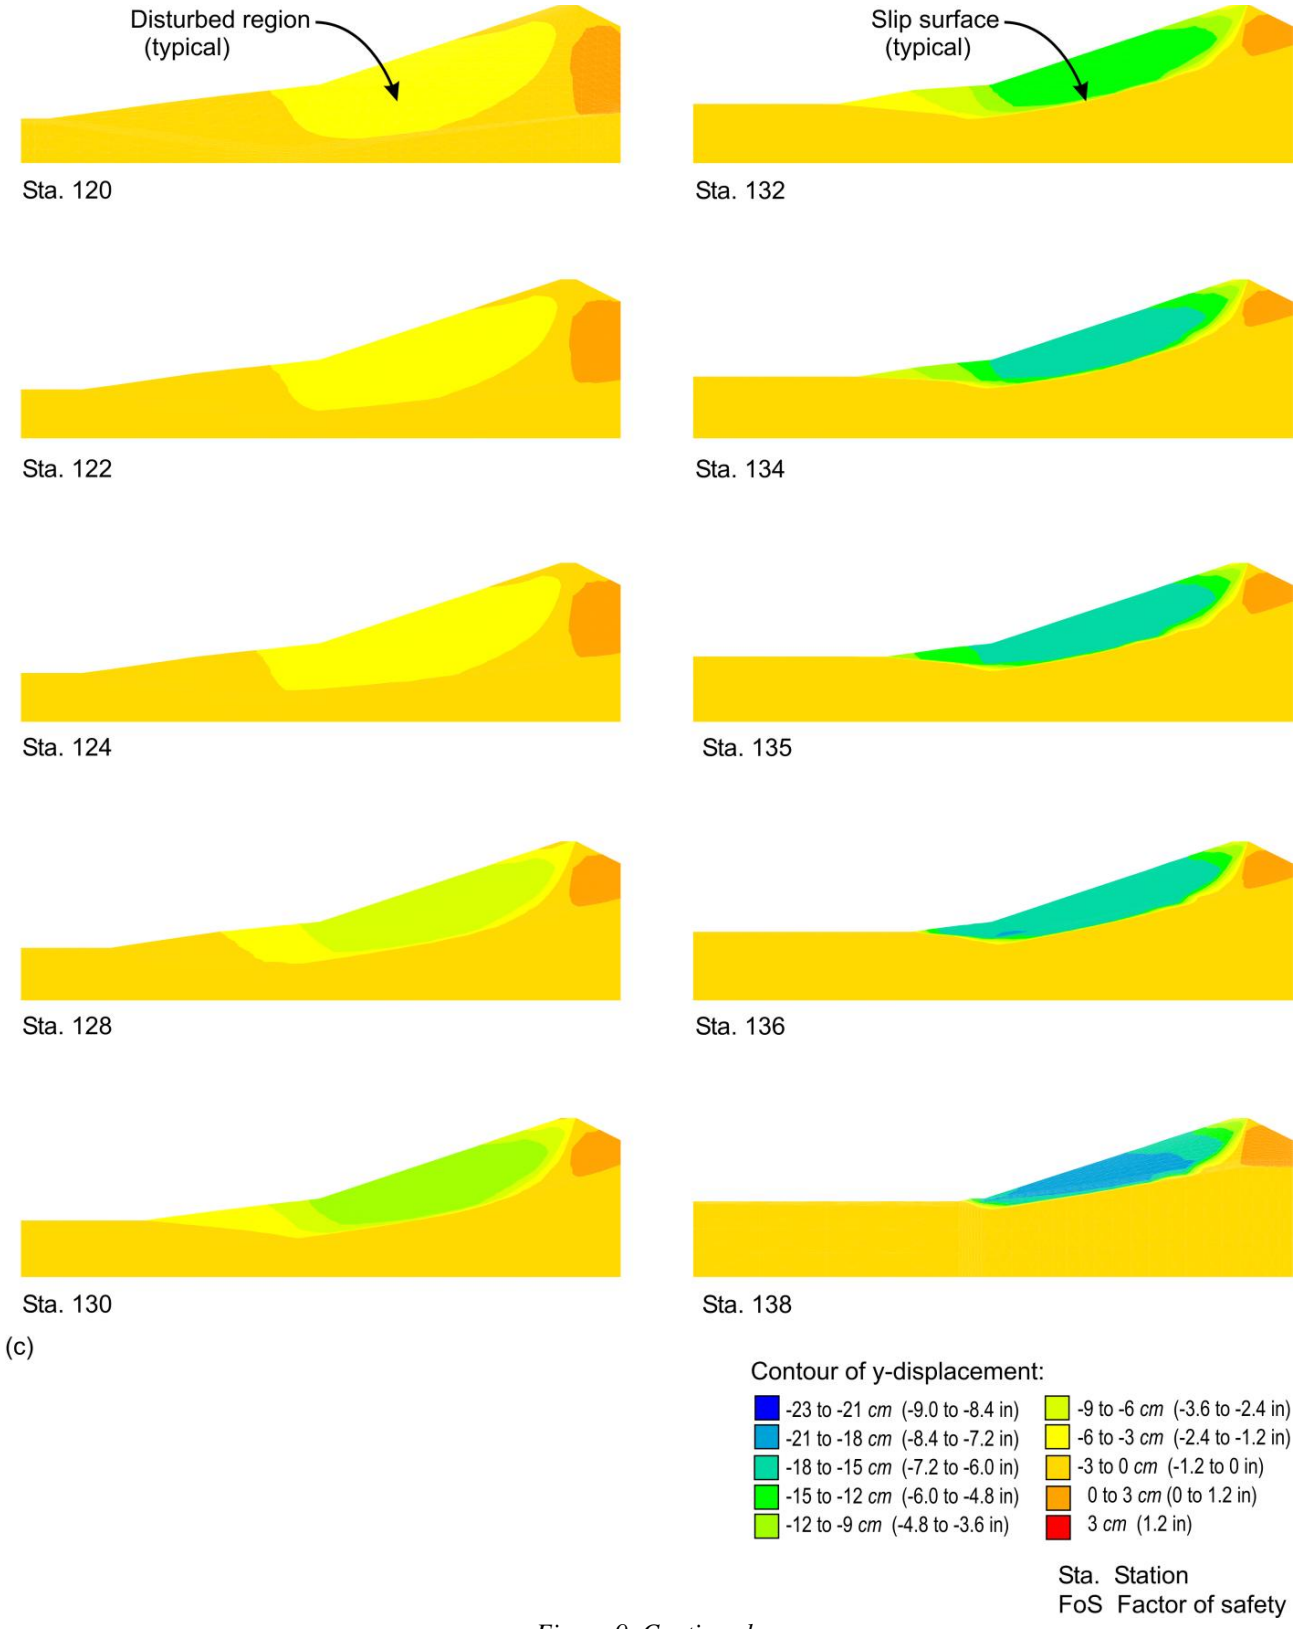
Figure 9. Slope stability analysis results of three-dimensional continuum model between stations 120 and 138. Reservoir water level is 110 m (360 ft), angle of internal friction for slopewash is 22°, and the slip surface geometry is determined by the continuum-mechanics-based computer program FLAC3D. (a) Spatial distribution of y-displacement contours; (b) Spatial distribution of surface cracks in longitudinal direction; (c) Planar views of slip surface geometry from station 120 to station 138.

(b) For RWL = 110 m (360 ft) and adjusted shear strength (c' = 0, φ' = 22°) for the slopewash, the factor of safety is 1.08 which is close to 1.0. For the 3-D factor of safety to be unity, the shear strength of slope wash is estimated from Figure 11(d) to be about (φ′ = 20°, c′ = 0). This estimated shear strength for the slopewash was checked via an additional 3-D analysis which resulted in a 3-D factor of safety = 1.01. The middle portion of the slip surface is located in the slopewash and the active and passive wedges pass through the zone 1 and zone 3, respectively. The tension zones develop near the centre of the dam crest and the scarp is arch shaped. These results compare well with the field observations and support the back-calculated value of slopewash material to be c' = 0 and φ' = 22° (or the slightly lesser value of 20° from 3-D) at the onset of instability (FoS = 1.0). The difference between (φ′ = 22°, c′ = 0) and (φ′ = 20°, c′ = 0) as being representative shear strength for the slopewash is considered minor given other uncertainties and assumptions necessary in these back-analyses.
