Stability Analyses of the 1981 San Luis Dam Slide

Ashok K. Chugh, *Civil Engineer, U.S. Bureau of Reclamation, Denver, CO 80225, USA; email: achugh@usbr.gov*
D.V. Griffiths, *Professor, Colorado School of Mines, Golden, CO 80401, USA; email: d.v.griffiths@mines.edu*

KEYWORDS: analysis; case history; dams; failure; slope stability; two- and three- dimensional numerical analysis

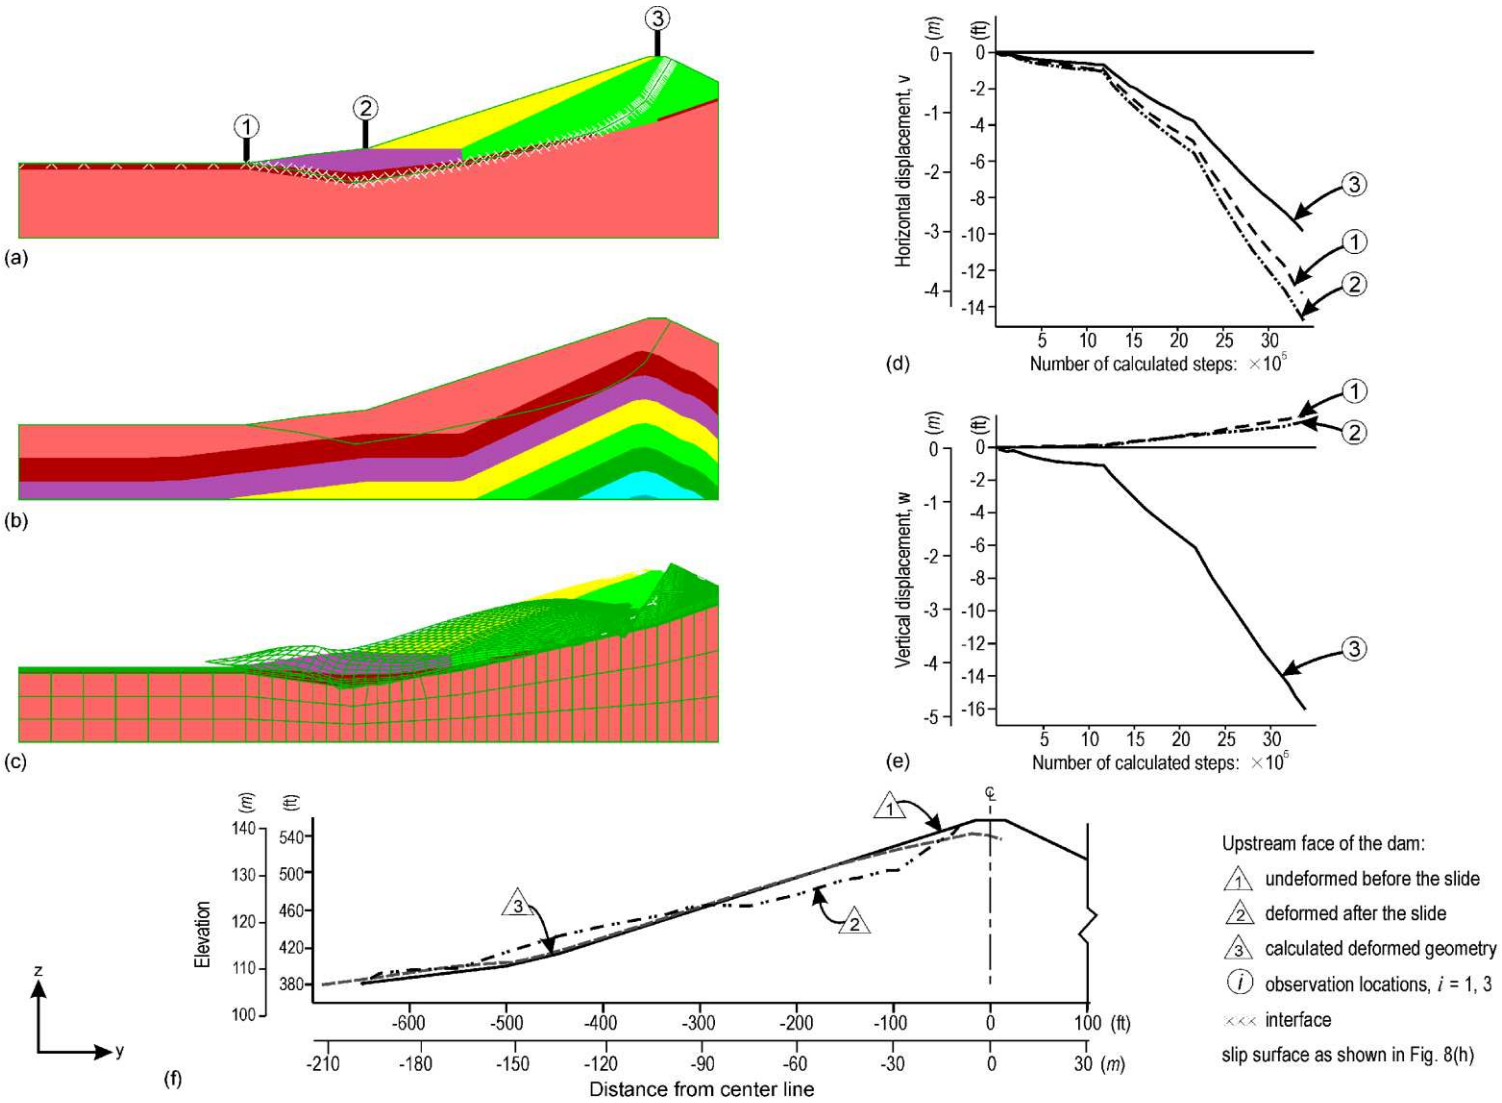
(b) For the rate of sliding, the results shown in Figs. 10(d) and (e) are interpreted in relative terms, since there is no involvement of time in the analyses performed. The horizontal (v) and vertical (w) displacements at the observation points increase from almost null for φ' = 22° to their maximum value for φ' = 15° in different increments over the same number of calculation steps. For φ' = 15°, the computed rate of sliding towards the upstream, after the initial start of observable displacement (corresponding to φ' = 20°), is at about one-and-half to two times as fast as at the start. This range is calculated using the rates of v and w displacements at the observation locations shown on Figure 10(a) and are with respect to the number of computation steps (i.e. slopes of the lines shown in Figures 10(d) and (e)). The field data on the rate of slide movements are: 15 cm per day on 14 September 1981 to up to 30 cm per day by 10 October, 1981 (i.e. twice as fast as at the start). This comparison between the computed results and the field data is considered 'good'.

(c) The overall comparison of the computed and observed deformed geometry of the upstream face of the dam shown in Figure 10(f) is considered 'poor'. It is discussed further in the next section.

Figure 10. Displacement analysis results for the cross section at station 135. Reservoir water level is 110 m (360 ft), angle of internal friction for slopewash is decreased from 22° to 14° in steps of 2° with numerical instability occurring at friction angle of 14°; the slip surface geometry is as shown in Figure 8(h). The slip surface is modelled as an interface in the continuum-mechanics-based computer program FLAC: (a) Model set-up; (b) Pore pressure contours; (c) Deformed geometry (magnified 5×) at friction angle = 15° for the interface; (d) Horizontal (v) displacement history for friction angle from 22° to 15°; (e) Vertical (w) displacement history for friction angle from 22° to 15°; (f) Computed and surveyed geometry of the upstream face of the dam.

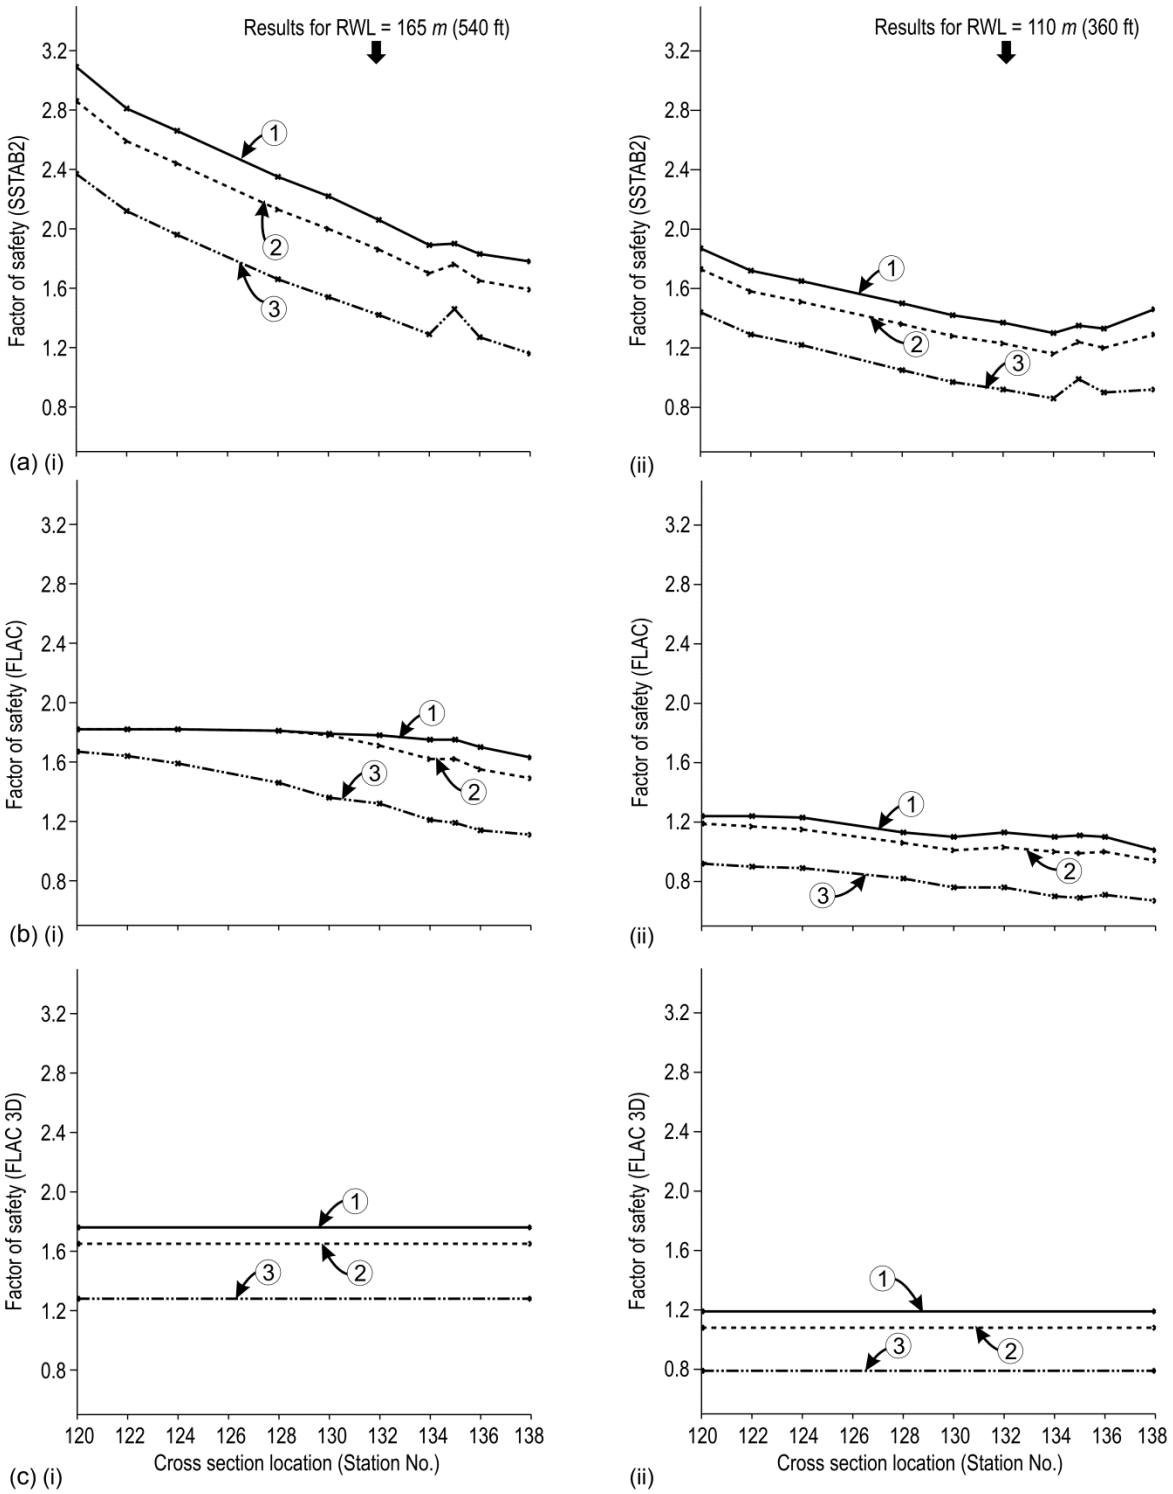
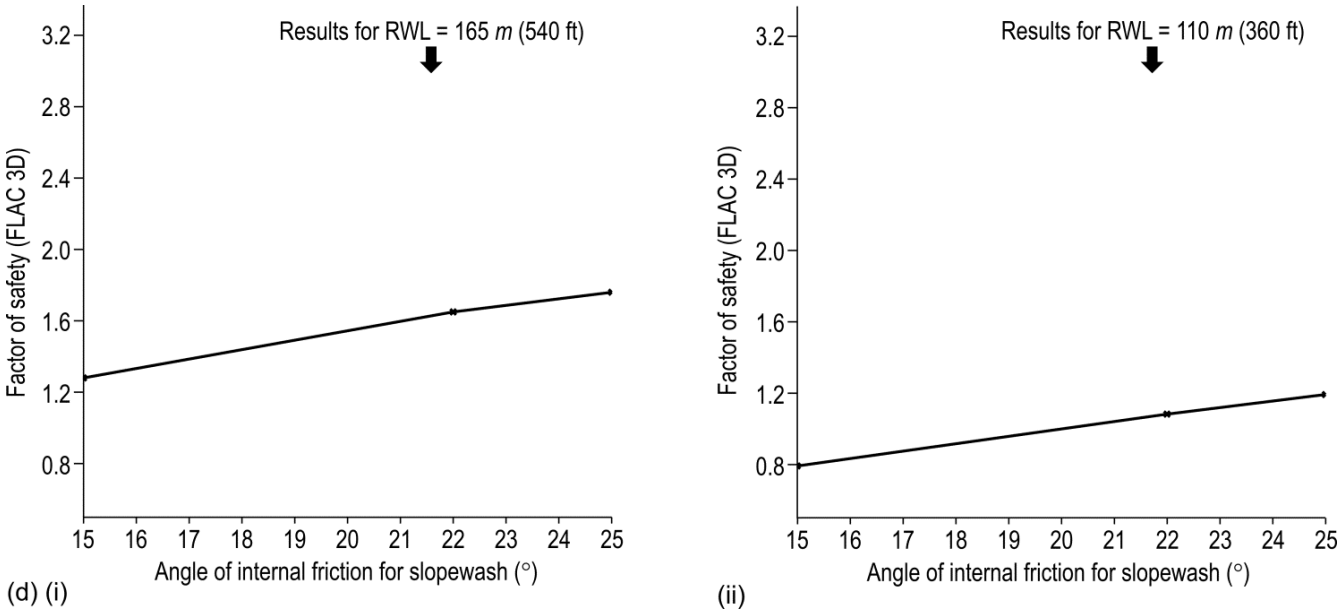
(a) The limit-equilibrium-based factor of safety results shown in Figure 11(a) show a spike at station 135, in an otherwise smooth decrease from station 120 to station 138, for each of the two reservoir water levels and each of the three strength values for the slopewash. This observation has two aspects: (i) the smooth character of the plot validates fairly consistent projection of the estimated shear surface geometry for station 135 at cross sections located at other stations; and (ii) there is something unique about the cross section at station 135 which causes the factor of safety to be higher than that at neighbouring cross sections, say at stations 134 and 136. It should be noted that the dam cross section at station 135 is smaller than the cross sections at stations 134 and 136 – this results in a smaller destabilizing force at station 135; however, the resisting forces at these near-by stations are identical (because of identical shear surface). This results in a higher factor of safety against sliding failure at station 135 as compared to the corresponding values at stations 134 and 136. A similar spike is also displayed, to a smaller scale, in the 2-D continuum-based results shown in Figure 11(b).

Figure 11. Summary plot of computed factor of safety results in the reach of the slide: (a) Computed results from SSTAB2: (i) RWL = 165 m (540 ft), (ii) RWL = 110 m (360 ft); (b) Computed results from FLAC: (i) RWL = 165 m (540 ft), (ii) RWL = 110 m (360 ft); (c) Computed results from FLAC3D: (i) RWL = 165 m (540 ft), (ii) RWL = 110 m (360 ft); (d) Computed results from FLAC3D: (i) RWL = 165 m (540 ft), (ii) RWL = 110 m (360 ft).

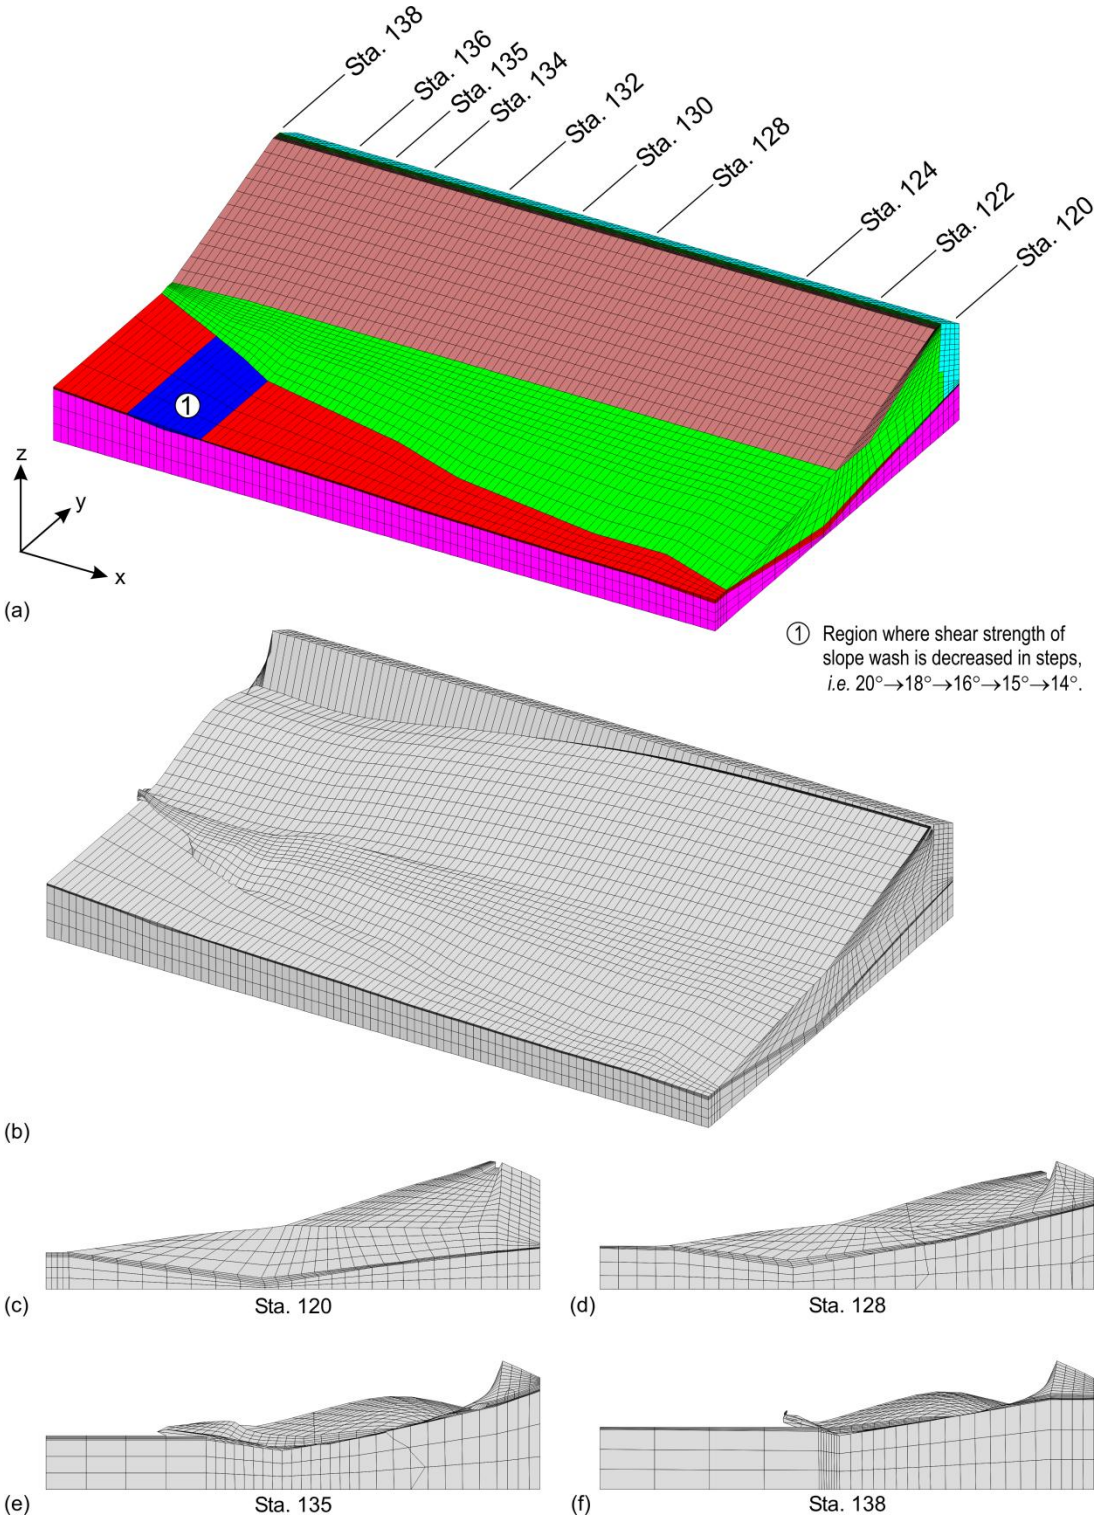
(f) The 3-D deformation results shown in Figure 12, in principle, are in agreement with the lateral load transfer mechanism envisioned in Skempton and Vaughan (1993). While the computed pattern of deformations for the u/s face of the dam is similar to the signs of distress observed in the field after the slide, the magnitude of computed deformations is very small compared to the surveyed data.

Figure 12. Computed displacement results (effects of lateral load transfer and progressive failure simulation) for the three-dimensional continuum model between stations 120 and 138. Reservoir water level is 110 m (360 ft). Angle of internal friction (φ') for slopewash from station 134 to 136 is decreased in steps, (20° → 18° → 16° → 15° → 14°). (a) Assumed region of progressive failure in slopewash; (b) spatial extent of deformed geometry (magnified 100×) for φ' = 15°; (c) to (f) planar views of the deformed geometry (magnified 100×) at station 120, 128, 135, and 138, respectively.
