Reclamation and Safety of High Cantilever Strong Box Pipe Pile Seawall in Marine Clay

Kok Kee Soh, *AGS Consultants Pte Ltd, Singapore; email: kksoh48@yahoo.com.sg*
Than Than Wai, *AGS Consultants Pte Ltd, Singapore; email: tthanwai@gmail.com*
Lily Yeo, *AGS Consultants Pte Ltd, Singapore; email: yeolily@agscpl.com*
Peng Kiat Lim, *AGS Consultants Pte Ltd, Singapore; email: lim_pk2000@yahoo.com.sg*

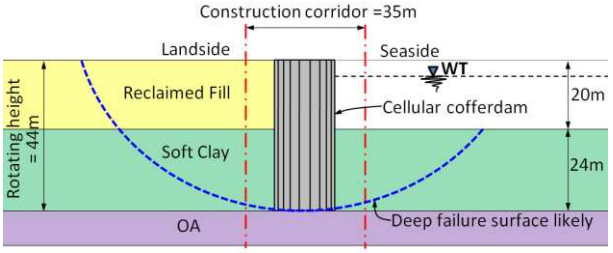
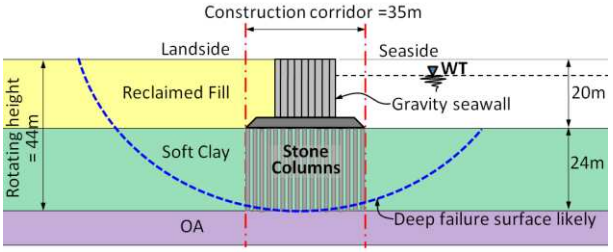
(a) A Cellular cofferdam

The applicable strong box seawall that is buildable in these physical circumstances are detailed by Soh et al. (2014). The high rotating height and the construction corridor of 35 m limit the seawall solutions. A cellular cofferdam is not able to resist the deep seated failure as shown in Figure 3(a). Ground improvement such as stone column or deep soil mixing are impossible to construct in the marine condition and also likely to fail by tensile breakage as shown in Figure 3(b).

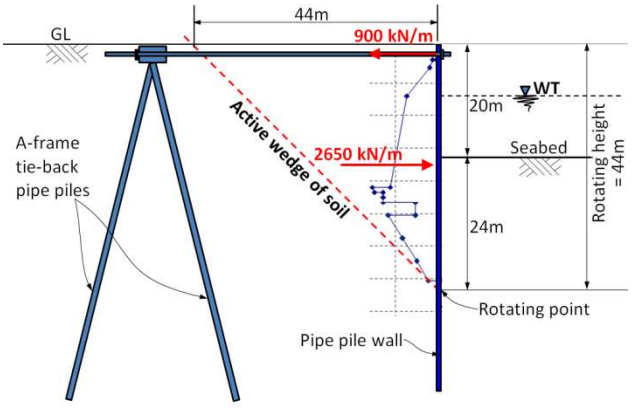
(c) A safe sandkey solution but not buildable.

* 150 m wide and 44 m deep sandkey is necessary to cut off the deep slip failure plane.

A safe sandkey of 150 m width is impossible to build within the 35 m construction corridor as shown in Figure 3(c). A-frame tie-back as shown in Figure 3(d) is not able to derive the adequate pull-back force and there is no single row steel structural wall strong enough to resist the high active force. It is necessary to design an integrated strong box structure with the adequate geo-structural turning back capacity above the rotating point, adequate geotechnical passive resistance below the rotating point, and buildable within the 35 m construction corridor as shown in Figure 4.

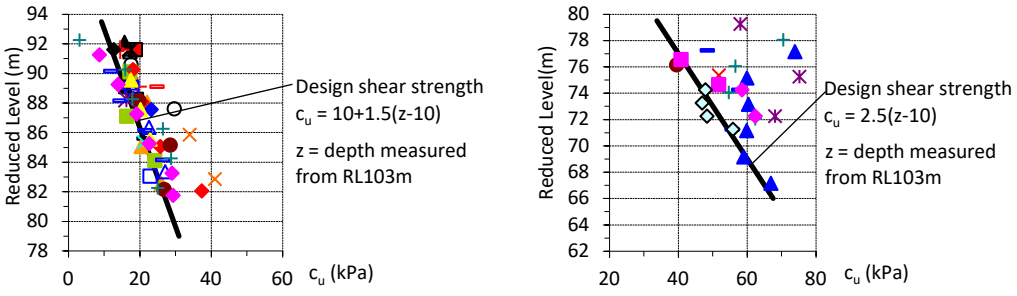
The strength parameters of soil layers are indicated in Table 2. The undrained shear strength based on field vane test is shown in Figure 5. The inappropriate reclamation method resulted in significant clay flows, and the tremendous drop from undrained strength to slurry consistency.

Figure 5. Undrained vane shear strength of soft clay. Note: Reduced level is the ground elevation level of the reclaimed fill.

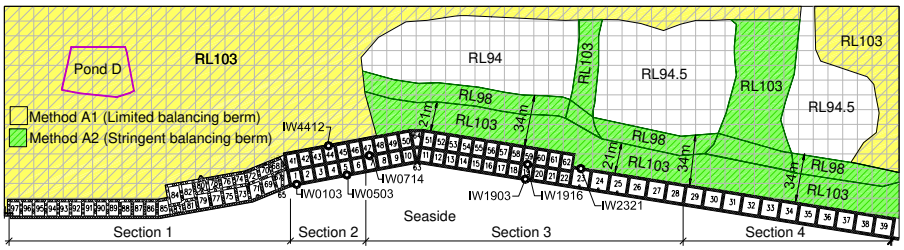
Figure 6. Stage 1 reclamation - Extent of reclamation where the seawall deflection was in accordance with the anticipated deflection (Method A1 & Method A2).

where the seawall was behaving in accordance with the anticipated deflection as shown by seven inclinometers IW0103, IW4412, IW0503, IW0714, IW1903, IW1916 and IW2321. The slow limited balancing berm method A1 or stringent balancing berm method A2 were enforced up to this stage 1 reclamation.

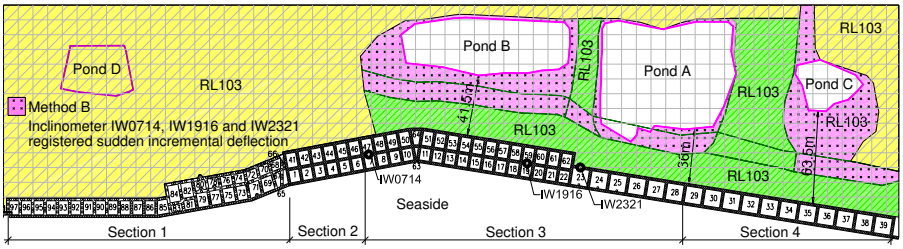
Figure 7. Stage 2 reclamation - Extent of reclamation where three inclinometers IW0714, IW1916 and IW2321 showed significant incremental deflection or sudden plunge (Method B).

Figure 7 shows stage 2 reclamation, where three inclinometers IW0714, IW1916 and IW2321 of the seawall were observed to deflect significant incremental amount or sudden plunge. The surface area of reclamation was noted to be relatively small

in comparison to the stage 1 reclamation of Figure 6. It was interpreted that the full earth discharge method B was applied around the edges of the then created clay slurry ponds beyond the 44 m active wedge and were not observed at that period of time. Figure 8 shows stage 3 reclamation whereby very stringent controlled filling was carried out to prevent the created clay slurry ponds from further slurry flows.

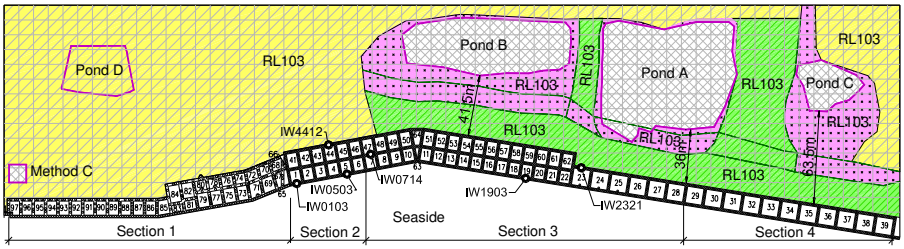
Figure 8. Stage 3 reclamation - Filling of ponds B, A, and C showed insignificant incremental deflection of the seawall (Method C).

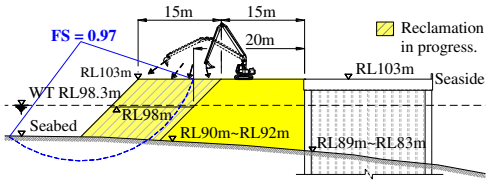
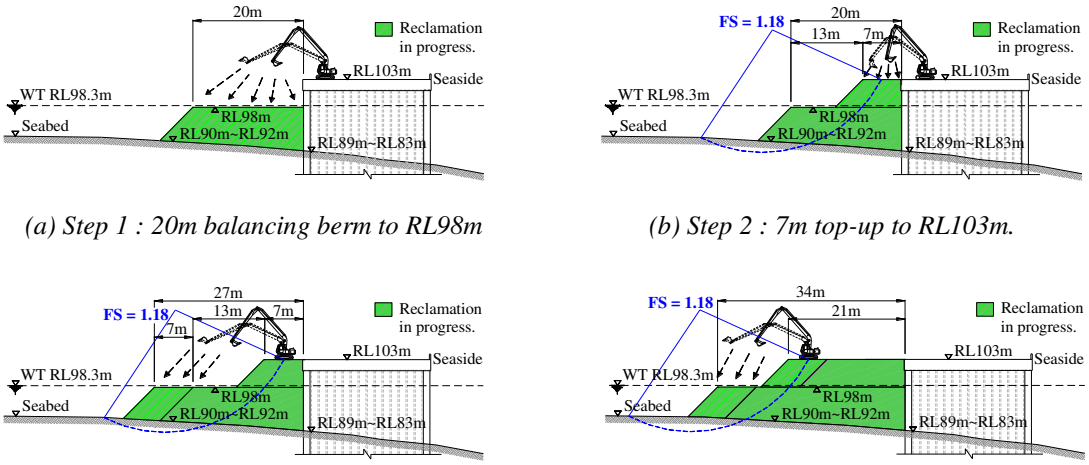
Reclamation steps of limited balancing berm method A1 is shown in Figure 9. The reclamation filling of Grade A material by the limited balancing berm was likely to cause minimal localized squeezing of the soft clay below the seabed. The squeezing effect was probably limited at 1 m to 2 m below the seabed as the factor of safety was slightly less than 1. The lowest factor of safety was at step 2 and step 3 and was localized after completion of 20 m berm to RL103 m.

Figure 9. Limited balancing berm for stage 1 reclamation - Method A1 .

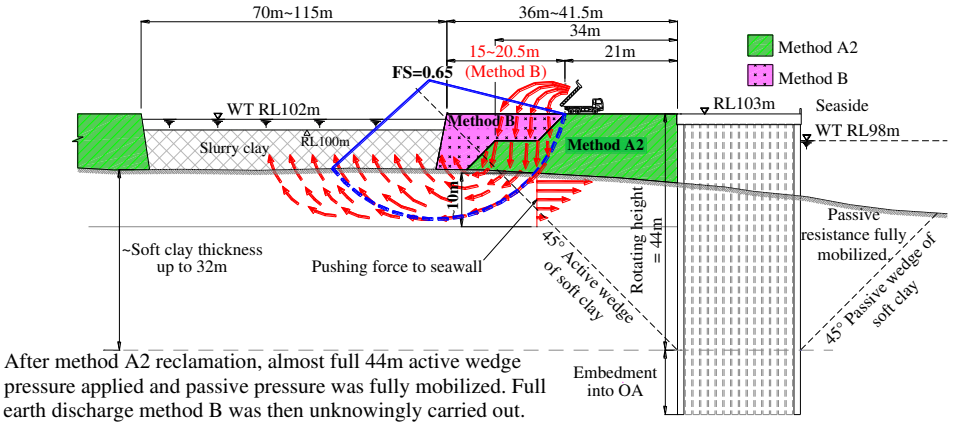
Reclamation steps of full earth discharge method B are shown in Figure 11, after stringent balancing berm method A2. Direct full discharge of Grade B material straight from the lorry was likely to cause significant slurry clay flows during stage 2 reclamation. The extent and depth of the slurry clay flows could be deep, intensive and extensive, if the direct discharge was concentrated on a particular spot. The factor of safety was extremely low for the accumulated lorry load by direct full earth discharge. This method of reclamation was extremely fast. Vast quantity of Grade B material was poured directly into the enclosed water within a very short period as shown in Figure 7, and this caused the massive slurry clay flows at ponds B and A. This method of reclamation was not recorded in the site. The method was interpreted during the period when the inclinometers recorded sudden plunge in the deflection of seawall and the sighting of heaving of clay slurry at pond B on 25 Nov 2011. Chu et al. (2009) reported the slurry clay upheaval in a stringently controlled filling procedure for a slurry pond in Singapore.

Figure 11. Full earth discharge method B for stage 2 reclamation at section 3.

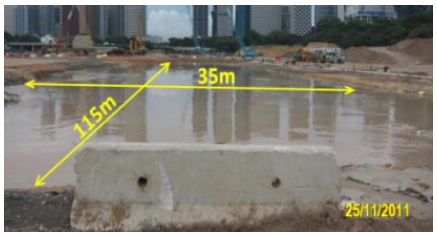
Cross-section of Pond A

The clay slurry ponds B and C were observed on 25 Nov 2011 as shown in Figure 13, when the clay slurry was pushed sideways and upward to the pond water level RL102.0 m. Pond A was still submerged in water and the clay slurry thickness was determined by chain sounding.

(a) Photograph of pond A (90 m x 70 m x 5.5 m) with slurry clay heaved from RL94.5 m to RL100 m.

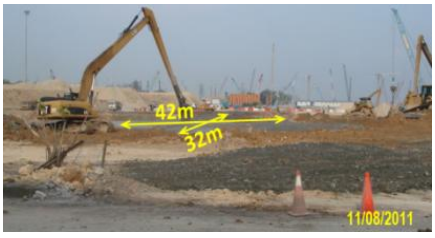
Cross-section of Pond C

(c) Photograph of pond C. (37 m x 30 m x 7.5 m) with slurry clay heaved from RL94.5 m to RL102 m.

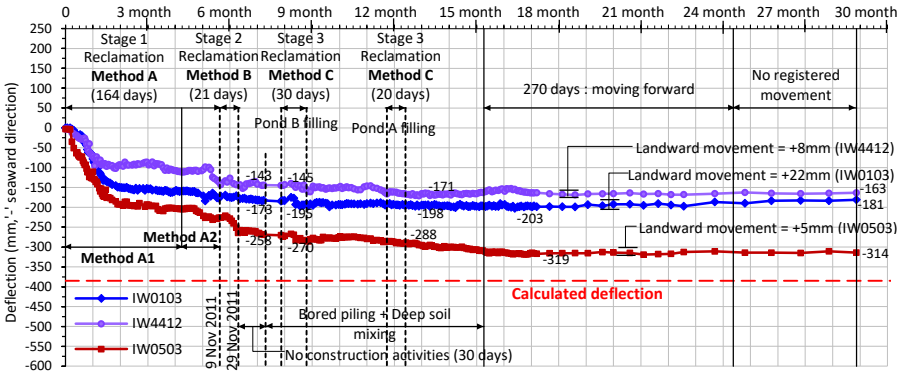
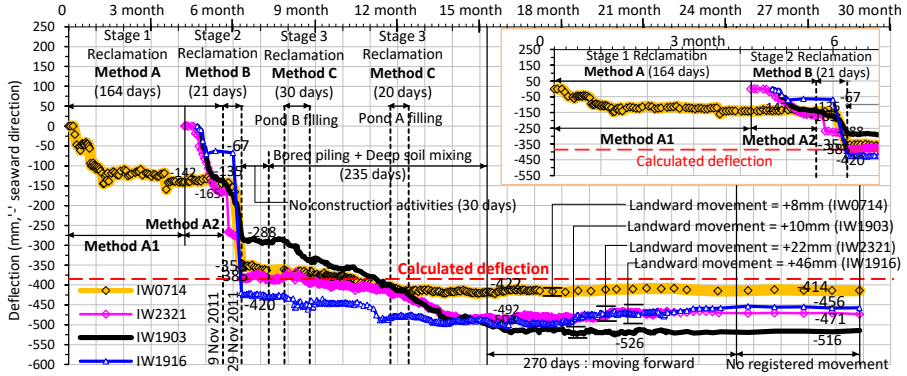
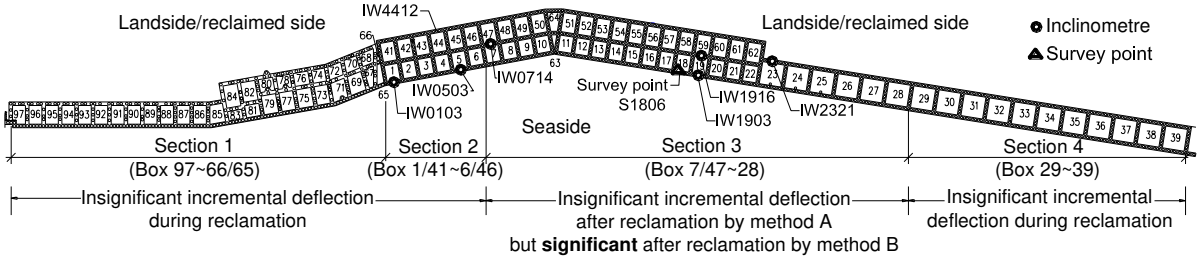
Figure 14 shows the comparison of deflections of the sections 2 and 3 of the seawall. Section 2 is from box no. 1/41 to box no. 6/46, and represented by inclinometers IW0103, IW4412and IW0503, whereas section 3 is from box no. 7/47 to box no. 28 and deflection is from inclinometers IW0714, IW1903, IW1916and IW2321. The influence of the various methods of reclamation is examined. Method A1, A2, and C reclamations were supervised and recorded on site. There was no record of supervision for method B reclamation.

After the reclamation filling by method A1 and A2, the full active pressure wedge was on section 2 and an almost full 44 m active pressure wedge on section 3. At this stage the passive resistance of soft clay was fully mobilized. Deflection of both sections was lesser than the 60% of the calculated value. Method B was in the proximity of section 3 and caused a plunge in 3 inclinometers IW0714, IW1916 and IW2321, with a maximum value of -353 mm or 0.80% of H as shown in Figure 14b. The plunge was caused by the concentration of the generated lateral force of the slurry clay flow beyond the 44 m active wedge, using the constructed seawall as a reaction. Inclinometer IW1916 suggested that this slurry clay force might be higher than the 44 m active wedge force. This was a transient force which dissipated after the creation of the massive slurry clay ponds B and A.

The average deflection of the stringent balancing berm method A2 was -122 mm at section 3 (Rotating height = 40 m to 44 m) and this was lower than the limited balancing berm method A1 with an average deflection of -156 mm at section 2 (Rotating height = 25 m to 40 m). This lower deflection at section 3 showed that the stringent balancing berm method A2 had the minimum seawall deflection, as shown in Table 4.

Figure 14. Comparison of deflection of capping beam of section 2 and 3 of seawall.

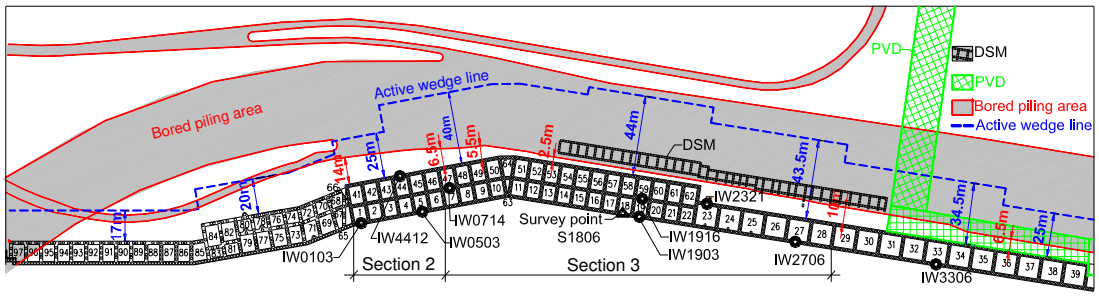
It was noted that high deflection occurred when construction activities were carried out near the seawall and within the 44 m active wedge as shown in Figure 15, with the incremental magnitude in Table 5. A deflection magnitude varying from -17 mm to -166 mm was recorded.

Figure 15. Construction works within 44 m active wedge.

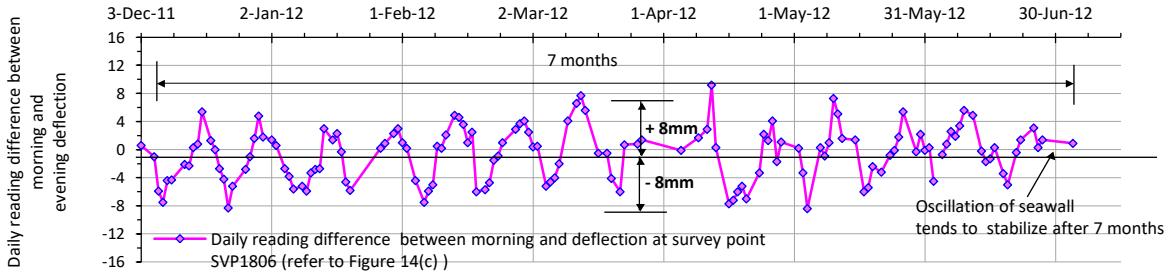
It was observed that the seawall oscillated with an amplitude of ± 8 mm as shown in Figure 16 during tidal fluctuation of 2.55 m. This observation was for a period of approximately 7 months, after which the deflection fluctuation gradually tapered off. A possible explanation of the deflection lies in the mechanism of the very loose partially saturated reclaimed fills. The reclaimed fill was haphazardly and loosely deposited into the enclosed water. While settling under its own weight, slight tension force was created below and higher tension force above the natural water level. The tensile pore pressure will gradually dissipate during each tidal cycle. This would result in higher bulk density and reduction of tension force of the fill within the tidal zone. As the active wedge is 44 m wide, this significant fluctuation in lateral pressure oscillated the wall up to a magnitude of ±8 mm. After a period of seven months this active force came to an equilibrium within the tidal levels and the oscillation movements tapered off.

Figure 16. Difference in seawall deflection registered between morning and evening reading for survey point 1806.

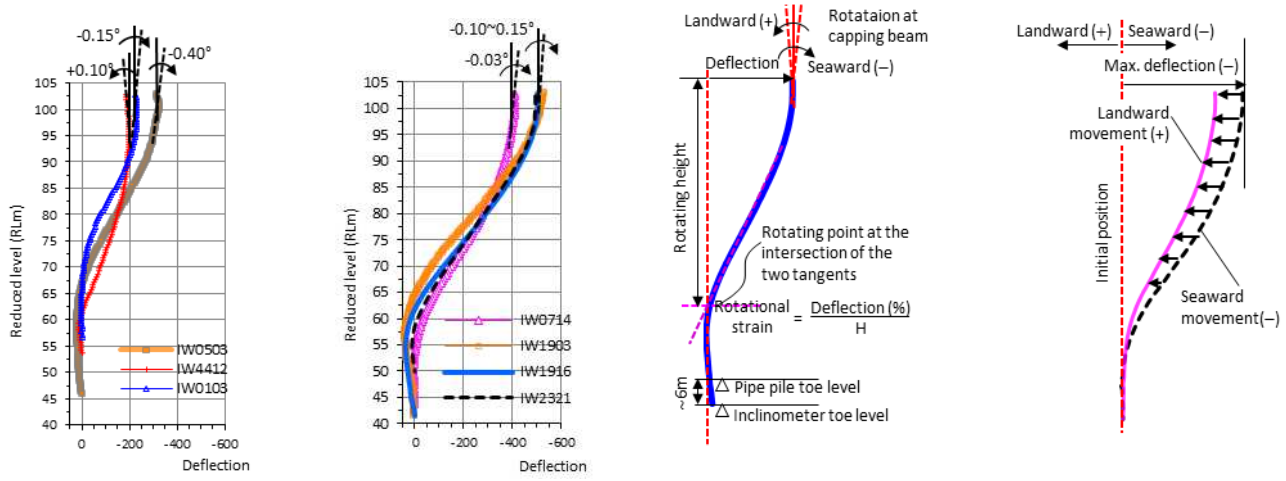
Based on the inclinometer installed inside the hollow pipe piles, the deflection of the seawall for section 2 and 3 are shown in Figure 17. As the cantilever structure rotates just above the embedment into OA, the rotating point is the intersection of the tangent line into OA and above OA. The rotating height is from the rotating point to top of capping beam. The deflection profile of the inclinometers are shown in Table 6. The long-term stability of the seawall is demonstrated by the inclinometer deflection profiles.

Figure 17. Inclinometer profiles at maximum deflection, seaward and subsequent landward movement.

Depth of embedment into OA by inclinometer readings is higher than design construction of pipe pile embedment. This higher passive resistance of the OA indicates no loss of design passive resistance despite the high seawall movement of 1.20% of H. The bottom of the strong box is rigidly held together. The profile of the inclinometer deflection indicated robustness of the integrated strong box. The robustness was derived from (a) the optimization of the vertical bending capacity of the pipe pies, (b) capping the top of the pipe piles as a box, (c) utilizing the P-P interlock to produce the box action within the rotating height. The deflection profile of the inclinometer was at the elastic state.

The deflection seaward (-ve) was the accumulation of lateral forces from reclamation within the 44 m active wedge, other construction activities within the 44 m active wedge and the creation of the slurry clay pond B and A beyond the 44 m active wedge. The maximum seaward (-ve) of -353 mm or 0.80% of H was caused by the slurry clay pond B and A. After the lateral push of these forces stabilized, the seawall then moved in the reverse direction towards the landside (+ve) as shown in Figure 17. The landward movement was monitored for a period of 13 months and the maximum magnitude is +46 mm as shown in Table 6. The landward movement suggested that the seaward (-ve) deflection of 1.20% of H is still within the elastic state of the geo-structural turning back moment capacity of the strong box. The landward movement was caused by the vertical consolidation of the 44 m active wedge.
