St. Isaac Cathedral (St. Petersburg, Russia): A Case History

ABSTRACT: *St Isaac's Cathedral in St. Petersburg was completed in 1858 after 40 years of construction; it is today the fourth largest domed Cathedral in Europe. The underlying soil is a relatively soft saturated sediment and carries this 3155 MN structure that is 100 meters high with an imprint of 92 m by 100 m. It is founded on a 7.5 m thick mat of granite and limestone blocks resting on relatively short timber piles of different lengths. The Cathedral has progressively experienced significant deformation including differential settlement causing cracks in the pillars and tilting of the porticoes. The paper summarizes the available geotechnical engineering and engineering geology aspects of the soil on which the Cathedral is built as well as classical issues such as foundation ultimate capacity and settlement analysis through simple calculations and numerical simulations. It also includes some less classical issues such as the influence of microbial activity on the behavior of the Cathedral through the changes the microbes and their activity create in the engineering properties of the soil and in the groundwater compos

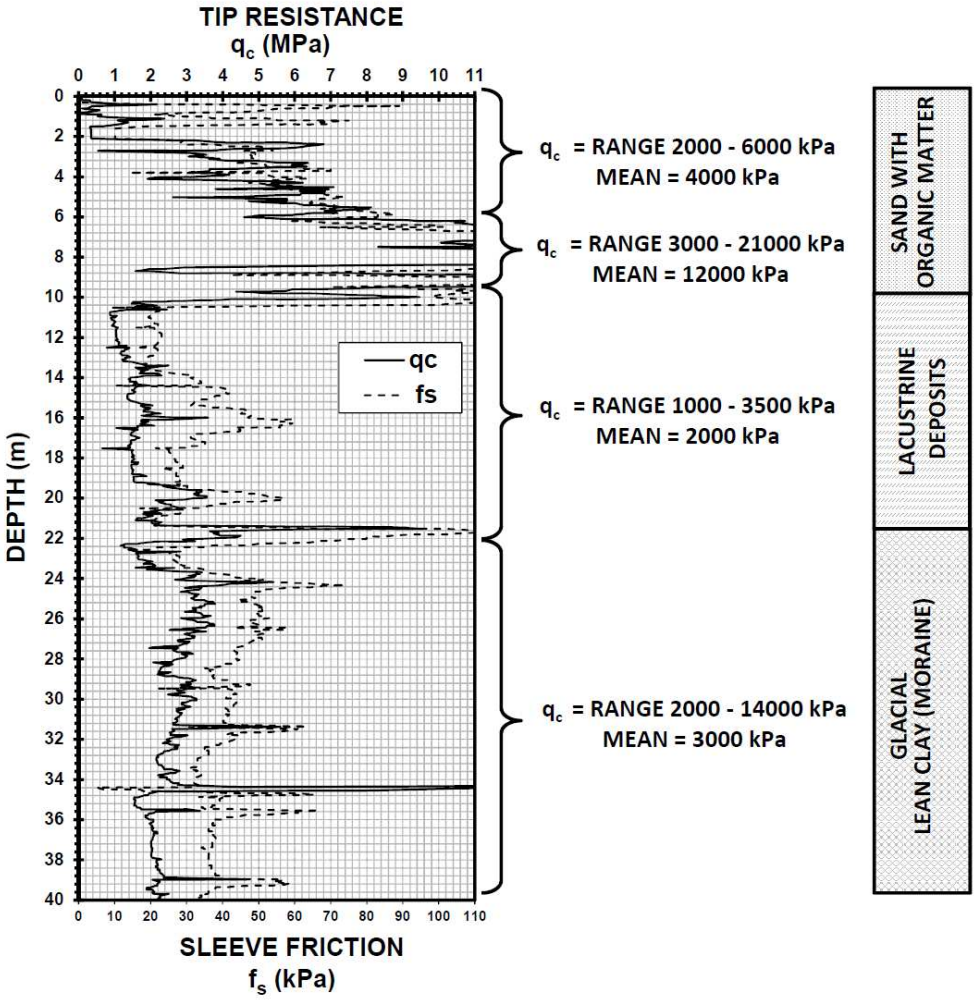
Figure 4. CPT profile near St. Isaac Cathedral.

Using Fig. 4 and a lower-bound cone tip resistance of 1500 kPa together with a cone bearing capacity factor of 0.35 (Briaud, 2013) the bearing capacity is 615 kPa. This is much higher than the bearing capacity based on the Skempton (1951) equation and when compared to the applied pressure of 415 kPa gives a much more reassuring factor of safety against bearing capacity failure of 615/415 = 1.48. The low bearing capacity based on the undrained strength from the samples may be due to sample disturbance. Indeed, the cone N_k factor linking the undrained shear strength of the cone tip resistance is back-calculated to be about 50; this is unusually high.

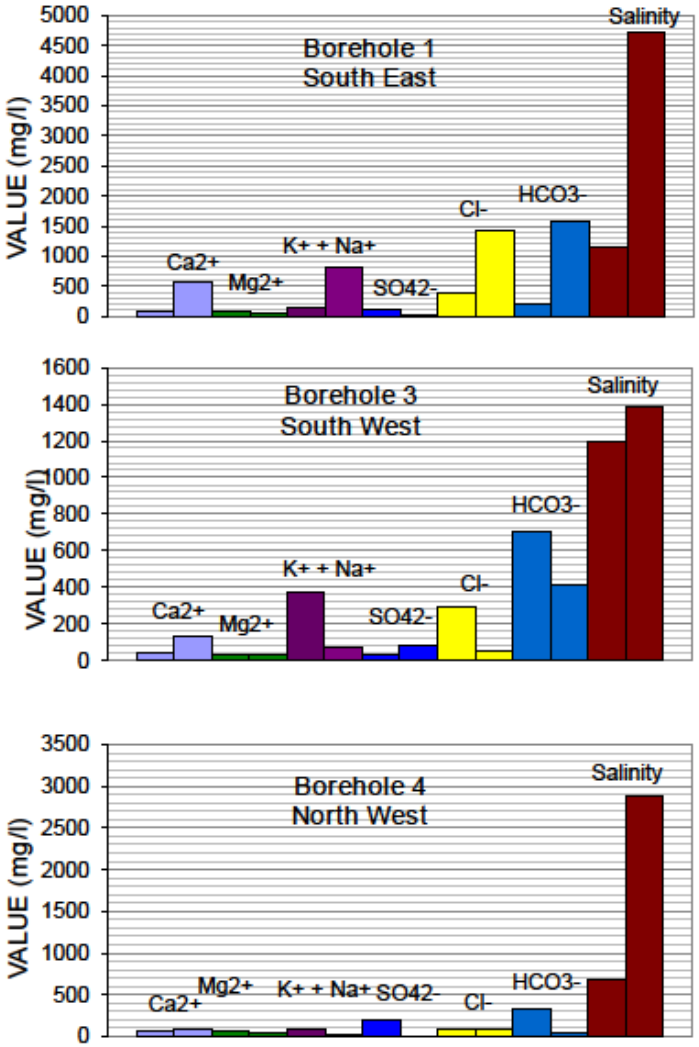
Figure 6. Chemistry of groundwater (1954 and 2009 data).

A comparison between the groundwater chemistry in 1954 and 2009 shows that during that 55-year span there has been a considerable change in groundwater chemistry (Fig. 6). In the bar graphs, each chemical is represented by two side-by-side columns; the first column gives the concentration in 1954 and the second column in 2009. During that period (1954-2009), a dramatic increase in water salinity can be observed indicating an increase in groundwater contamination. The salinity of uncontaminated groundwater is typically around 1000 mg/l. High contents of chlorides (1418 mg/l) and sulphur (81.8 mg/l) also indicate contamination by sewage. Furthermore, the increase in calcium content suggests leaching from the limestone blocks and the limestone-based mortar from the foundation mat located below the groundwater level.

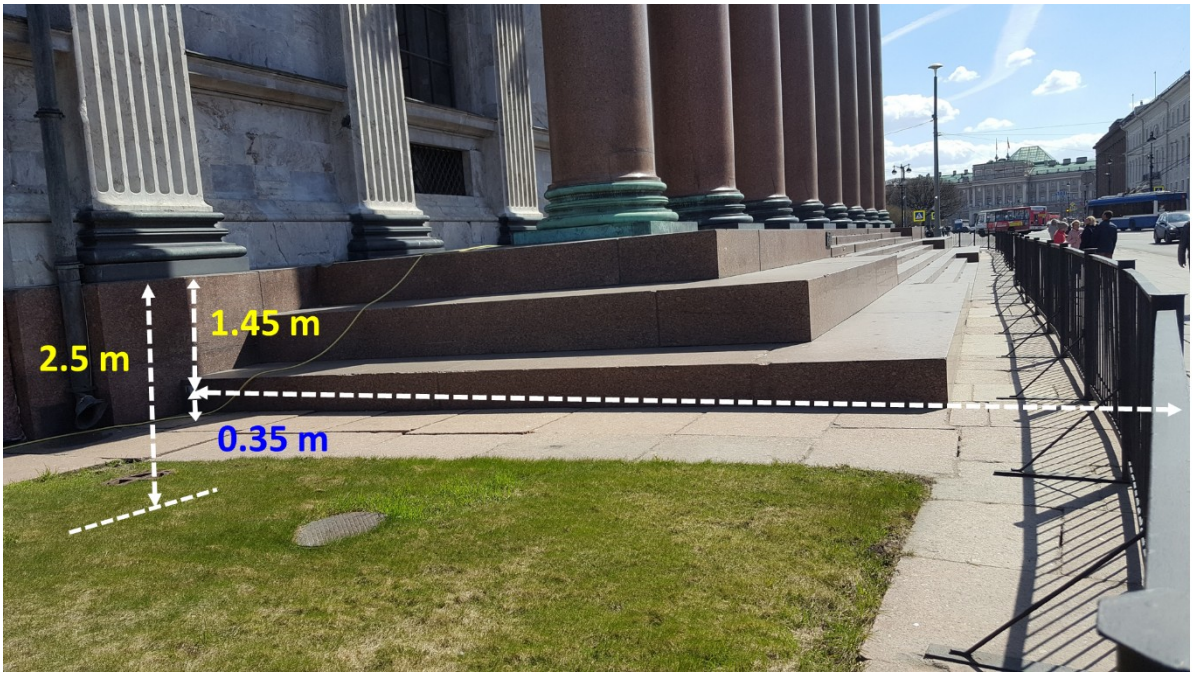
Figure 16. Settlement measurements at the northwest corner.

Settlement calculations are usually done by using the results of consolidation tests or by using the modulus of drained triaxial tests as the settlement has taken place over the last 150 years. None of this data was available to the authors. However, settlement measurements were made as follows (Fig. 15, 16): At the time of construction the 7.5-m thick mat was 2.5 m above the ground surface. Today the mat was measured to be 1.9 m above the ground surface at the southwest corner and 1.8 m above the ground surface at the northwest corner. This indicates that the Cathedral has sunk 0.6 and 0.7 m at those corners respectively. Furthermore, the ground surface at the base of the Cathedral is lower than the street level by 0.5 m at the southwest corner and 0.35 m at the northwest corner. These simple measurements allow one to conclude that the total settlement of the Cathedral is of the order of 1 m.

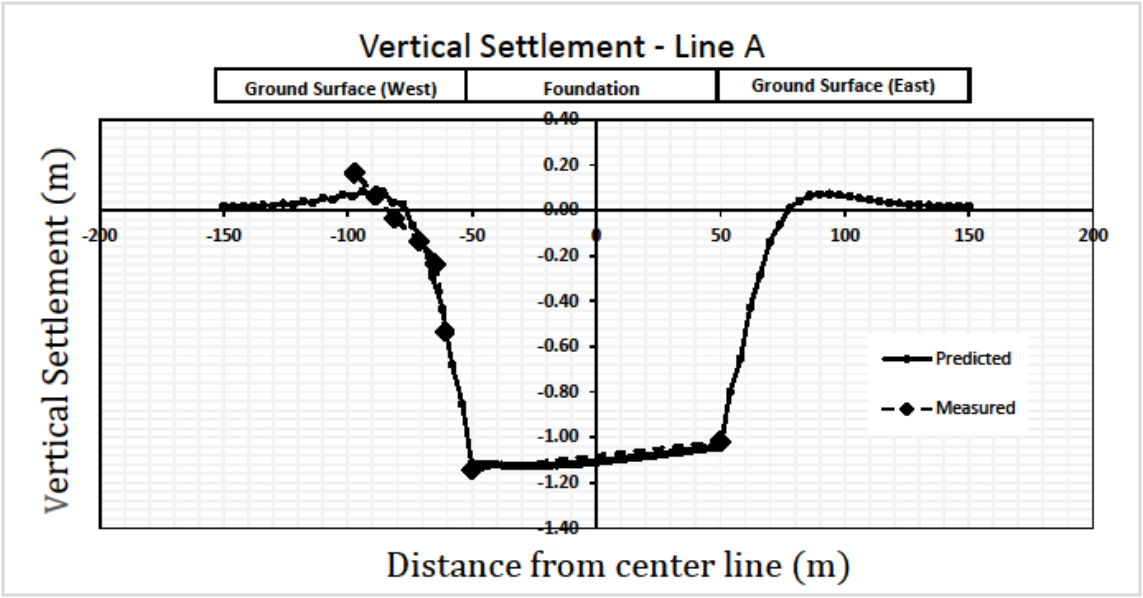
Figure 18. Ground surface settlement around and under the Cathedral.

Fig. 18 shows the settlement of the Cathedral along the centerline East-West axis for the case that matches the measured total settlement of 1 m. A tilt is observed due to the uneven depth of the pile foundation; indeed, the Cathedral does not settle evenly due to the different lengths of piles in the foundation (Fig. 19) and the calculated difference in elevation between the eastern most point and the western most point of the Cathedral is 0.16 m. A parametric study was also conducted to investigate the influence of the structural parameters on the results. Fig. 20 shows the impact of the modulus of the foundation material on the bending of the foundation mat and associated distortion of the structure leading to increased cracking. Additional results of the analysis including ground surface settlement profiles, contours of vertical settlement with depth, and stress distribution in the soil mass can be found in Mohammadrajabi et al. (2015).

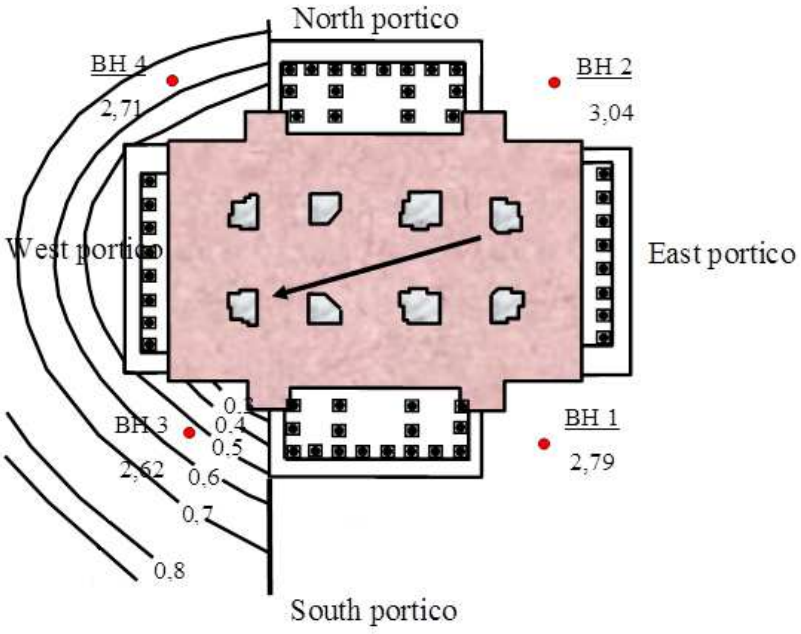
Figure 21. Ground surface survey around the Cathedral (Sotnikov, 1986).

The survey of Sotnikov (1986) gave the elevation contours of the ground surface West of the Cathedral (Fig. 21). These elevation contours were used to create a settlement profile along a direction perpendicular to the contours. This settlement profile is plotted on Fig. 18 and is compared to the numerical simulation predictions. The match on Fig. 18 is reasonably good and gives some credibility to the theoretical work. As explained previously and as shown on Figs. 15 and 16, the Cathedral has likely settled about 1 m including some punching of the mat into the soil. Fig. 23 shows the plastified elements in the stress field at the Cathedral edges; this certainly indicates a very likely yet limited and localized punching failure at the edges.

The observed tilt of the structure seems to be due to the difference in length of the pile foundation on both sides of the structure. The differential movement is estimated to be about 25 cm according to the measurements as compared to 16 cm by the simulations. The value of 25 cm comes from using the elevation of the borings shown in Fig. 3. On the West side, they are 2.62 m and 2.71 m for an average of 2.665 m while on the East side they are 2.79 m and 3.04 m for an average of 2.915 m leading to a difference of 25 cm. The differential movement can also be estimated using the 0.004 value of the tilt measured in 1984 by the Leningrad Construction Institute (LISI) (Table 7) and the distance of 78 m between the two points. Using this approach, the differential movement of the cathedral is about 31 cm which corresponds approximately to the data obtained using the elevation of the borings.

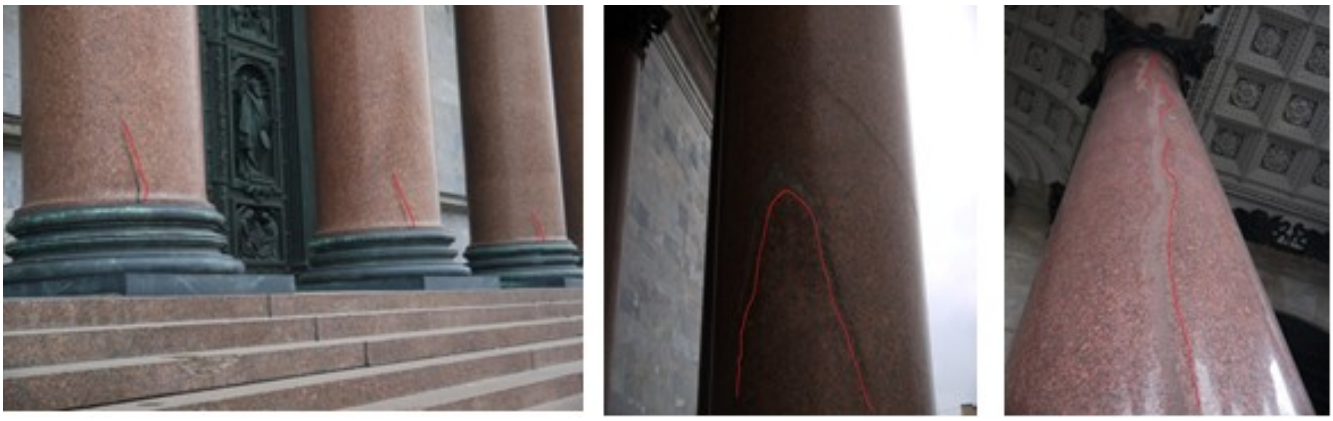
Figure 22. Intensifying cracks in the columns.

The main problems with St. Isaac Cathedral is cracking of the columns due to excessive differential settlement and a slight overall tilt of the structure to the southwest. The purpose of this paper is to analyze the behavior of St. Isaac Cathedral based on existing historical documents, on site investigations performed in 1954 and 2009 including in-situ and laboratory tests, on settlement calculations and observations, and on a series of numerical simulations of the Cathedral foundation and soil by the finite element method using ABAQUS.

The magnitude of this differential settlement continued to increase as well as the severity of the cracks in the columns and the tilting of porticoes. In 1950, the deterioration of the bearing structures was documented including cracks in the pilonces, the arches, and the columns (Florin, 1954; Butikov, 1974). In 1983, a survey of the ground surface near the southwest end of the Cathedral was performed and indicated a maximum difference in elevation around the southwest part of the Cathedral of 0.85 m (Sotnikov, 1986, Fig. 21). The summary results of all the surveys performed at different times are shown in Table 7. Today the differential settlement has intensified causing additional cracking in the pillars supporting the dome, tilting of porticoes, deformation and dilapidation of the columns (Fig. 22).
