Lessons Learned from Dike Failures in Recent Decades

ABSTRACT: *The paper describes five different dike failures that occurred in recent decades. The case histories were located on different rivers and involved different loading conditions. The observed failure mechanisms involved erosion and stability problems. The types of erosion observed were both internal erosion due to extreme groundwater flow and external erosion caused by the river flow and wave action. The case involving instability was caused by uplift, i.e., increased hydraulic head led to a sharp reduction in maximum shear strength between subsoil layers. Two cases demonstrate the importance of dike management and maintenance. Despite the variations in the loading conditions and failure mechanisms, all the cases show that the strength of a dike depends not only on the material used to build the dike but also on the strength of the subsoil.*

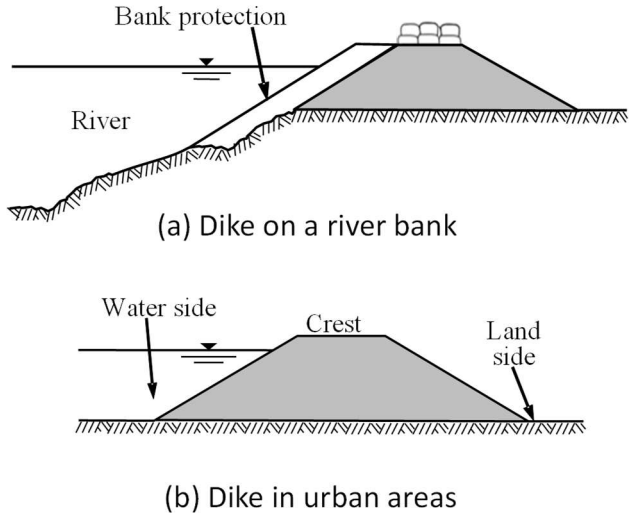
gradients generated by these fluctuations – and rain infiltration in the crests of the dikes (Figure 3). Auvinet et al. (2008) observed that problems in river banks commonly begin with erosion which, depending on the type of soil, can cause piping in some areas, possibly resulting in landslides (Figure 4). These eroded sections are generally protected with dikes consisting of clayey material. Elements that can better withstand erosion by river water are also used, examples being rock fill, systems with concrete bags (*bolsacreto* or *colchacreto*), breakwaters or sheet pile walls. River embankments may also fail when the weight of these structures exceeds the bearing capacity of the foundation soil (Figure 3). Generally, failure occurs in layers with low shear strength such as the highly compressible clays and peats which are found in unpredictable locations along the banks of the rivers in Villahermosa (Figure 1). It has also been found that factors such as scour of the riverbed and over-loading caused by the weight of additional protection such as sand bags result in dike instability. In addition, intense rainfall in the region can cause large and rapid variations in the levels of local rivers, lagoons and reservoirs.

Figure 3. Consequences of water drawdown in Tabasco State, Mexico

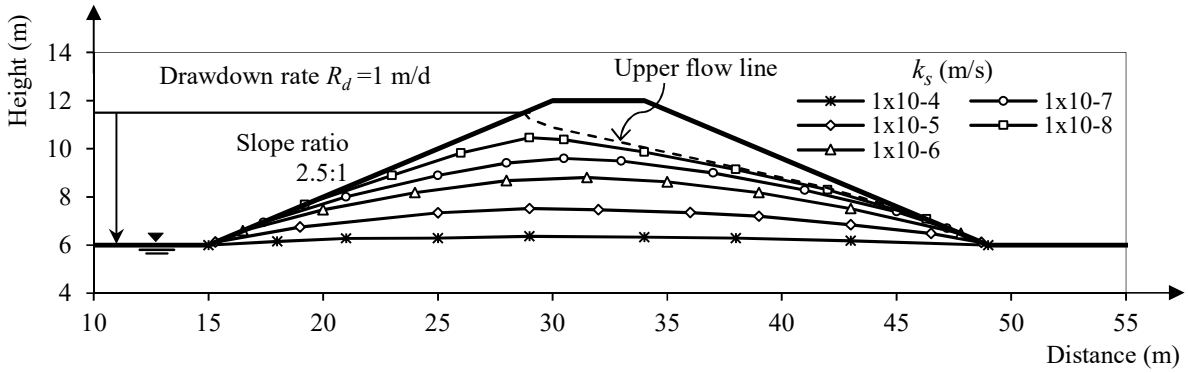
Figure 7. Phreatic surfaces (desaturation lines) at the end of the water drawdown stage in a dike with variable hydraulic conductivities k_s, (López-Acosta et al. 2015)

These analyses evaluated several homogeneous and isotropic dikes with a 2.5(H):1(V) slope and total dewatering head of 5.5 m for different hydraulic conductivities. Figure 7 shows the upper flow line for the initial steady-state condition and desaturation lines at the end of water drawdown in dikes with different hydraulic conductivities k_s for the transient-state condition and assuming a constant drawdown rate of R_d = 1 m/d. As can be seen from this figure, where $k_s = 1\times10^{-08}$ m/s, the desaturation line remains practically in the same position as the upper flow line, which is associated with the *fully rapid drawdown mode*. In this case, it can be assumed that the soil behaves undrained. For $k_s = 1\times10^{-04}$ m/s, the desaturation line inside the dike drops down almost in line with the reservoir water level, which is associated with the *fully slow drawdown mode*. In this case, it can be assumed that the soil behaves drained. It can also be assumed that the desaturation lines between these two extreme modes represent the *transient drawdown mode* in which a curvilinear water line is generated in the soil structure, the position of which depends on the drawdown rate and the constitutive material properties. The remaining pore pressure in the dike is therefore transient, it varies as a function of time, but also with the soil's ability to retain water. Several authors have recognised the three water drawdown modes described here (examples being Lane & Griffiths, 2000 and Berilgen, 2007).

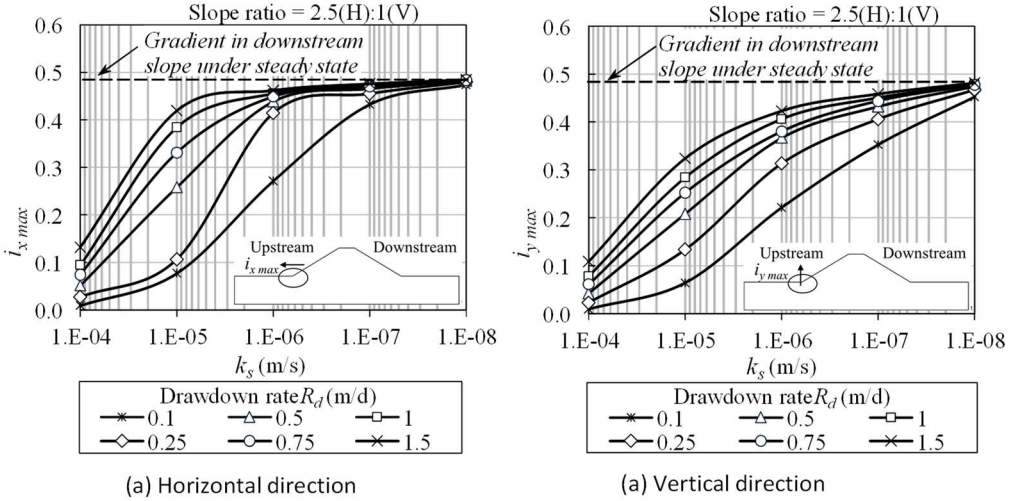
Figure 8. Effect of drawdown rate R_d on exit hydraulic gradients in dikes for variable hydraulic conductivities k_s, (López-Acosta et al. 2015)

Figure 8 shows the effect of the drawdown rate on exit hydraulic gradients in the horizontal and vertical directions, corresponding to the x and y axes respectively, in both the upstream and downstream slopes of the dikes with variable hydraulic conductivities k_s. In addition, Figure 9 summarizes the results obtained assuming variable permeabilities k_s and a constant drawdown rate (R_d = 1 m/d). The following conclusions can be drawn on the basis of the results of these parametric analyses:

- The exit hydraulic gradients were observed to increase when the drawdown rate increased.
- In general, given the admissible values suggested by several authors for local erosion and piping (for example, Den Adel et al., 1988; Wan & Fell, 2004; Ahlinhan & Achmus, 2010), the magnitude of the gradients computed here is significant. One suitable way of preventing internal erosion or piping is the installation of filters or drains placed strategically in the earth structure.

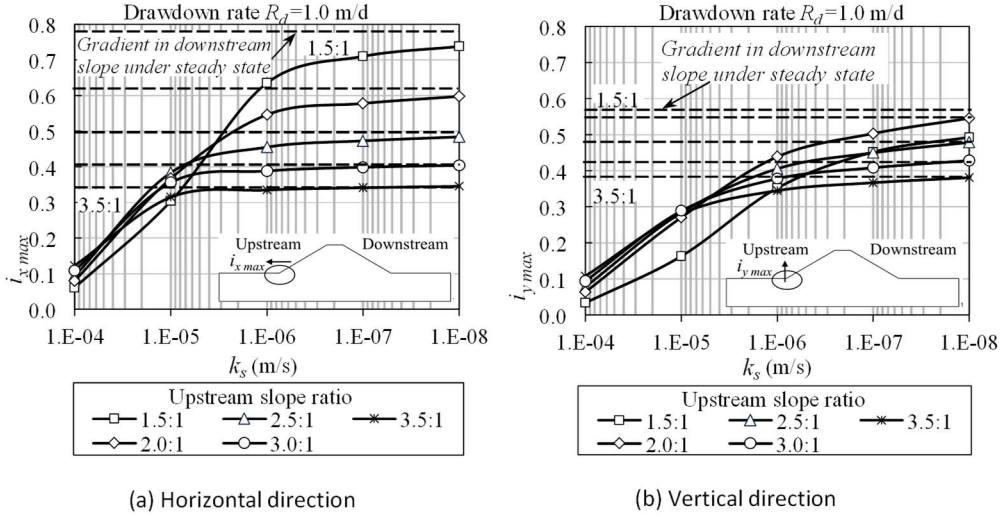
Figure 9. Effect of the slope ratio (H:V) on exit hydraulic gradients in dikes for different hydraulic conductivities k_s, (López-Acosta et al. 2015)

- Under a steady-state flow, the exit hydraulic gradients in the downstream slope remain constant for all k_s permeabilities studied.
- Changes in the slope ratio of dikes have a more significant effect on the magnitude of the exit hydraulic gradients than changes in the drawdown rate. It was observed that steeper slopes generate greater values for exit gradients.

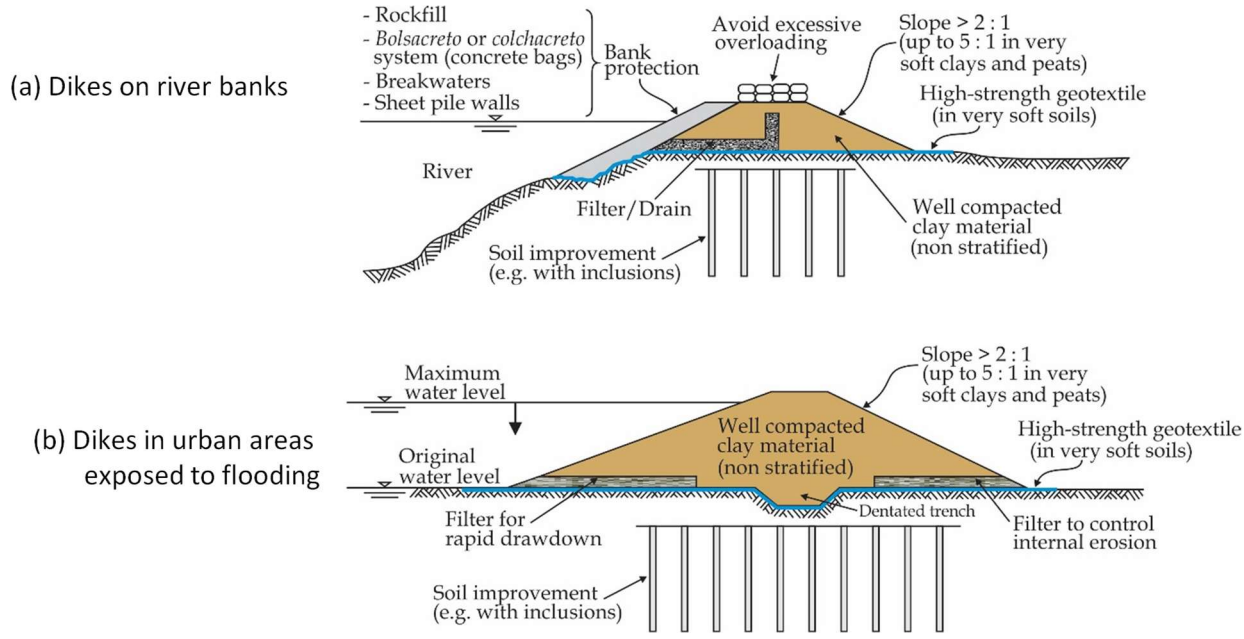
This study focused on one of the main problems affecting the stability of Tabasco dikes: the water drawdown phenomenon caused by sudden changes in the levels of rivers, lagoons and reservoirs. Particular emphasis was placed on the study of exit hydraulic gradients at the toe of homogeneous and isotropic dikes. The effects of different parameters (drawdown rate, hydraulic conductivity and slope ratio) for the dikes were assessed in unsaturated, transient-state, flow analyses based on numerical modelling with the finite element method. Based on the results, it is concluded that analyses should consider the susceptibility to erosion of the material used to build the dike. However, analyses should also include measures – such as the installation of drains and filters – to reduce the hydraulic gradients and seepage forces generated inside the soil mass. The results of the analysis led to the practical recommendations shown in Figure 10, which should be taken into consideration for the protection of the Tabasco dikes.

Figure 10. General recommendations to protect Tabasco dikes

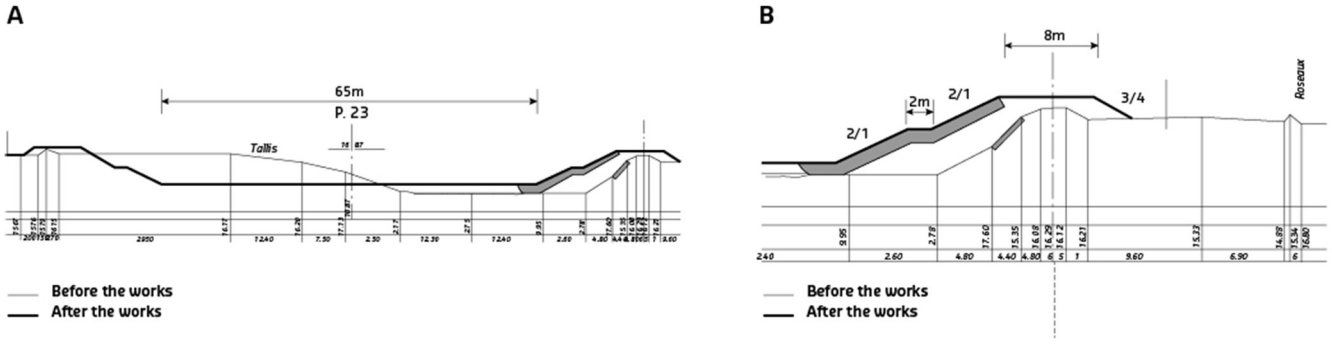
When the river was re-profiled in 1970, the bed was widened to 65-70 m. The dikes generally were constructed to an elevation of 2-3 m, 8 m wide at the crest, with 1V/2H slopes, see Figure 12 and were built using local material. Thus, the materials used vary along the dikes and may consist of loam and sandy loam or even gravel. There is riprap toe protection on the river side, and armour protection over the full height on the concave side of curved sections, as shown in Figure 12b.

Figure 12. a) Re-profiling of the river and construction of the dikes, b) armouring of the river side of the dikes in concave sections

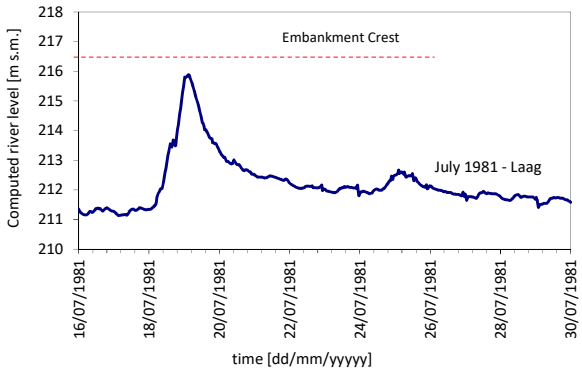
The river level at Laag and St Florian was derived from hydrometer measurements upstream (Branzoll hydrometer), assuming a uniform flow between the section where the hydrometer was installed and the sections where the embankment instabilities were located. The river level computed during the flood event is shown in Figure 17 and 19. At its peak, the river level in Laag and St Florian was still approximately 50 cm below the crest of the dike (Figure 17). Failure was therefore associated with water flow through the dike and/or its foundations and the collapse involved the instability of the landside bank.

Figure 17. River level computed at Laag (km 106.185) from 16 July to 30 July 1981. The elevation of the embankment crest is reported as a reference.

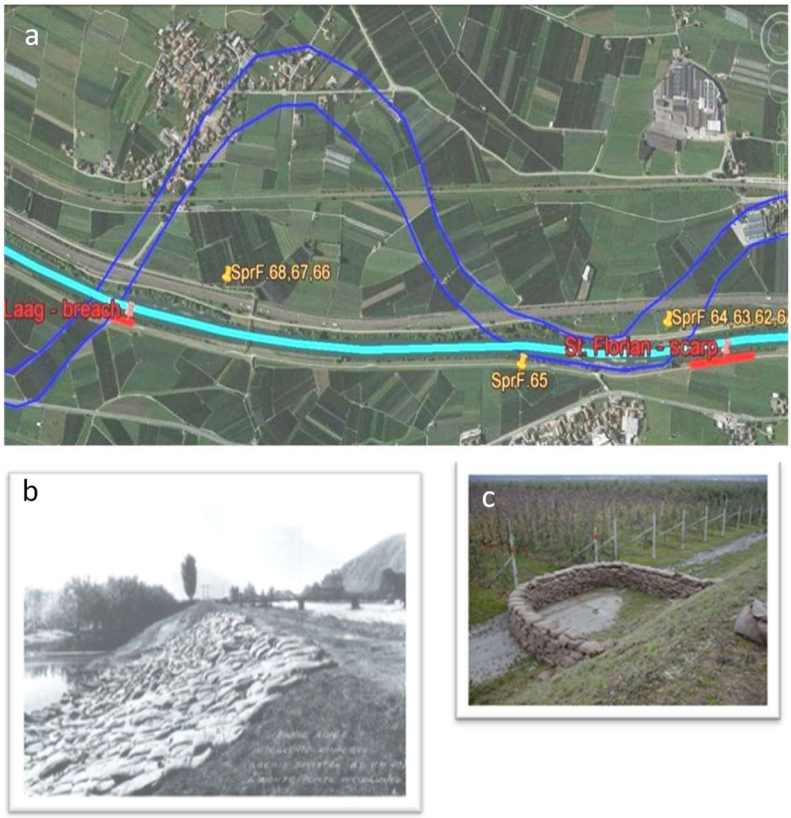
Evidence of water flowing through or underneath the embankment is provided in Figure 18b, c. Ponded backwater often accumulates during a flood event and springs form at the toe of the embankment on the landward side.

The original riverbed meandered through the Adige valley and was straightened at the end of the 19th century, as shown in Figure 18a, by constructing the current embankments. The ancient river bed is filled with material that is coarser then the surrounding clayey and silty deposits. At some places the current riverbed intersects the ancient river beds and locally the embankments are founded on the coarse-grained filling. As a result, the hydraulic conductivity of the embankment foundation at these intersections is relatively high and groundwater flows preferentially through these layers.

Figure 18. (a) Current and ancient river bed profiles and spring formation during the flood events in 1997 and 2000 (b) Backwater areas during the 1966 flood (c) Spring formation during the 1997 flood event

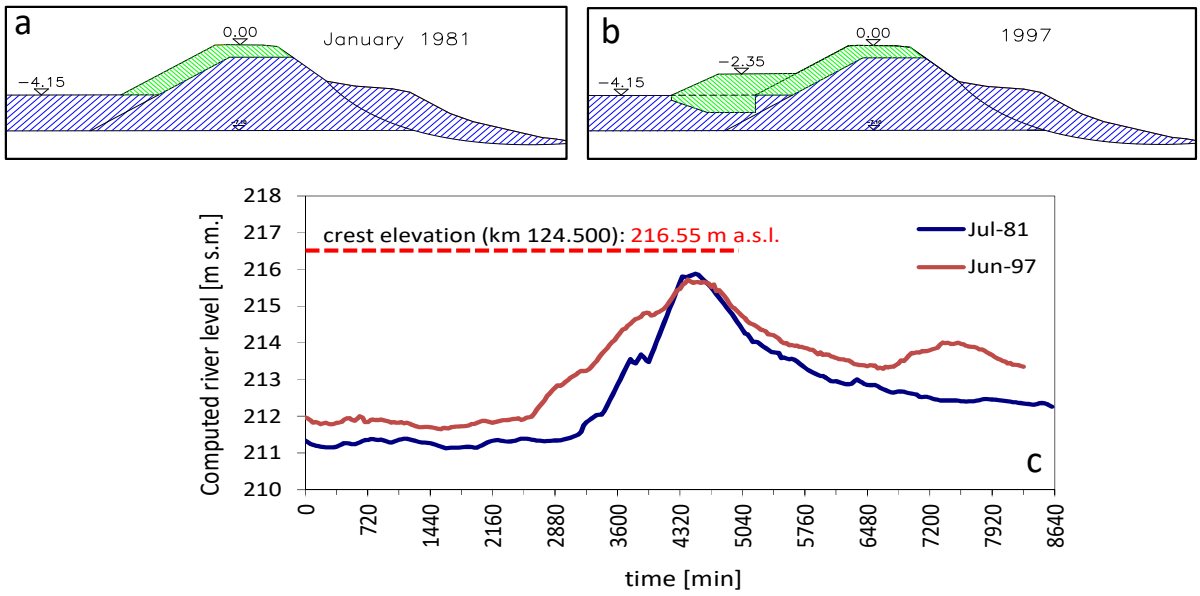
Figure 19. a) cross section during the flood event in 1981 b) remedial works consisting of a berm on the landward side, c) the river level during the flood events in 1981 and 1997 The elevation of the embankment crest is also reported as a reference.

Evidence for the collapse mechanisms involving the landward bank can be inferred from the remedial works undertaken on the embankments following the 1981 flood event. In fact, a berm was constructed on the landward side of the embankment to increase the factor of safety with respect to global instability involving the landward bank, Figure 19a and 19b.
During the flood event in 1997, which was even more intense than the one in 1981 (Figure 19c) no collapse phenomena were observed in the segments that had experienced instability in 1981. This can be attributed to the construction of the berm and the increased stability on the landward side.

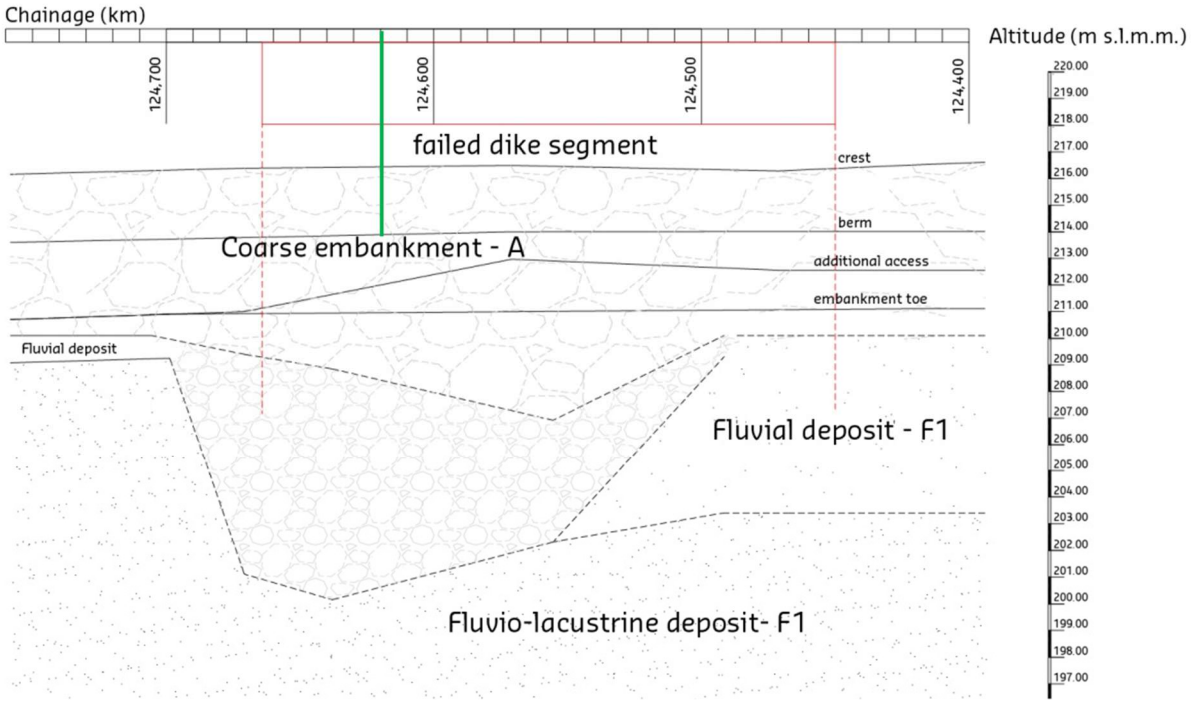
Figure 20. Longitudinal soil profile of the dike segment in Laag that includes the section breached in 1981. The location of the representative cross-section is indicated by the green line.

Figure 20 shows the longitudinal soil profile that includes the segment of the dike in Laag breached in 1981 and then reconstructed after 1981. The dip in the interface between the coarse-grained embankment and the ancient river bed is attributable to the excavation of the ancient river bed material after the dike was breached. During the flood, the embankment was patrolled frequently (a few times a day) and no evidence of sand boiling was detected. It is not possible to exclude that

sand boiling was occurring between one visual inspection and another. However, it would appear that failure was mainly caused by underseepage rather than erosion triggered by uplift pressures at the landside toe of the embankment.

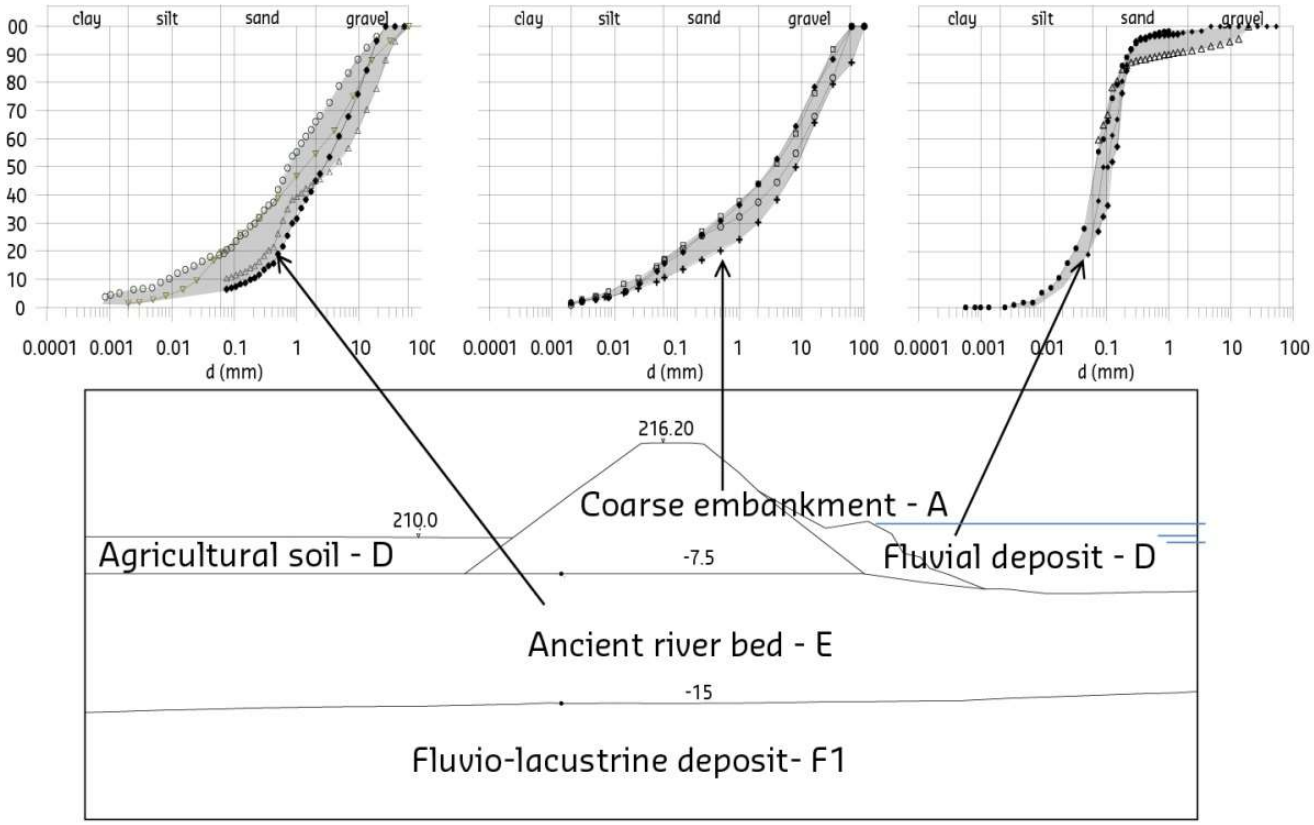
The cross-section at chainage 124.620 km was selected to analyze the hydro-mechanical response of the embankment (Figure 21). Figure 22 shows the longitudinal soil profile that includes the segment of the dike in St Florian affected by instability in 1981 (scarp of about 50 cm). The cross-section at chainage 122.248 km was selected to analyze the hydro-mechanical response of the embankment (Figure 23).

Figure 21. Soil profile for the cross-section representative of the dike segment in Laag breached in 1981 (chainage 124.620 km)

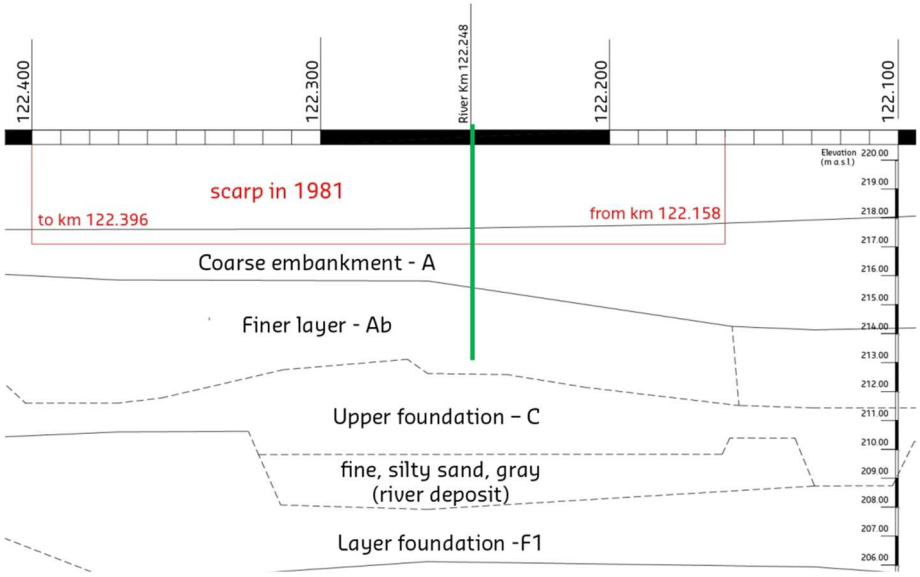
Figure 22. Longitudinal soil profile of the dike segment in St Florian that includes the portion affected by instability in 1981. The location of the representative cross-section is indicated by the green line.

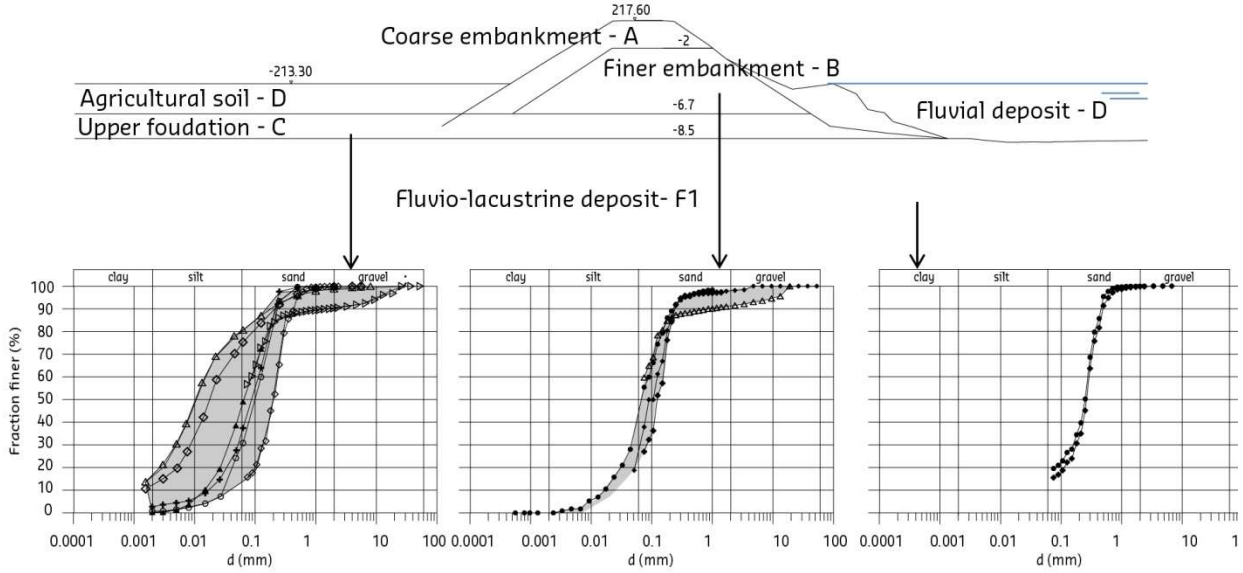
Figure 23. Soil profile for the cross-section representative of the dike segment in St Florian affected by instability in 1981 (chainage 122.248)

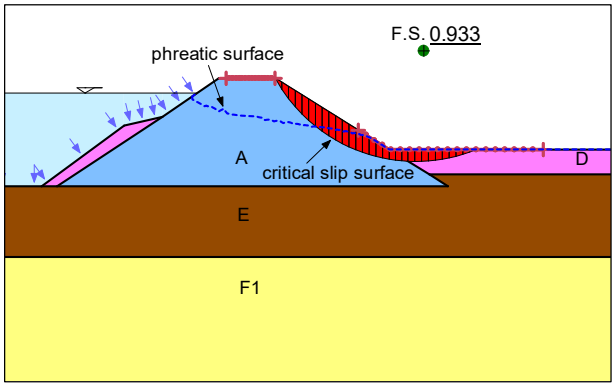
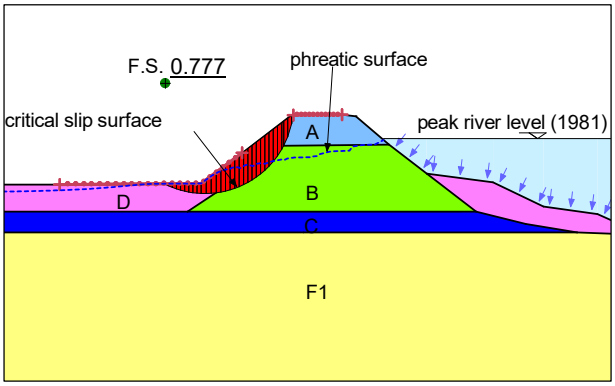
Figure 24. Stability analysis and relevant soil parameters at flood peak and transient flow condition of the section at km 124.62 in Laag; c' = 0 kN/m²

Figure 25. Stability analysis and relevant soil parameters at flood peak and transient flow conditions of the section at km 122.248 in St. Florian; c' = 0 kN/m².

where σ_n is the normal stress, ϑ_w is the volumetric water content, ϑ_s is the saturated volumetric water content and ϑ_r is the residual volumetric water content. The results of the stability analyses at flood peak for the two cross-sections based on transient flow conditions are shown in Figures 24 and 25. The stability analysis consistently returns factors of safety < 1 for these sections, which proved to be unstable in 1981.

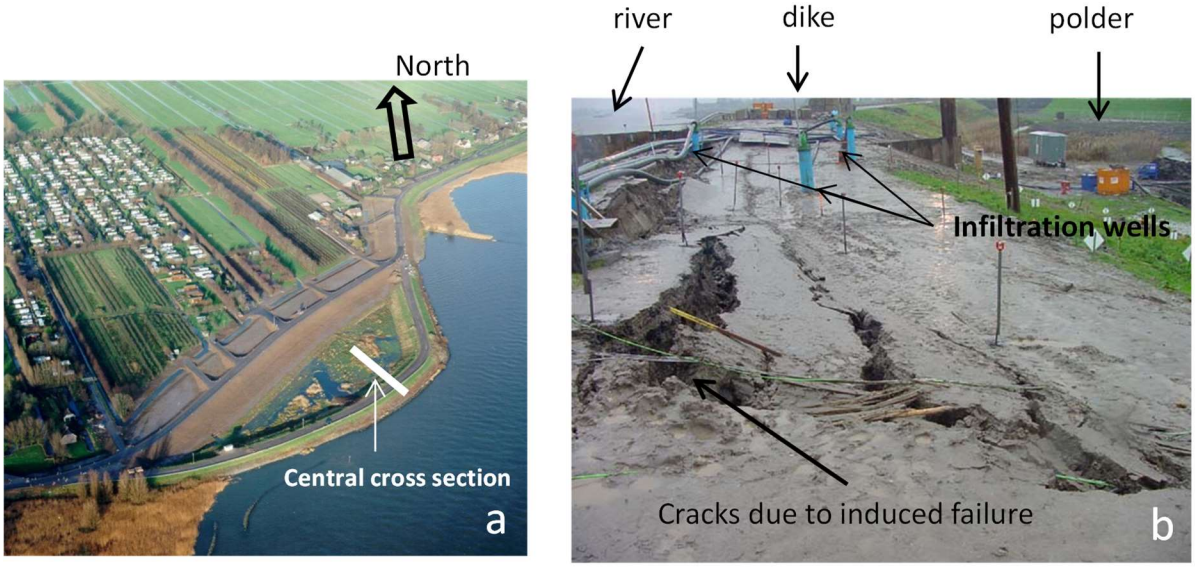
Figure 27. Test site, a; aerial photograph before testing, arrow indicates North direction, white line indicates the location of the central cross section shown by Figure 29, b; failed dike body after testing

The test began at 06.00 on 26 November 2000, t = 0 in the graphs below. Figure 32 shows the river level and the average head in the nine infiltration wells. Infiltration started at t = 370 min, 6 hours after the start of the test. Initially, the hydraulic head in the wells followed the fluctuations in the river level. It should be noted that the test site is close to the sea and that the tidal wave has a pronounced influence on the water level in front of the dike. Although drinking water was used for infiltration, the infiltration wells clogged up after 26 hours, t = 1580 min, reducing well capacity. Due to maintenance, required to regain the full pumping capacity, the hydraulic head was seen to fall between t = 1580 and 2260 min, a period of 11.3 hours (Figure 32). Maintenance was also needed between t = 3090 and 3308 min, a period of 3.6 hours. Failure was observed at t = 3450 min, approximately 2.5 days after the start of the test, in the form of large longitudinal cracks in the dike body accompanied by major subsoil deformation (see Figures 33 and 34). The difference in height at the location of the cracks increased to more than 1.0 m (Figure 27b).

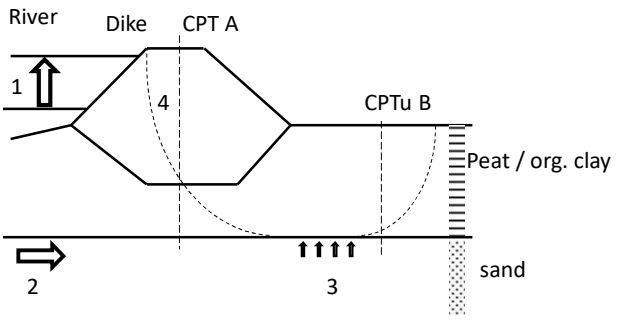
A typical failure mechanism for dikes in this area is loss of stability due to uplift of the soft soil layers at the toe. Figure 28 explains the failure mechanism. There is a hydraulic connection between the river and the Pleistocene sand layer. A rise in the river level (1) results in an increase in the hydraulic head in the Pleistocene sand layers (2) until the pore pressure equals the weight of the Holocene layers on top (3). The shear strength at the transition between the Holocene clay and peat layers on the one hand and the Pleistocene sand deposit on the other is drastically reduced, creating the conditions for a long, deep, slip plane (4). The uplift phenomenon is described in further detail by Cooling & Marsland (1953), Marsland (1961), Bauduin et al. (1989) and Van (2001). Observations of stability loss due to uplift are scarce and it was decided to study the uplift phenomenon at the Bergambacht test site.

Figure 28. Impression of the uplift failure mechanism, 1: river level rise, 2: hydraulic connection to sand layer, 3: pore pressure rise until uplift top layer, 4: failure plane.

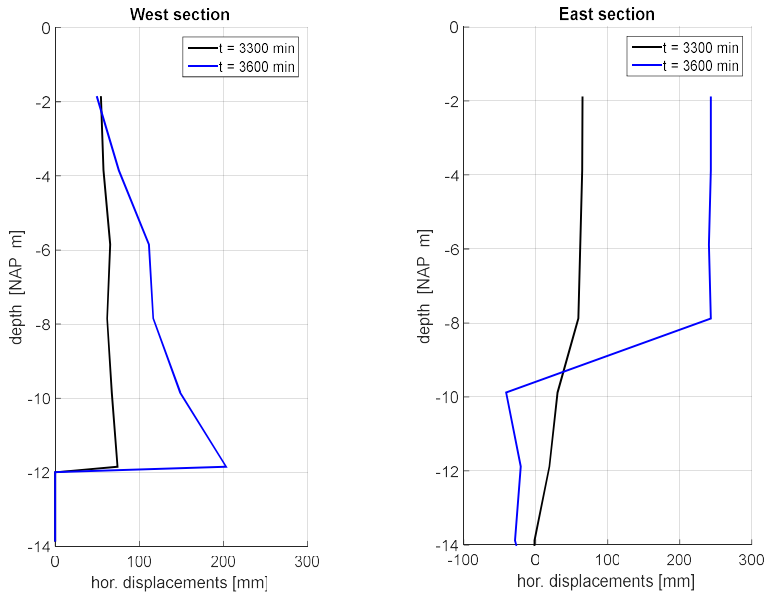
Figure 33 shows the horizontal displacements measured at the toe in the eastern and western sections at t = 3300 min (55 h) and t = 3600 min (60 hours). Note that there was no inclinometer in the central section. The maximum displacement was found at the transition between the Pleistocene and Holocene layers, which was not at the same depth in both sections. Figure 34 shows the development of the maximum displacement for both sections. In the western section, horizontal displacements started to develop as soon as infiltration began. At approximately t = 1500 min, infiltration was suspended temporarily and no further deformation was observed until t = 2500 min, when infiltration resumed. Soon after, horizontal displacement developed in the eastern section as well. Infiltration was suspended for a second time, and horizontal displacement stopped again. Soon after infiltration resumed, displacement accelerated until the dike failed at t = 3450 min (57.5 hours) after the start of the test.

Figure 33. Horizontal displacement at the toe (both polder-side west respectively east of the central section as shown in Figure 27a)

Figure 33 shows that horizontal displacement in the western section was initially higher than in the eastern section. This corresponds well to the lower μ-value found for the west section, indicating that uplift was reached at an early stage of the test in the western section. The dike was seen to fail when the μ-value reached the lowest level during the test in the central section, $\mu = 1.01$, and eastern section, $\mu = 1.05$.

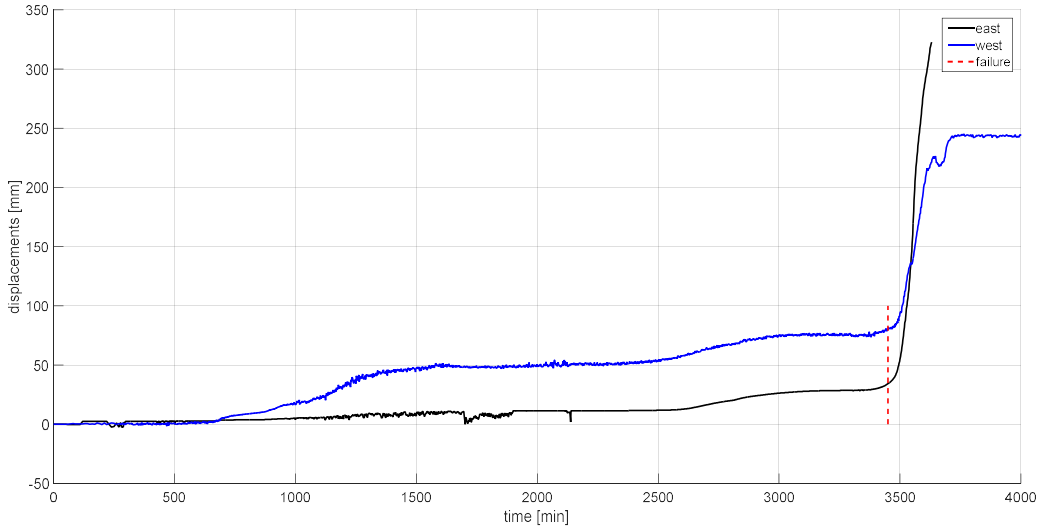
Figure 34. Development of maximum horizontal displacement during the test

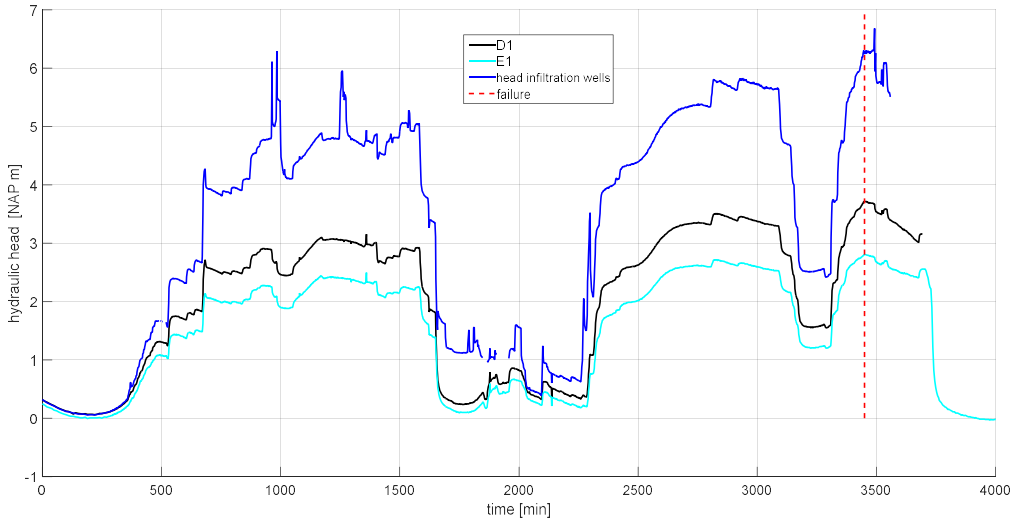
Figure 35. Hydraulic head in Pleistocene sand layer, locations D1 and E1 (see Figure 29)

Figure 35 shows the hydraulic head observed in the Pleistocene sand layer at distances of 21 and 42 m from the infiltration wells. The effect of infiltration declined with increasing distance from the well; the hydraulic head at D1 was lower than in the infiltration wells and a further reduction in maximum head was observed in E1.

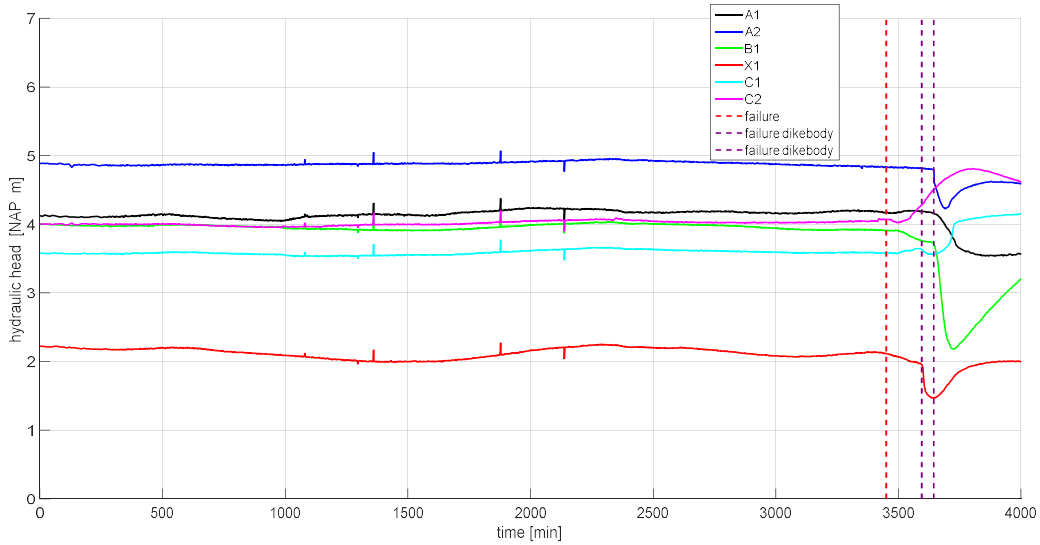
Figure 36 shows how hydraulic head developed inside the dike body. Prior to failure there was no significant fluctuation in hydraulic head. The range in hydraulic heads measured by the different transducers can probably be explained by suction forces at the top of the dike. With the exception of C2, there was a sharp drop indicating failure. Close inspection shows that, inside the dike body, the response to failure was later than given by the observed horizontal displacement at the toe, $t = 3450$ min at which only the pore pressure at location C2 shows a response. There was a minor initial response at B1 and C1 shortly after $t = 3450$ min. The sharp drop in hydraulic head was observed later. The drop at X1 and C1 was observed at $t = 3595$ min, or 145 min (2.4 hours) later. At $t = 3644$ min (50 minutes later) the hydraulic head at B1 and A2 dropped significantly. The time differences for local failure found at different locations shows the propagation of the failure plane, starting deep in the subsoil and moving towards the crest. It should be noted that the development of the failure plane resulted in breakage of the infiltration wells. When infiltration ceased, the uplift conditions were no longer in place and sliding along the slip plane as indicated by Figure 28 stopped.

Figure 36. Hydraulic head in the dike body for locations A1 to C2 (see Figure 29)

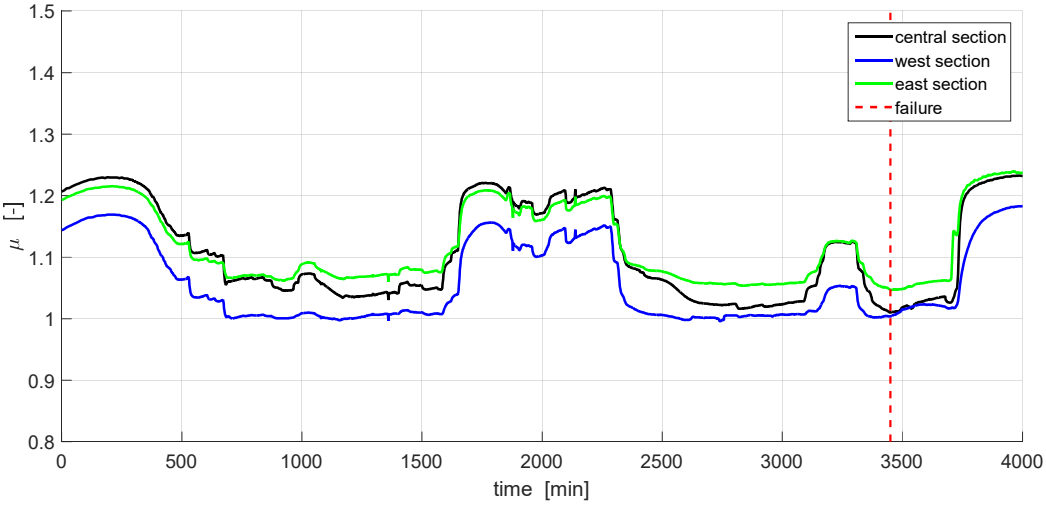
Figure 37. Ratio of total overburden pressure to pore pressure, μ, during the test

To check on the uplift conditions during the test, the ratio, μ, of the weight of the Holocene layer to pore pressure in the Pleistocene sand layer was determined for each of the transducers in the Pleistocene sand layer. Figure 37 shows the ratio, μ, during the test for the transducers placed at 46 m from the crest of the dike in the central, eastern and western sections. Initially, $\mu = 1.2$. When infiltration began, this value reduced, as expected. Due to differences in the subsoil layer, μ varied for the different sections, with the lowest value in the western section, where the value remained approximately 1. In the central and eastern sections, μ seemed to reduce slightly during the test. This corresponds to the slight increase in infiltration pressure during the test, as shown in Figure 35. The value did not drop significantly below 1.0. This could be explained by the pumping capacity, which does not allow for any further increase in pore pressure in the sand layer at the toe of the dike. It can also be hypothesized that when the pore pressure in the sand layer starts to exceed the weight of the clay and peat layers above it, a gap is created which is filled with pore water from the sand layer until a new equilibrium is attained. When pumping capacity is further increased, the gap may be widened, maintaining the equilibrium in vertical forces. In this hypothesis, $\mu = 1.0$ could be a physical boundary that will have prevented any further decline in the μ value in the western section during the test. It should be noted that, at larger distances from the dike, the Pleistocene hydraulic head decreased, causing an increase in μ. Close to the dike, μ is affected by the weight of the dike body.

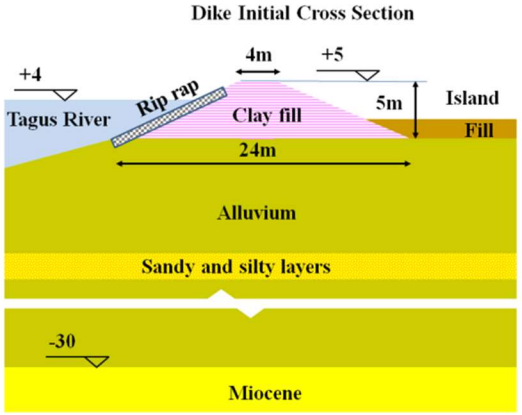
Figure 39. Initial dike cross-section and geotechnical profile.

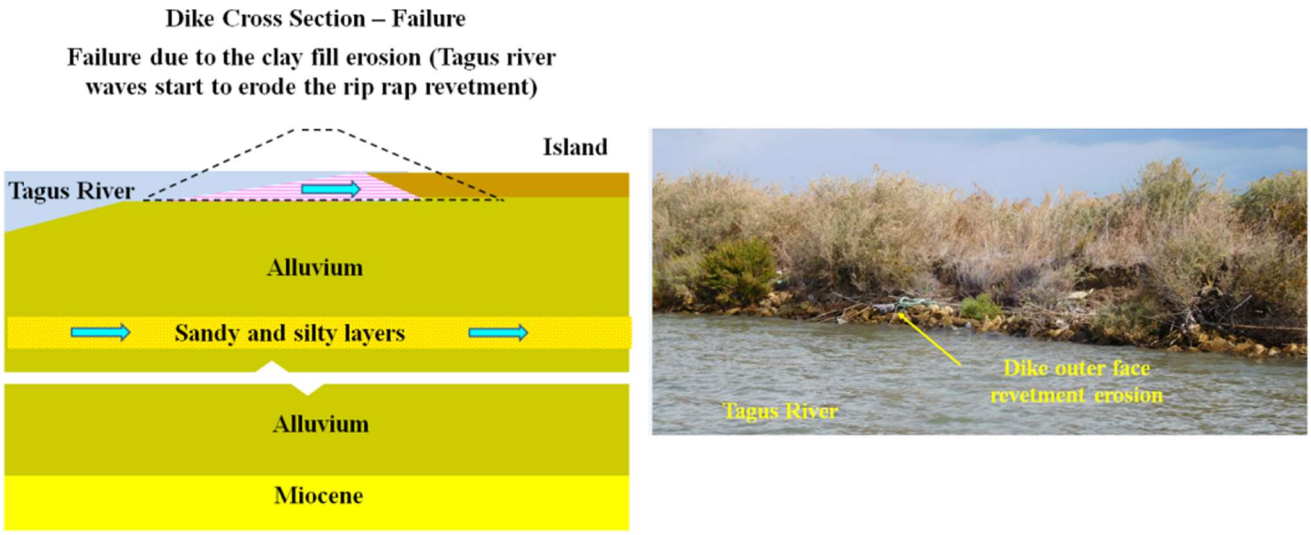
The main failure mechanism is related to the erosion of the clay fill due to water inflow and the mechanical action of the waves on the outer face of the dike. Failure originated with the erosion of the riprap revetment (Figure 39). The presence of a permeable sandy layer below the dike foundations also contributed to the failure mechanism. The actual dike failure began during the severe winter of 2015 - 2016 and involved a section with an overall length of approximately 30 m. When the failure occurred, the water level in the Tagus River was approximately Mean Sea Level, MSL, +4.20 m. In October 2016, the overall length of the dike failure line had increased to approximately 80 m.

Figure 40. Dike failure due to the erosion of the clay fill, cross-section and view of the outer face.

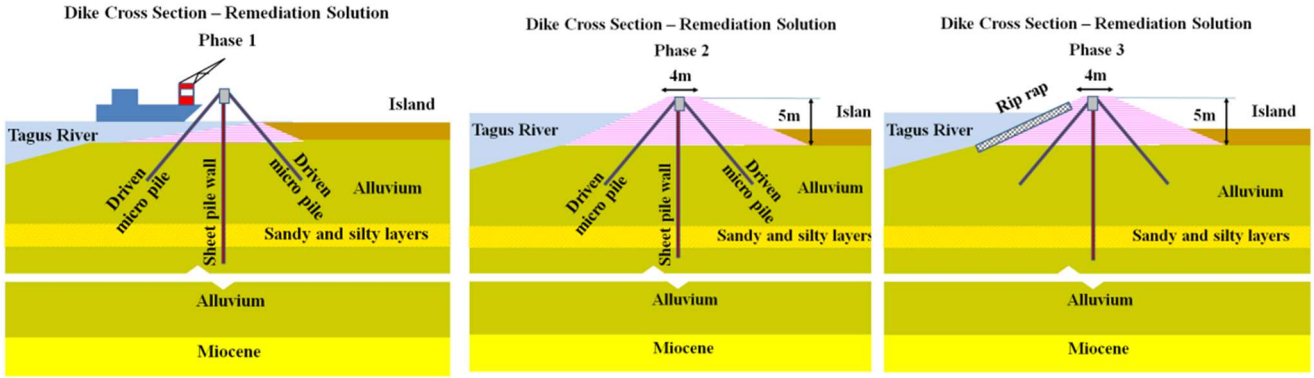
Figure 41. Dike remediation: main construction phases.

The proposed dike remediation solutions comprised the use of a driven sheet-pile wall braced by inclined driven steel micro-piles, all capped with a top and a central, reinforced, concrete beam. Those works are to be performed from a barge at high tide. The depth of the sheet pile walls will have to be enough to pass through the silty and sandy alluvial layers. A protection and stabilisation fill will be required on both the outer and inner sides of the sheet piling. On the outer face of the fill, a riprap protection revetment will be required to protect the fill from hydraulic erosion. Figure 41 illustrates the reconstruction works.
