Flooding Vulnerability Lessons Learned in Assessing the Effects of Flooding Caused by the Canterbury Earthquake Sequence

Mark Taylor, *Civil Engineer, Tonkin & Taylor Ltd, Auckland, New Zealand; email: mtaylor@tonkintaylor.co.nz*
Tim Fisher, Dr, *Water Resources Engineer, Tonkin & Taylor Ltd, Auckland, New Zealand; email: tfisher@tonkintaylor.co.nz*
KKS Ng, *Water Resources Engineer, Tonkin & Taylor Ltd, Auckland, New Zealand; email: kng@tonkintaylor.co.nz*
Mark Pennington, *Water Resources Engineer, Tonkin & Taylor Ltd, Tauranga, New Zealand; email: mpennington@tonkintaylor.co.nz*

Submitted: 4 September 2017; Published: 9 November 2018
Reference: Taylor, M., Fisher, T., Ng, K.K.S. and Pennington, M. (2018). *Flooding Vulnerability Lessons Learned in Assessing the Effects of Flooding Caused by the Canterbury Earthquake Sequence*. International Journal of Geoengineering Case Histories, Vol.4, Issue 4, p.242-253. doi: 10.4417/IJGCH-04-04-02

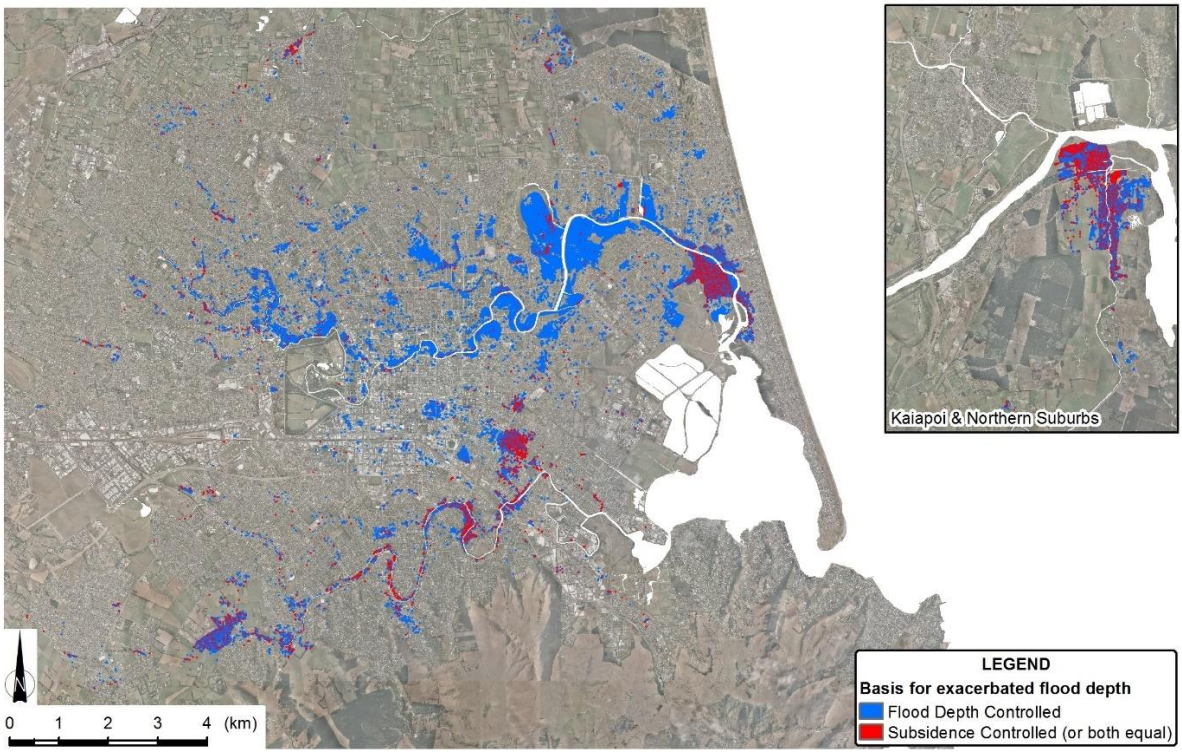
Figure 5. Map showing (shaded blue) areas where the earthquake induced subsidence is greater than the resulting increase in flood depth. Area (shown shaded red) is where the flood depth has increased more than the subsidence that has occurred.

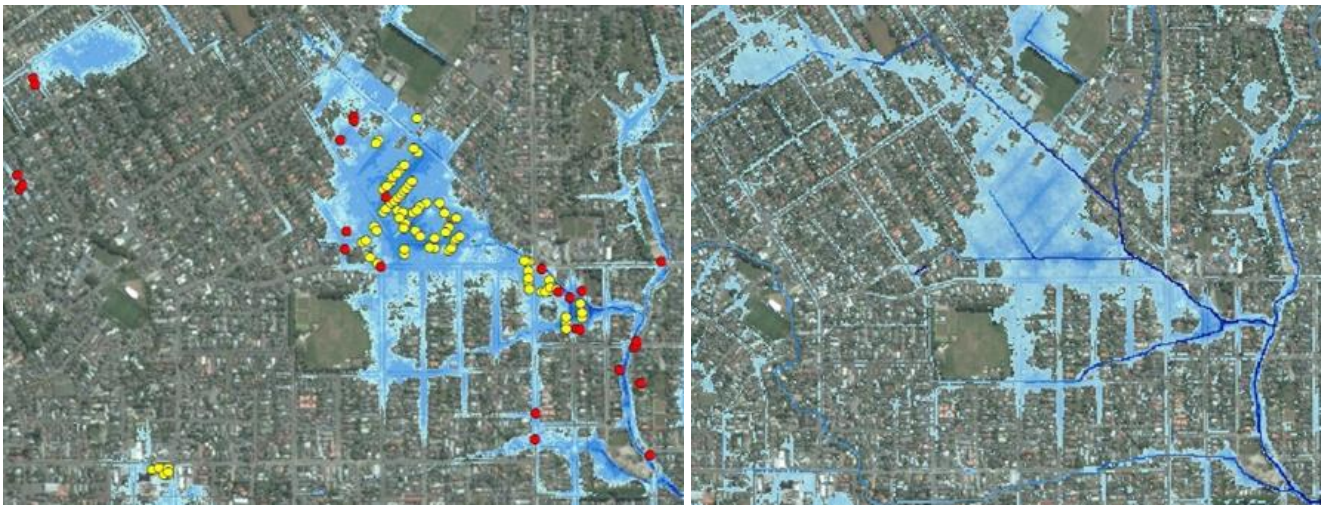
The usefulness of the increase processing speed became apparent following the 4 and 5 March 2014 flood event. At the time of the flood event occurring (which T+T hindcast as between a 20 and 50 year Average Recurrence Interval (ARI) river flood event as measured in the Avon at the Gloucester Street gauge), the IFV model was in the final stages of completion. However, the model had not (because there was no data available) been verified or calibrated to actual flooding. The event provided an opportunity to undertake this. Again, the value of rapid mapping proved extremely useful. Teams involving T+T, EQC, NIWA and CCC independently mapped flood extents. CCC also collated flood reports from residents. This mapping together with river and rain gauge data was used to calibrate the model. We consider (and the International Peer Review Panel agreed) that the resulting Overland flow model was appropriate for the use of IFV. A comparison of the calibrated model and the observed mapping for the Avon catchment is shown in Figure 6. A similar comparison is shown for a badly affected area known as the Flockton Basin in Figure 7.

Figure 7. Calibration run of maximum depths (right) compared to a combined T&T, CCC and NIWA observed flooding map (left) for the 4 and 5 March 2014 event – Flockton Basin.
