A Constructability Problem in a Deep Shoring System

KEYWORDS: Deep Excavation, Retaining Wall, Secant Bored Pile, Prestressed Anchors, Shotcrete, Inclinometer Measurements

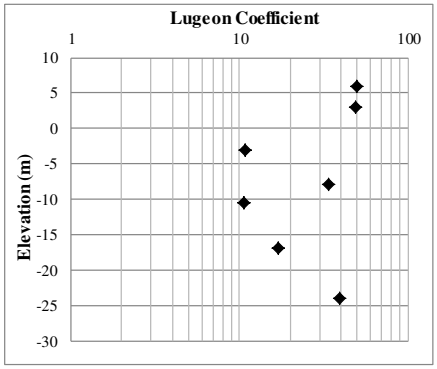
Figure 4. Packer Permeability Test Results.

To determine the permeability characteristics of the Trakya formation rock units, the packer permeability tests were conducted within the suitable rock conditions in BH-4 and BH-5 boreholes. The summary of obtained results and the variation of the Lugeon coefficient versus elevation are given in Figure 4. The Lugeon values are L_v=10 to 50, indicating permeable to highly permeable formation.

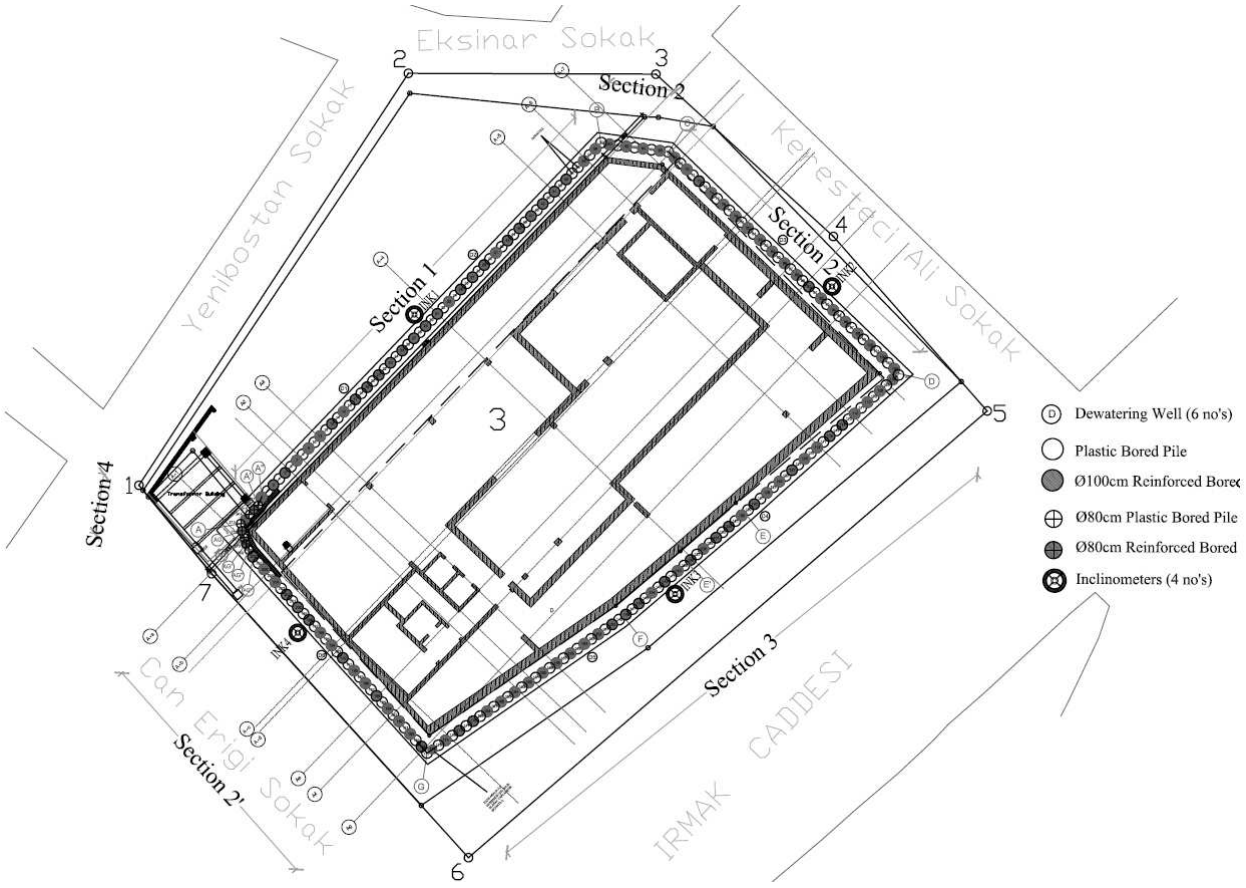
Figure 6. The Plan View of the Retaining System.

In all sections, the diameters of the secant piles are 1.0m with 0.2m overlapping. The lengths of the piles are 34.7m. However, due to the lack of sufficient construction area, the diameter of the secant piles was reduced to 80cm with 0.1m-0.2m overlapping where the transformer building exists. The plan view of the retaining wall is presented in Figure 6.

As can be seen from Figure 6, four inclinometer boreholes were drilled around the project site and used to measure lateral displacements of the soil/rock mass behind the secant pile wall. Measurements for inclinometers were taken for each construction phase and at frequent intervals during the construction period.

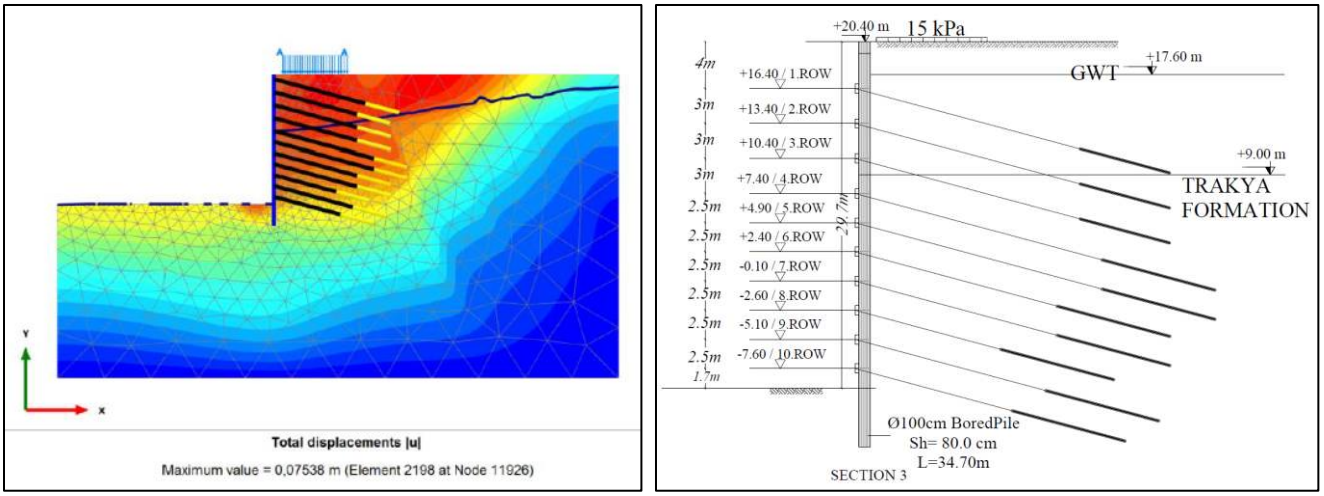
Figure 7. Section View of the Retaining System.

To reduce the groundwater elevation behind the secant bored piles, six (6) dewatering wells were installed outside of the excavation area at a distance of about 1.0m from the face of the secant piles.

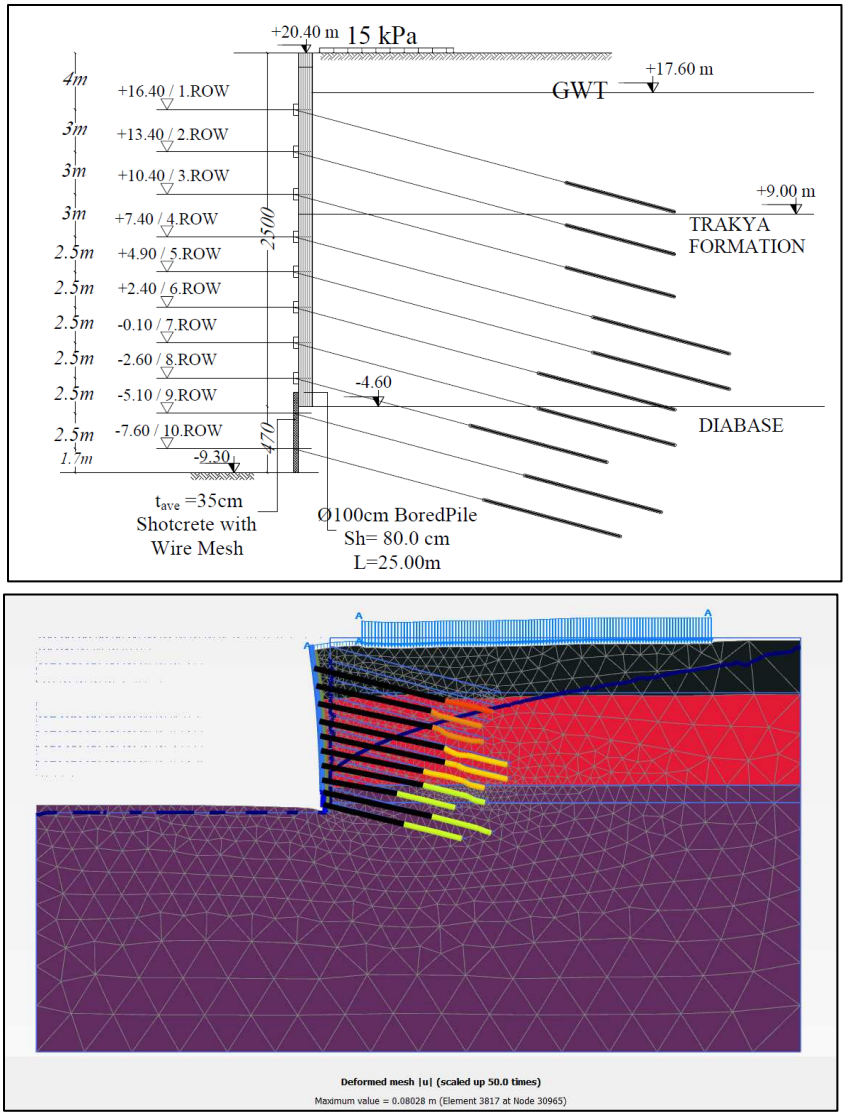
Figure 9. Section View of the Revised Retaining System.

During the pile installation, it was observed that the strength of the Trakya Formation rock units fared better than expected, especially below the 25.0m depth (-4.6m elevation). The progress rate of the drilling unit was controlled regularly for each pile; it is shown that the progress rate was less than 1.0m/hour after 25.0m depth. Additionally, magmatic origin diabase blocks were encountered after a certain depth.

Considering the aforementioned reasons, due to the challenges encountered in such hard units, the design of the retaining system was revised. The length of secant bored piles was reduced to 25.0m and the remaining part of the excavation was designed to be supported by shotcrete with wire mesh having thickness, t, equal to 35cm.

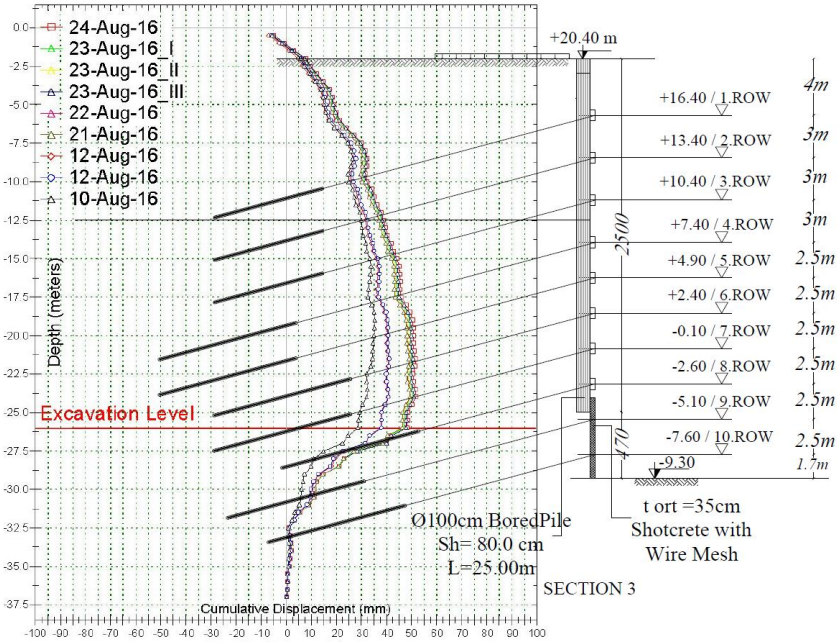
Figure 10. Encountered Excessive Displacements on Section 3.

In the excavation phase of Section 3, the lateral displacement exceeded the critical limit (45mm) in the middle of August 2016. Following immediate discussion by the client, contractor, and project engineers, mitigation measures were determined.

In the second half of August 2016, toe filling was carried out up to the middle of 6th and 7th row prestressed anchor levels (19.25m depth, +1.15m elevation), and six additional prestressed anchors (each 32.0m in length) were installed.

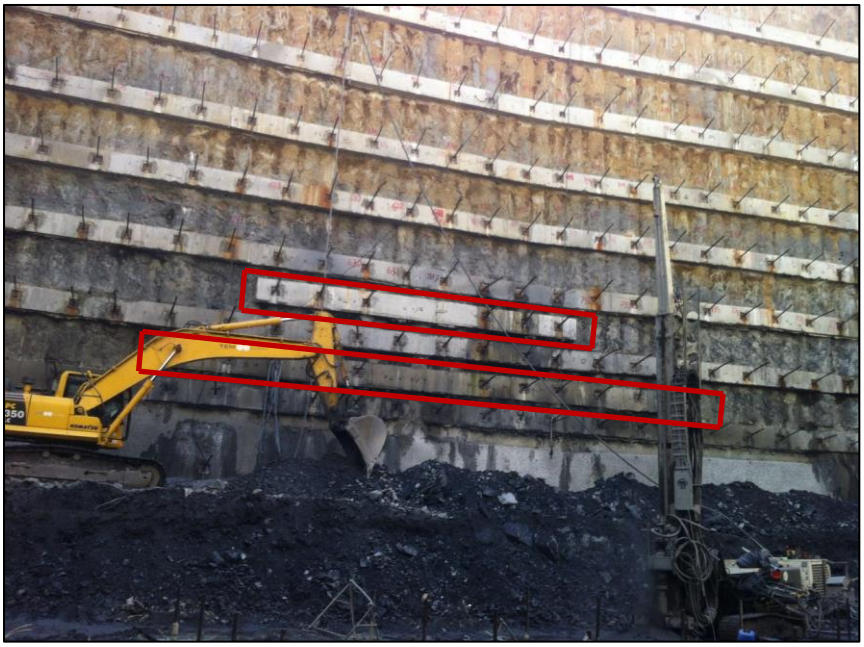
Figure 11. Additional Anchors on Section 3.

At the beginning of September 2016, excessive lateral displacements were observed again in the inclinometer readings. An additional ten prestressed anchors, each 32.0m in length, were also implemented between the 7th and 8th row anchor levels. A frontal view of Section 3 is shown in Figure 11.

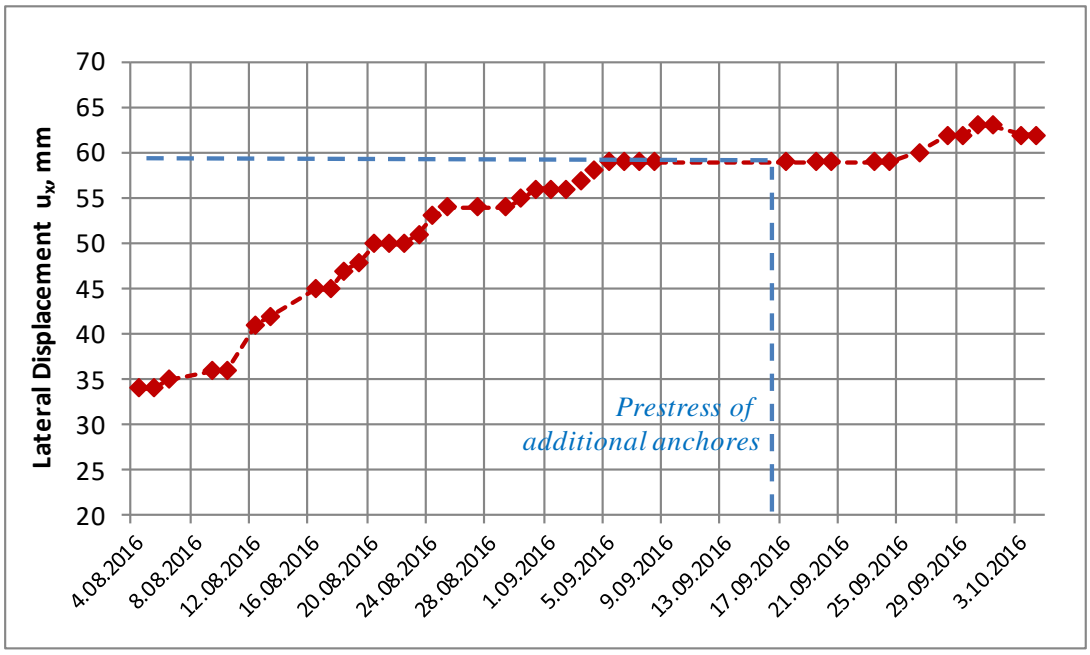
Figure 12. Section 3 Lateral Displacements.

During the prestressing of the additional anchors on September 17th, 2016, the lateral displacement was measured as 58.0mm. Due to the stage excavation of 9th row anchors, the lateral displacement was increased to 62.0mm on September 26th, 2016. From the completion of the stage excavation till October 4th, 2016, inclinometer readings were regularly collected and it was observed that the increase of the lateral displacement stopped. The graph of the measured lateral displacements between the -22.5m and -25m elevations of Section 3 is presented in Figure 12.

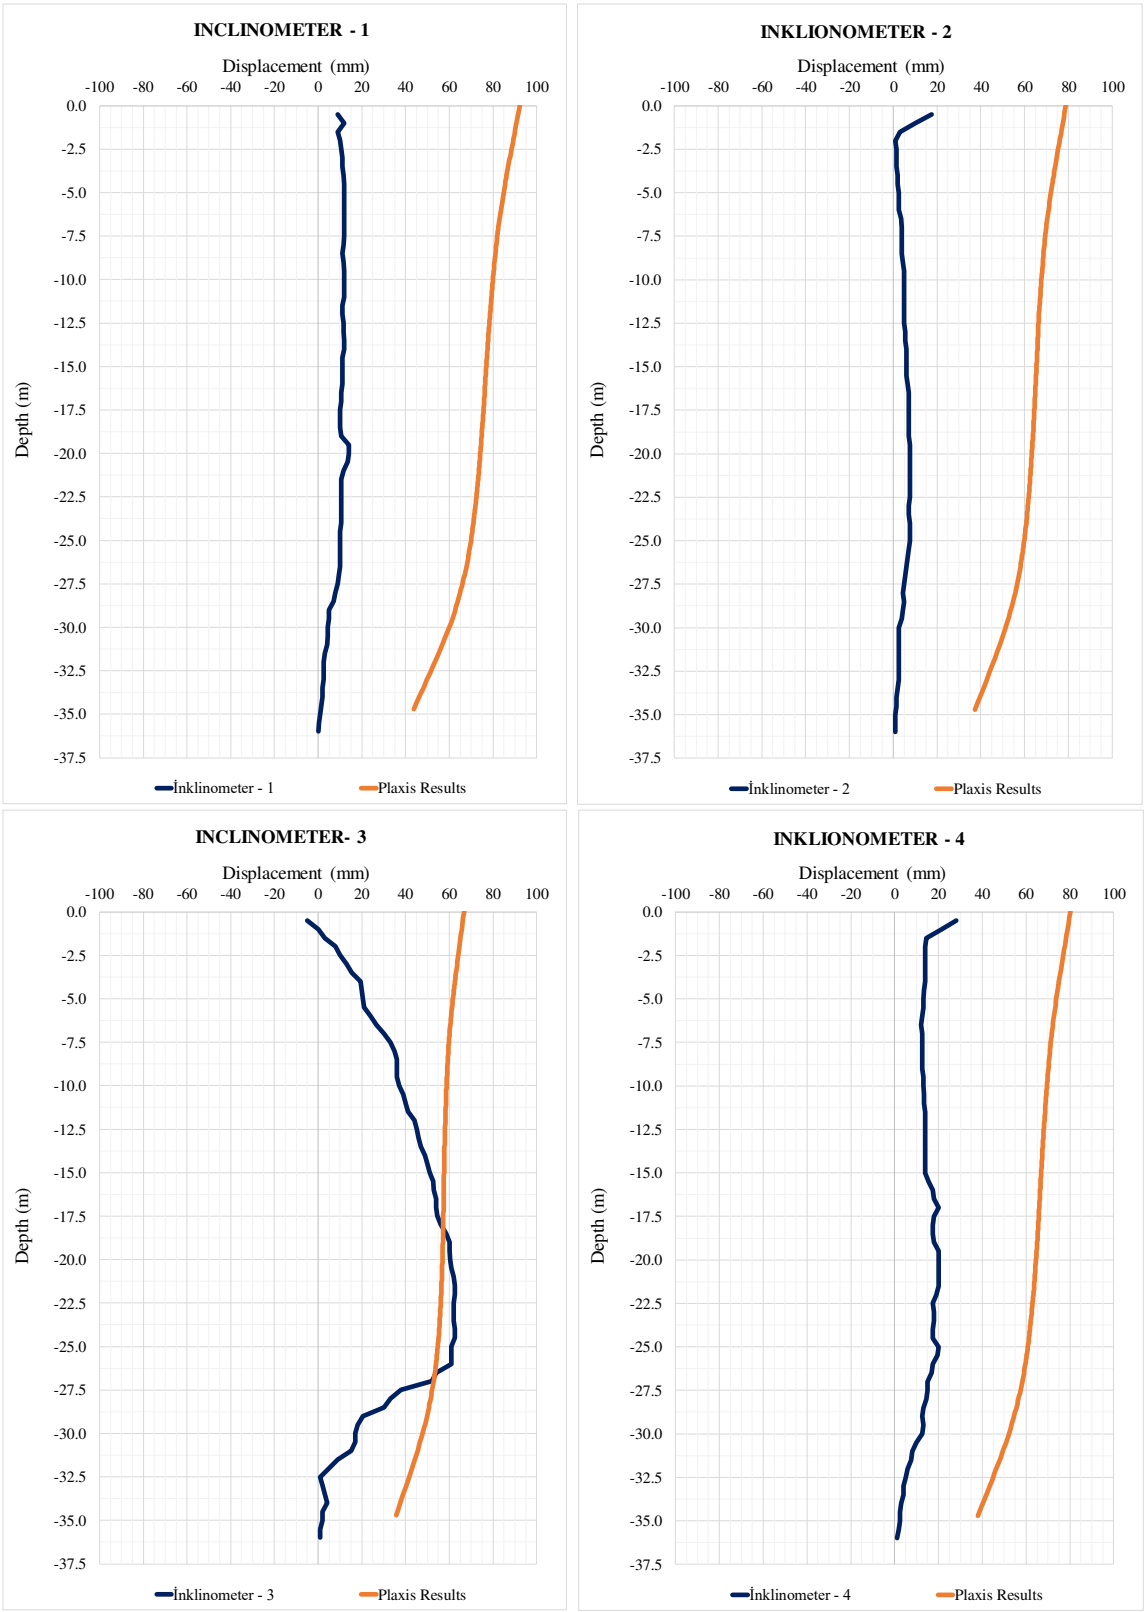
Figure 13. Inclinometer Readings.

In general, inclinometer readings were regularly collected during the entire construction phase and it was observed that the obtained lateral displacements were less than the design values.
