A Case Study on the Progressive Failure Mechanism of I-180 Slope Using Numerical and Field Observations

ABSTRACT: *A progressive failure of shallow slopes is commonly encountered in eastern Nebraska due to the region's unique geological and weather conditions. This study presents a case study for a slope in Nebraska that experienced a progressive failure. Emphasis was given to examine the condition and triggering mechanisms of the slope failure through a field observation and numerical modeling. FLAC2D was employed to conduct the numerical simulation of the progressive failure based on a hydromechanical coupled framework. Data from experimental test results were utilized to model the mechanical behavior of the soils. The progressive development of the slip surface, degradation of shear strength parameters, slope displacement, and variation of the local factor of safety with time were analyzed. A similar outcome from the numerical analysis to that of the field observations demonstrated how various strength degradation mechanisms could be integrated into a single numerical analysis to understand the progressive failure of shallow slopes.*

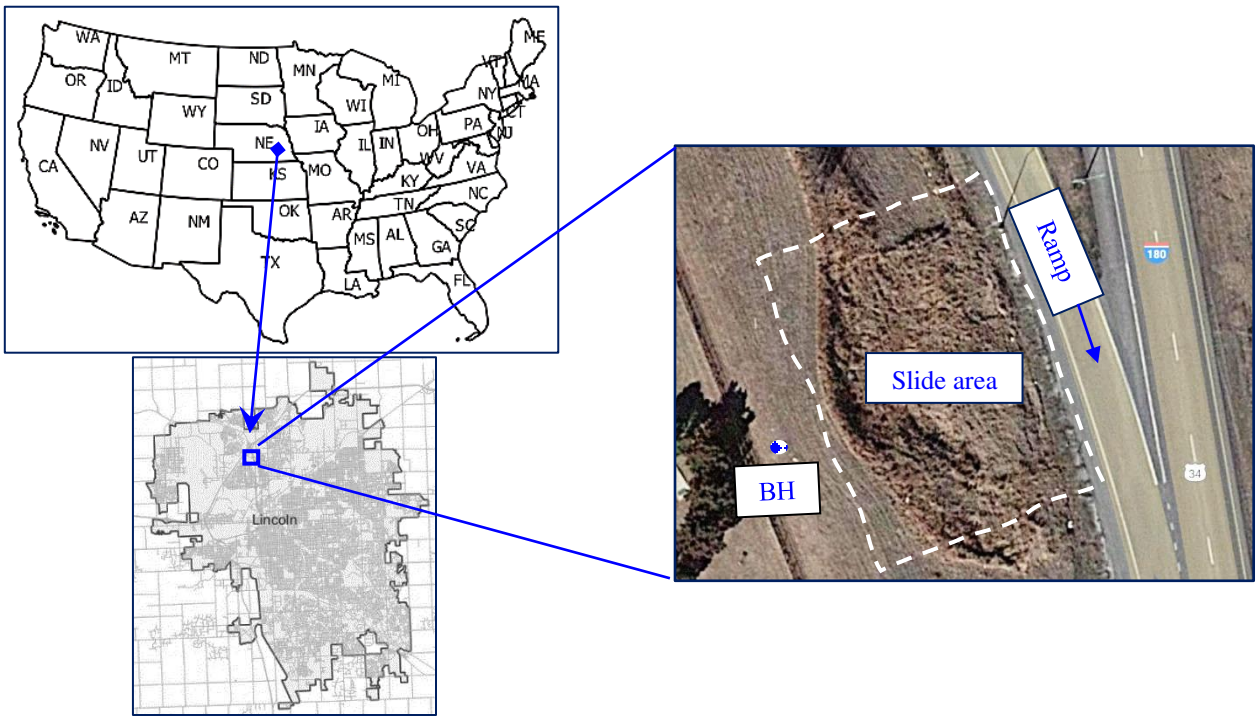
Figure 1. (a) Location of the failed slope site, and (b) plan view of the slope (2020) (note: BH is to mean borehole).

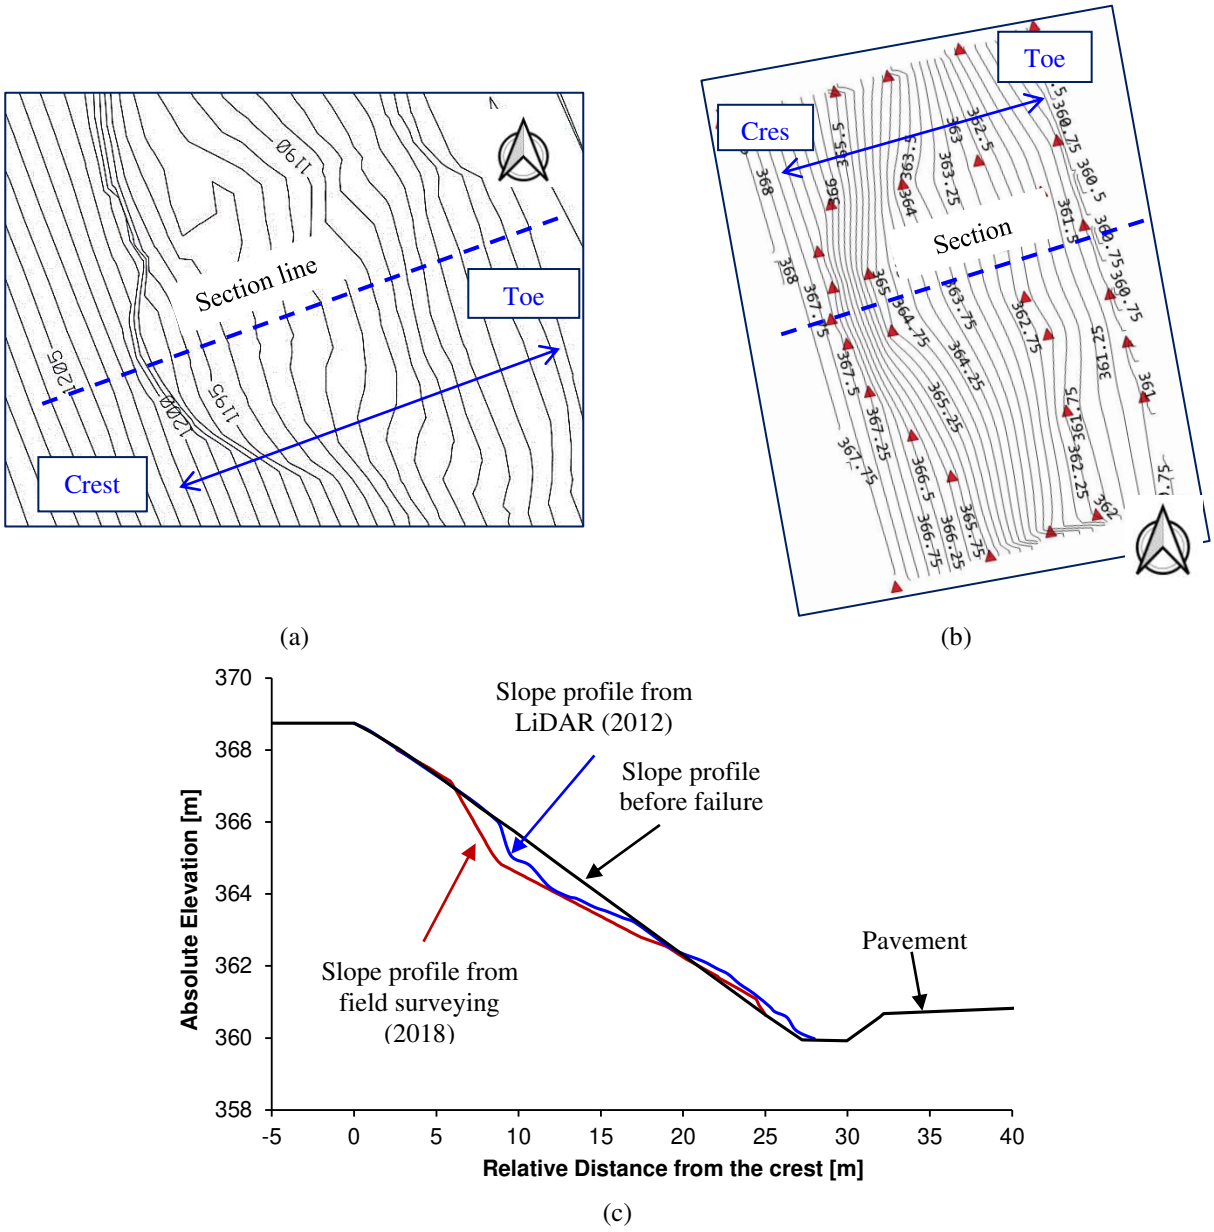
The failure of the slope had begun in 1996-1997. This means it had a long-term stability problem as it took about 32-33 years for failure to happen. A recent observation made from visual inspection and images from Google was used to describe the slope's failure condition. Figure 3 shows the surficial condition of the slope at various times (2012 to 2019). In all cases, it is observed that the failure zone did not extend to the crest of the slope and appeared to have a crown somewhere on the slope itself. The crown of the failed zone had potentially developed from an initial tension crack due to the tendency of the unstable zone to detach from the stable zone. The stable zone above the crown had an almost unnoticeable deformation and seemed to be intact, as shown in Figure 3. This claim is also supported by slope surface deformation patterns obtained by LiDAR and field surveying, as shown in Figure 2(c). A scarp was formed, and soil was exposed due to continued slope movement (see Figure 3; image taken in July 2019). Moreover, the pavement adjacent to the slope toe had no visible distress induced by the slope failure as per a visual observation.

Figure 2. (a) Topographic contour plot from LiDAR (in 2012), (b) topographic contour plot from field surveying using a total station. (Note: Contour labels are elevations. The units are in feet for the LiDAR contour. The units are in meters for the field surveying contour. The red triangles in Figure (b) elucidate the location of surveying pegs.)

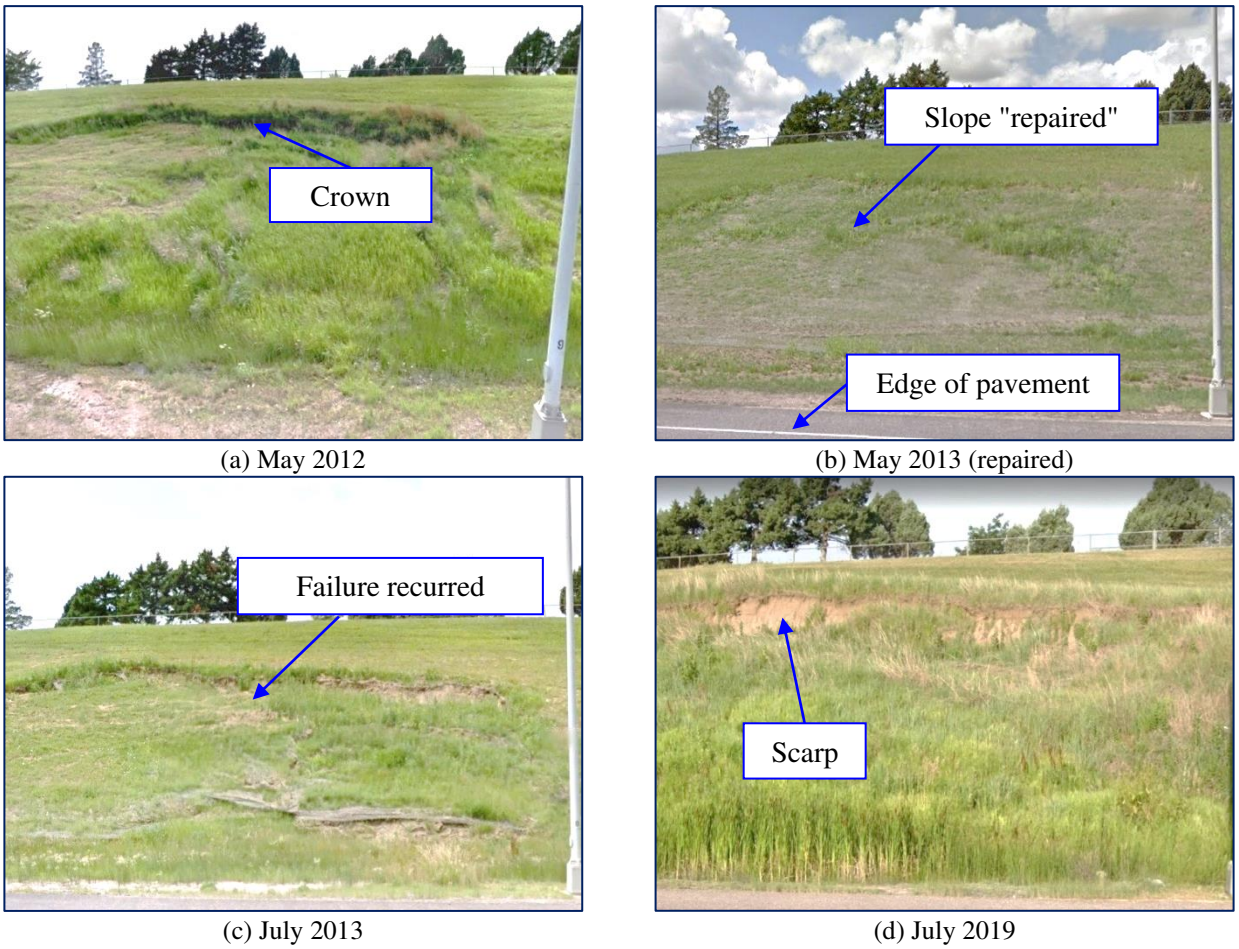
There had been no engineered “official” repair work conducted on the slope. However, there were a few “maintenances” performed. The maintenance work involved adding some fill material over the failed zone and repairing the face of the slope, as shown in Figure 3 (see the image taken on May 2013). However, the slope restored the observed failure condition after the “repairs” (see the image taken in July 2013 and after). The recurrence of failure suggested that the slip surface may be located below the zone of “repair”.

Figure 3. Images depicting the failure condition of the slope (From 2012 to 2019).

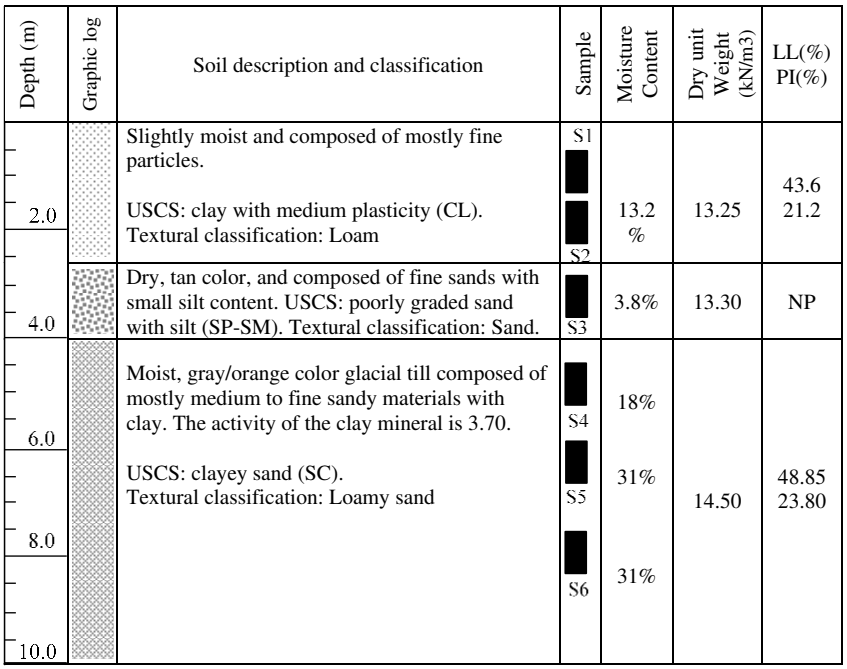
Samples from S4, S5, and S6 showed an identical visual and index properties layer, and were designated as Layer-3. The parent material for this layer corresponded to the glacial till formation, which is also a typical geological formation beneath loess formation in eastern Nebraska (Song et al. 2020). It consisted of larger-sized sand particles, as depicted in Figure 4. However, it also contained considerable fines of 16% (which is > 12%). The Atterberg limits test on these fines showed marginal behavior between medium and high plasticity. The ratio of the plasticity index (PI) to the clay content indicated the soil had higher activity (expansion potential), which was about 3.5. The USCS and textural classifications of the indicated soils were clayey sand (SC) and loamy sand, respectively. Groundwater table was not observed during the drilling operation, suggesting it is below 8 m deep.

Figure 5. Borehole log and description of the soil conditions (note: LL is the liquid limit, PI is the plasticity index, NP means non-plastic, and USCS refers to unified soil classification system).

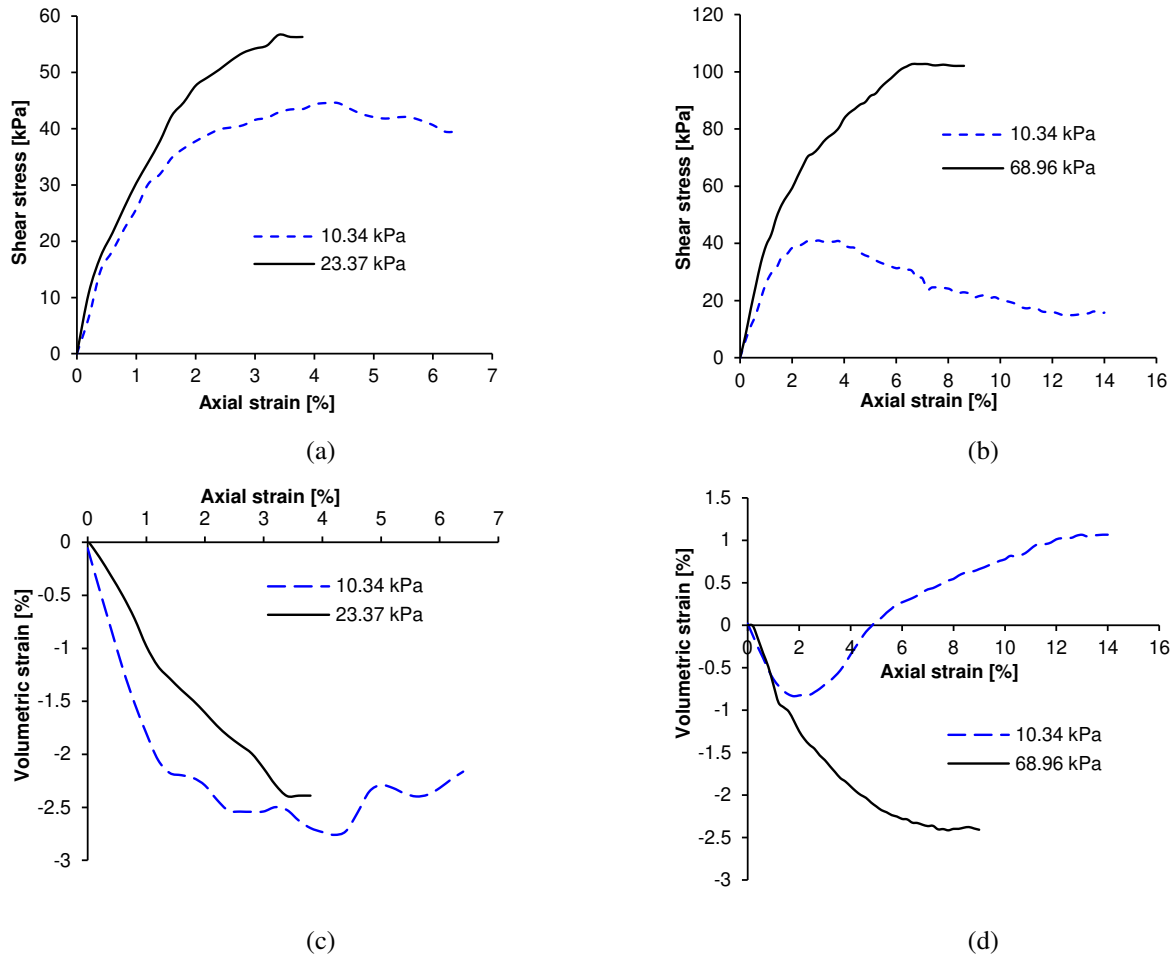
Isotopically consolidated drained (CD) triaxial tests (ASTM International D7181 2011) were conducted on undisturbed soil specimens. Triaxial specimens were prepared for Layer-1 and Layer-3 soils. However, it was difficult to prepare a triaxial sample for Layer-2 soils. CD tests were conducted under a saturated condition. The drainage systems (pumps and tubing) and specimens were saturated by allowing water to flow through. A backpressure saturation was conducted using a back pressure of 345 kPa and 450 kPa on Layer-1 and Layer-3 specimens, respectively, to dissolve any air remaining in the specimen voids. After a saturation check, the specimens were consolidated using the target confining stress level (cell pressure). The shearing stage was conducted under a drained condition and with a controlled strain rate. The strain rate was selected following a recommendation by ASTM International D7181 (2011). The drained tests were conducted under two distinct levels of confining stresses. The confining stresses were selected to mimic shallow depth for the anticipated shallow failure condition. Figure 6(a, b) shows the shear stress (deviatoric) versus axial strain plots for Layer-1 and Layer-3 soils with the confining stresses shown in the keys. In addition, Figure 6(c, d) shows the volumetric strain versus the axial strain relationship for Layer-1 and Layer-3 soils. The elastic modulus of the soils slightly increased as the confining stress was increased. From Figure 6(a, b), it is observed that the shear strength of the soils became higher for higher confining stress in both layers. Layer-3 specimen showed a strain softening behavior at a lower confining stress level, as shown in Figure 6(b). At a higher confining stress level, the specimen showed a peak shear strength without a tendency of softening. Looking at the volumetric strain vs. axial responses, the specimen from Layer-1 showed a contraction behavior for both levels of confining stresses, as shown in Figure 6(c). On the other hand, specimen from Layer-3 showed a dilation behavior under a lower confining stress level and contraction behavior under a higher confining stress level.

Figure 6. Isotopically consolidated drained triaxial test results: (a) shear stress vs. axial strain for Layer-1, (b) shear stress vs. axial strain for Layer-3, (c) volumetric strain vs. axial strain for Layer-1, and (d) volumetric strain vs. axial strain for Layer-3 (note: numbers in the legends are confining stresses used).

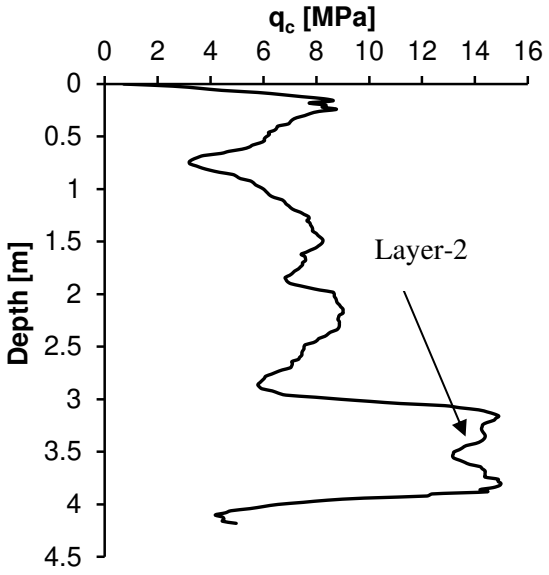
The stiffness and strength behavior of Layer-2 soils were evaluated from a cone penetration test (CPT). The penetration was conducted at the standard speed of 2 cm/s. The test was conducted up to a depth of 4 m. The relevant result from the cone penetration test result is shown in Figure 7. Based on the test, the cone tip resistance (q_c) of Layer-2 soils was found to be higher than the adjacent soil layers, which is typical for sandy soils (Dagger et al. 2018). The average cone tip resistance of the layer was found to be 14 MPa

Figure 7. Cone tip resistance versus depth.

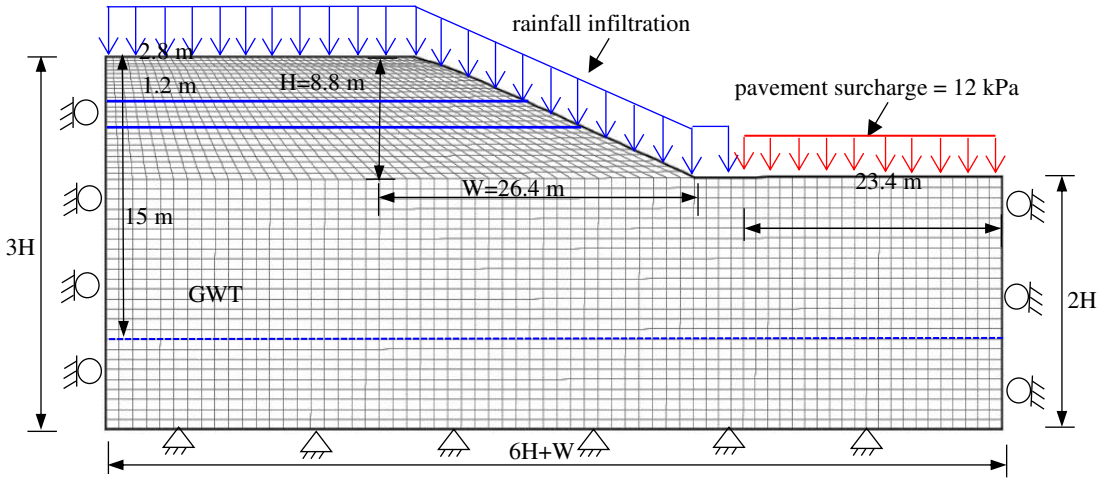
An optimal discretization was selected based on accuracy and computational efficiency. The boundaries of the domain were delineated as shown in Figure 10. The right, left, and bottom extents were selected as a function of the height of the slope, H, following a study by Rahardjo et al. (2000). The left and right boundaries were set to be rollers, and the bottom was fixed. A surcharge load of 12 kPa (for 0.6 m thick pavement with 20 kN/m^3 average unit weight) was applied to simulate the pavement self-weight. For the water flow analysis, the left, right, and bottom boundaries were assumed impervious. The top surface was assumed free for drainage. A rainfall infiltration was applied on the surface of the slope and the ditch adjacent to the pavement. The groundwater table was placed at 15 m below the ground surface.

Figure 10. Model setup: geometry, grid discretization, boundary, and internal conditions.

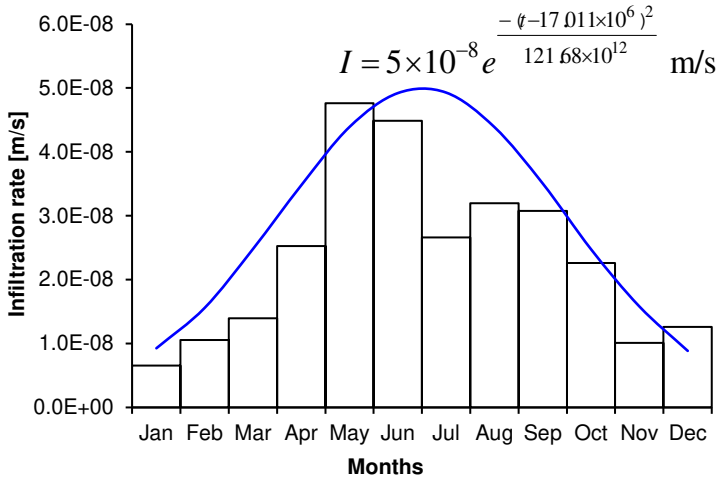
Rainfall infiltration was applied as a time-dependent boundary condition. The average infiltration rate for the Lincoln area was compiled from 20 years of metrological records (UNL 2020). The average monthly infiltration rate was computed by dividing the total monthly precipitation by the number of days in the month. Figure 11 shows the averaged infiltration rate for a year. The discrete average monthly infiltration rate shown in the bar graph was converted to a continuous Gaussian distribution type function, as shown in Figure 11.

Figure 11. Average rainfall intensity and infiltration rate model (average of 20 years data). Note: I is the infiltration rate in meter/second, and t is the time in seconds.

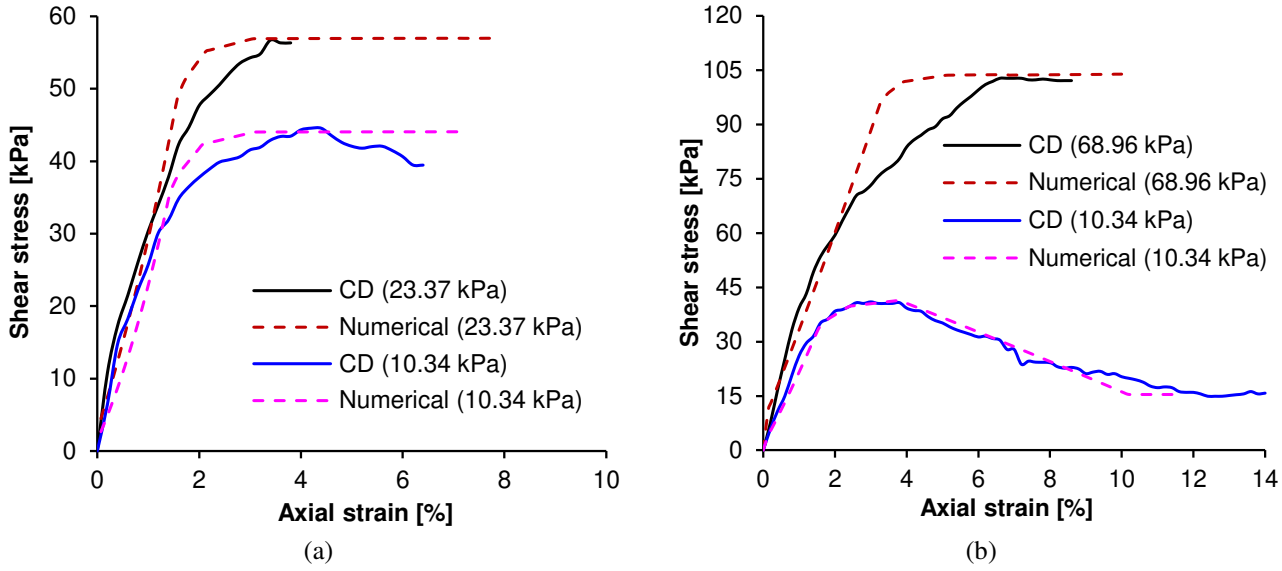
The strain softening behavior of Layer-3, which is shown in Figure 12(b), was calibrated by lowering the peak envelope to a critical envelope depending on the amount of plastic shear strain induced. A critical envelope (i.e., so-called fully softened

Figure 12. Numerical calibration of the CD test results: (a) Layer-1 and (b) Layer-3.

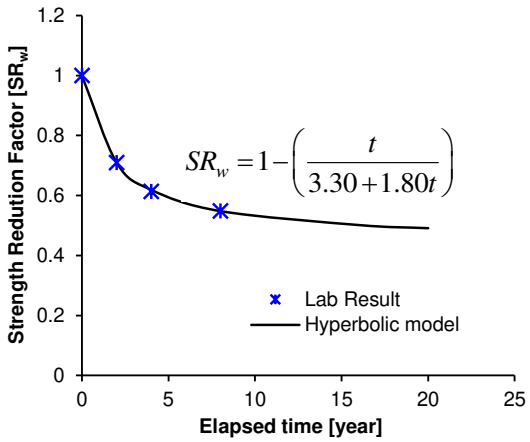
where $c'(t)$ and $\tan\phi'(t)$ are the effective cohesion and friction angle at a specific time t; SR_w is the strength reduction associated with weathering and is always less than or equal to 1; and (c'_p or c') means c'_p is used if the soil element is not in a strain softening state, and c' is used if the soil element is in a strain softening state. The time variation of SR_w was obtained from Bitar (2020) using a hyperbolic fitting model, as shown in Figure 13. In this Figure, it is noted that one laboratory cycle of weathering was taken equivalent to a one-year weathering effect for the purpose of simplicity

Figure 13. Weathering-induced strength degradation using a hyperbolic model (note: t is in years).

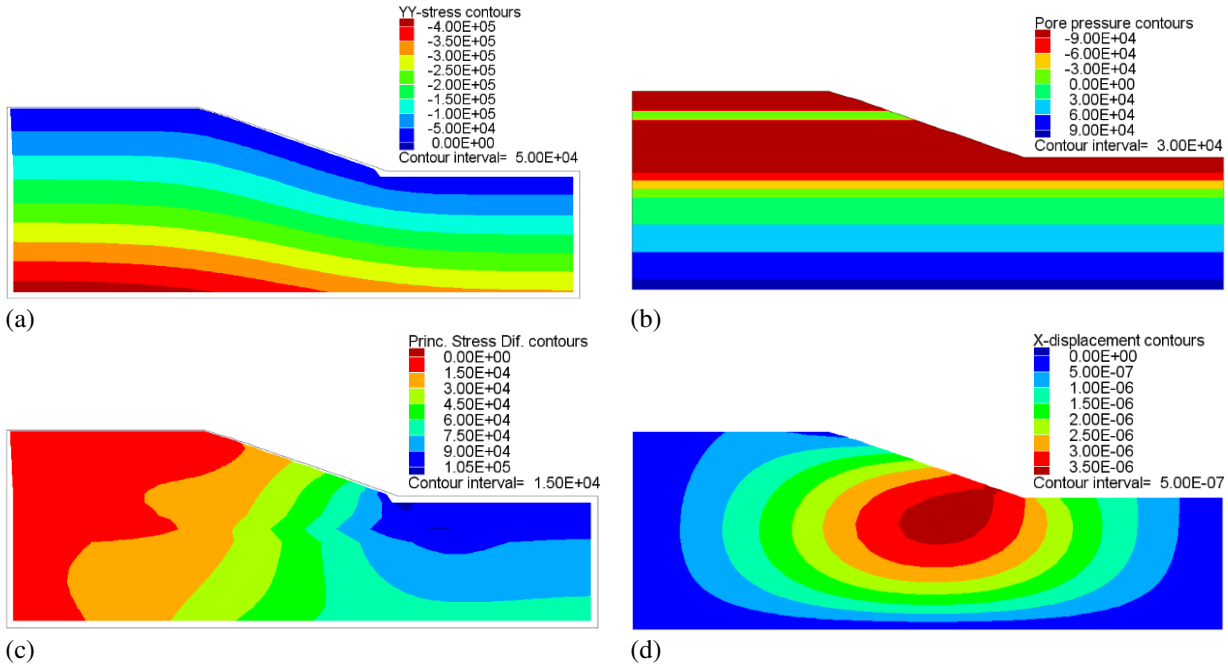
Figure 14 shows the initial conditions assumed in the numerical simulation. The vertical stress distribution is shown in Figure 14(a) and was governed by the self-weight of the soil materials and groundwater. The initial degree of saturation above the groundwater table dictated the distribution of the initial pore pressure based on the SWCC model, as shown in Figure 14(b). The pore pressure distribution was hydrostatic below the GWT. The shear stress distribution is shown in Figure 14(c). The magnitude of shear stress increased going from the left boundary (where there is no cut section) towards the slope (where there is a cut section). The initial displacement was almost negligible, as shown in Figure 14(d).

Figure 14. Initial conditions: (a) vertical stress, (b) pore pressure, (c) maximum shear stress, and (d) horizontal displacement (note: unit of stresses is Pa and unit of displacements is m in the contours).

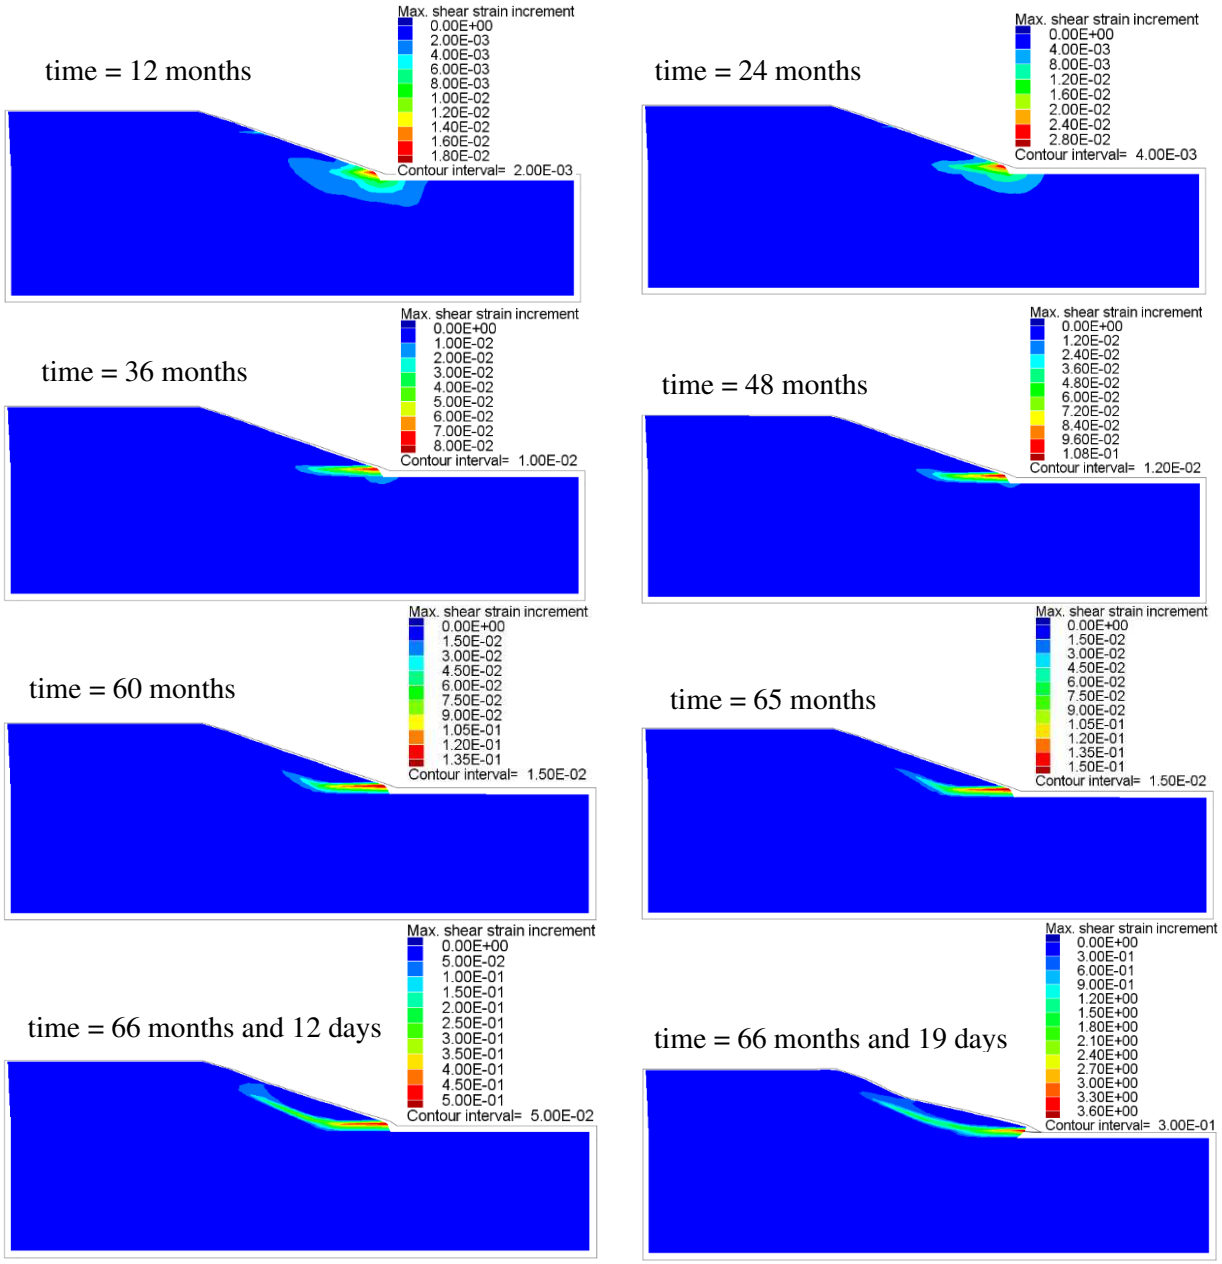
The gradual propagation of the slip surface at different time spans is depicted in Figure 15. The time shown under each figure is a numerical time scale. The potential slip surface is indicated by the localization of accumulated maximum shear strain, as shown in the contour plots. Initially, the shear strain was localized to the toe of the slope, where there is potentially maximum shear stress. As time went on, the localized shear strain further developed into a shear band projecting away from the toe. At the end of the 48th month, the slip surface showed a tendency to rotate upward towards the crest direction. Then, it continued its growth over time as shown in the 60th and 65th-month plots.

The development of the slip surface was more gradual in the beginning. However, it became spontaneous and fully developed in a matter of days, as shown in the last two plots of Figure 15. The maximum rate was observed during the maximum rainfall period (where 66 months means 5 Years + ½ Year). This finding suggested that in the presence of substantial strength loss due to other factors such as strain softening and weathering, rainfall could accelerate the rate of failure.

Figure 15. Progressive development of the slip surface with simulation time.

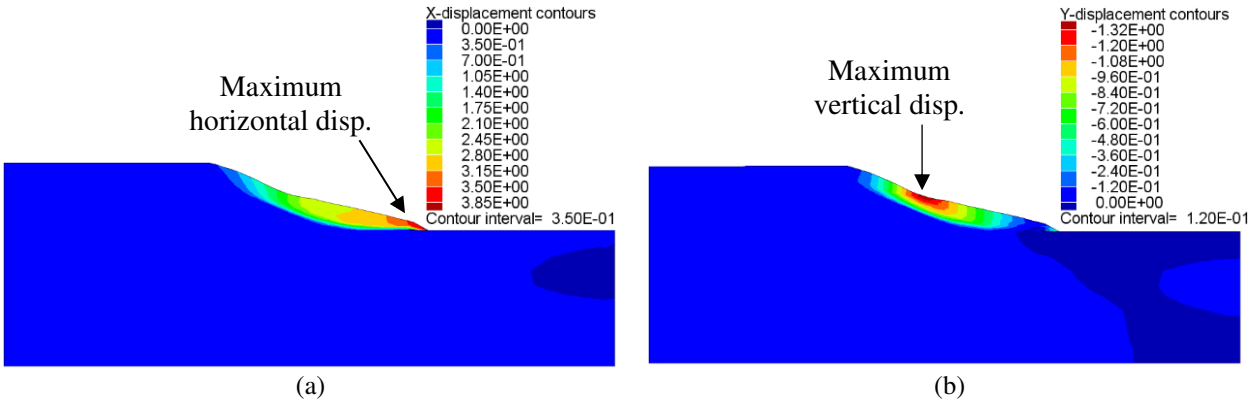
Figure 16 shows the deformation of the slope after the slip surface has fully developed. The maximum horizontal displacement was observed at the toe of the slope. There was a maximum horizontal displacement of 3.85 m as shown in the figure. On the other hand, the maximum vertical displacement (subsidence) was observed on the surface of the slope where the magnitude was 1.32 m. The location of the maximum vertical displacement was in line with the location of the crown of the failure zone observed in the field.

Figure 16. Displacement contours of the slope at general failure: (a) horizontal displacement and (b) vertical displacement. (Note: x-displacement is horizontal displacement, and y-displacement is vertical displacement. Unit of the contour plots is in meters.)

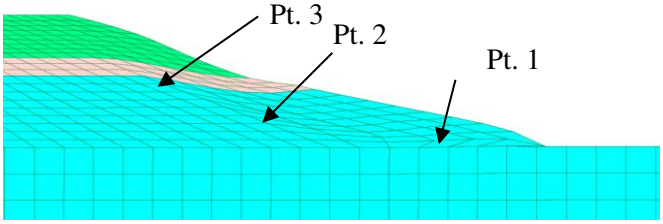
An evaluation was conducted to understand the effects of strain softening, rainfall, and weathering on the degradation of effective cohesion, the friction angle, and the local factor of safety. Three sensor points were selected along the slip surface, as shown in Figure 17.

Figure 17. Sensor points chosen for the numerical evaluations.

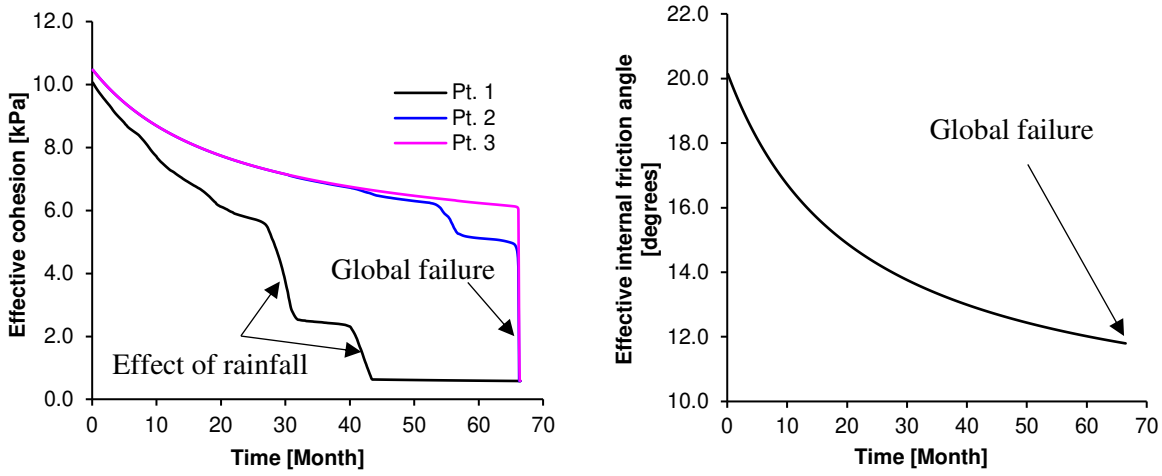
Figure 18(a) presents the progressive degradation of effective cohesion with time. Pt. 1 showed a relatively rapid degradation of effective cohesion. The reason for this could be the fact that there was a higher shear stress concentration around the toe of the slope, which led to the initiation of strain softening at Pt. 1 earlier than the other two points. On top of that, the additional effect of weathering speeded up the degradation at Pt. 1. On the other hand, Pt. 2 and Pt. 3 showed a degradation of effective cohesion which closely matched the weathering effect up to around the 40th month.

After that, Pt. 2 started to show faster degradation of effective cohesion since the progressive failure had been reached and the effect of all factors was active at that point. Pt. 3 had almost shown a weathering effect until the complete failure of the slope. The strain softening effect was so rapid that the effective cohesion dropped from around 7 kPa to the critical state almost spontaneously. The development of rainfall infiltration (i.e., loss of apparent cohesion) can be clearly seen in regions where there was a stepwise degradation of effective cohesion, as shown in Figure 18(a). Moreover, the effect of rainfall on the strain softening behavior seemed to be more prominent after periods of intense rainfall (hump of the rainfall infiltration function).

The degradation of the effective friction angle's contribution to the failure of the slope was equally important. Figure 18(b) shows the degradation of the effective friction angle. The degradation closely followed the hyperbolic model, which was used

Perhaps the time it took for the slope to fail, i.e., 32-33 years, means that the process was most probably much slower than the numerical timeframe. The global failure was induced when the effective friction angle reached around 12°, which is much lower than the slope inclination (18.43°) as well as the initial peak effective friction angle (20.2°). Perhaps based on a numerical back analysis, Song et al. (2019) reported that there must be a substantial shear strength degradation at the time of failure for slopes in eastern Nebraska.

Figure 18. Reduction of shear strength parameters due to softening and weathering: (a) cohesion, and (b) angle of internal friction.

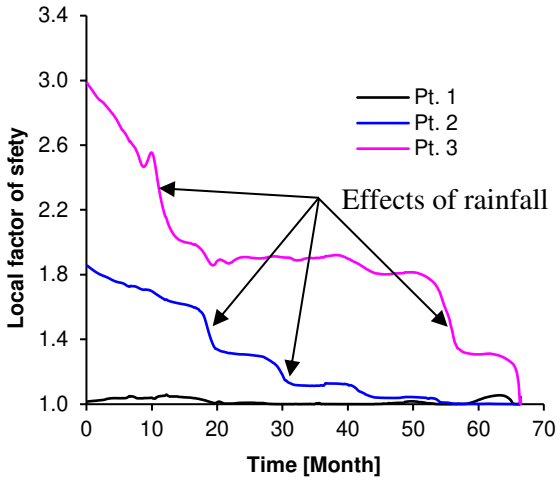
The initial local factor of safety was already close to 1 for Pt. 1. This means that the point was locally under critical condition. The initial local factor of safety for Pt. 2 and Pt. 3 was higher than 1, suggesting both elements were safe against failure. But as time progressed, the local factor of safety lessened in both Pt. 1 and Pt. 2. Pt. 3 showed a faster reduction of the factor of safety than Pt. 2 up to around the 12th month despite the fact that their shear strength parameters degraded equally, as shown in Figure 18.

Upon evaluation, it turned out that the effect of rainfall had caused Pt. 3 to lose more of its suction more rapidly than Pt. 2 due to a faster flow of percolated water near the interface between Layer-2 and Layer-3. Once the majority of the suction was lost and there was little suction variation with time, the factor of safety remained fairly constant for some time before the

effects of strain softening and weathering became more prominent at Pt. 3. After that, even a little variation suction due to seasonal changes substantially reduced the factor of safety. The critical factor of safety progressed from Pt. 1 to Pt. 2 and then to Pt. 3. The global failure happened once all points reach the critical factor of safety. Depending on how slow the weathering process is and how quickly the suction is lost (precipitation-evaporation effects), the rate of strain softening and time for global failure may be substantially different with the numerical time scale.

Figure 19. Variation of the local factor of safety at the sensor point.

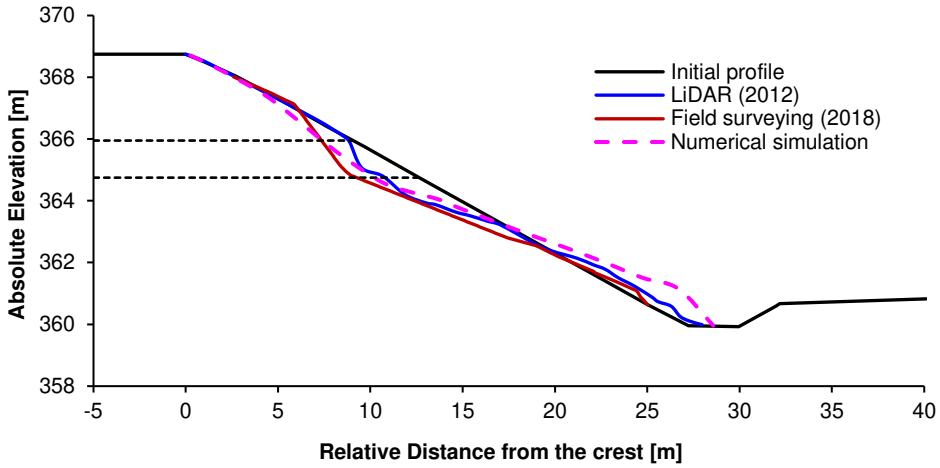
The numerical simulation result was compared with the observations made from LiDAR and field surveying. The comparison was performed on the deformation pattern of the slope surface from the numerical study and field measurements. The numerical surface deformation of the slope was extracted from the time of global failure because this is the condition where the slip surface was fully developed, and significant deformation was observed.

Figure 20. Comparison of slope profile from LiDAR, ground surveying, and numerical study

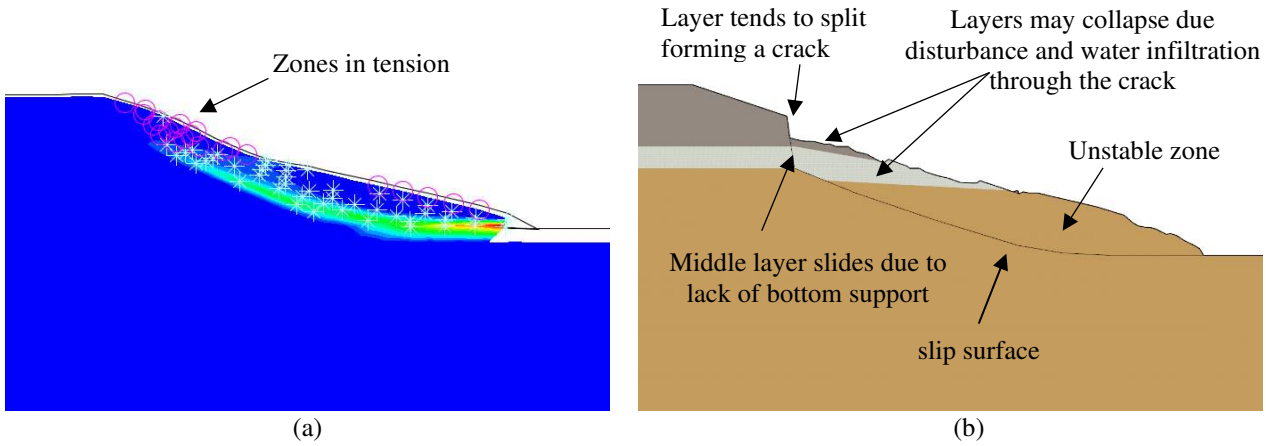
Moreover, the numerical modeling showed a tendency of crack formation around the crest of the slope through the development of the tension state, as shown in Figure 21(a). Even though there was this tendency, the two zones could not separate due to the employed continuum approach. More subsidence might have been observed if the separation was allowed by using a more robust numerical approach.

Based on the overall examination through both the measured observations and the numerical analysis, a qualitative engineering explanation is given to the failure condition in Figure 21(b). It is more likely that the failure was triggered by Layer-3 soils. The propagation of the local slip surface was gradual, as learned from the history of the slope. A global failure was triggered when the slip surface reached Layer-2. Due to the subsequent sliding of both Layer-1 and Layer-2, a portion of Layer-1 lost its bottom support, and a tension crack was formed. Through this tension crack, rainwater could have migrated

and induced the collapse of the loess and the formation of the scarp. The addition of fill materials will increase the weight of the unstable zone, and the slope will repeat the sliding mechanisms unless the mitigation work traverses the slip surface.

Figure 21. (a) States of different zones in the vicinity of failure indicating the possible location of crack (note: circles indicate tensioned zones and stars indicate sheared zones), and (b) qualitative explanation of the failure condition.
