INTERNATIONAL JOURNAL OF GEOENGINEERING CASE HISTORIES

Images Collected from the Internet Reveal the Failing Mechanism of the Tailing Dam Breach at Kolontar, Hungary

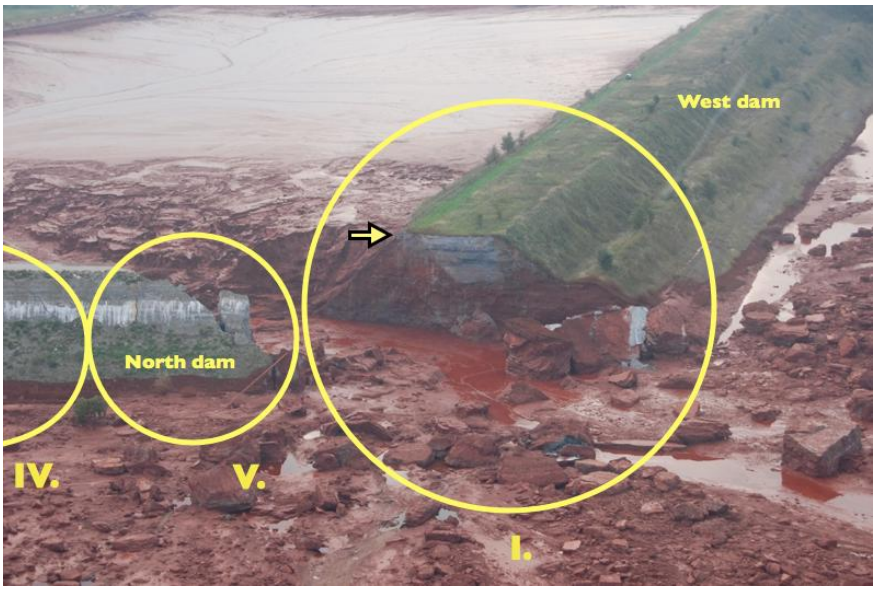
Figure 7. *Photo showing the fracture Locations I, IV, and V. The red mark of the sludge on the open surface of the fracture at Location I is the same as the original sludge level. Thus, this fracture occurred right at the breach of the dam before the sludge level decreased in the reservoir. (Source: https://www.aljazeera.com/photo_galleries/europe/20101072047436735;http://www.kormany.hu/en/photo-galleries/negy-eve-tortent-a-vorosiszap-katasztrof.)*

This location has one characteristic fracture (0_a), which has been exposed at the breach (Figure 7). The fracture occurred at the corner of the North and West dams and its surface is perpendicular to the West dam. This fracture is clearly the result of tensional stress acting in the direction of the axis of the West dam. The fracture occurred at the breach because the marks of the red sludge on the exposed surface are at the same elevation as the original level in the reservoir (Figure 7). The North

dam has been detached following the development of this fracture and displaced from the West dam, creating an opening. This opening was one of the initiators of the breach. The direction of the flow channel F_I is consistent with this conclusion.

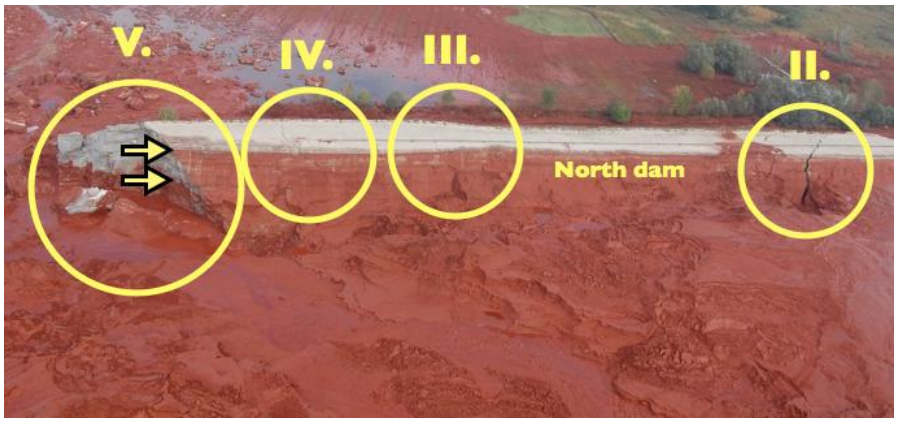
At Location V, the mark of the red sludge on the fracture (Figure 8) is lower than the original one, which indicates that this fracture occurred after the breach, when the sludge level in the reservoir was already lowered.

Figure 8. *Photo showing fracture Locations II-V. The red mark of the sludge on the open surface of the fracture at Location V is shown. This mark is much lower than the original level in the reservoir, indicating that this fracture was formed after the breach, when the sludge level was significantly lower. (Source: http://toleducation.org/achievements/red-legacy/.)*

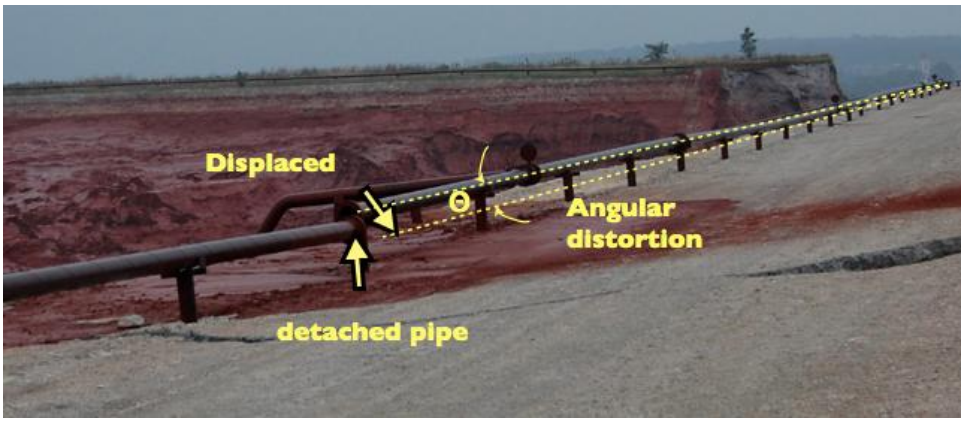
Figure 10. *The angular distortion of the failed section of the dam can be seen from the position of the displaced broken pipe. On the failed part of the dam the pipe moved towards the reservoir despite the outward movement of the failed dam section. This indicates that the displacement resulting from angular distortion exceeded the outward displacement of the dam. (Source: http://www.nbcnews.com/id/39610356/ns/world_news-europe/t/human-negligence-toxic-sludge-boss-arrested/.)*

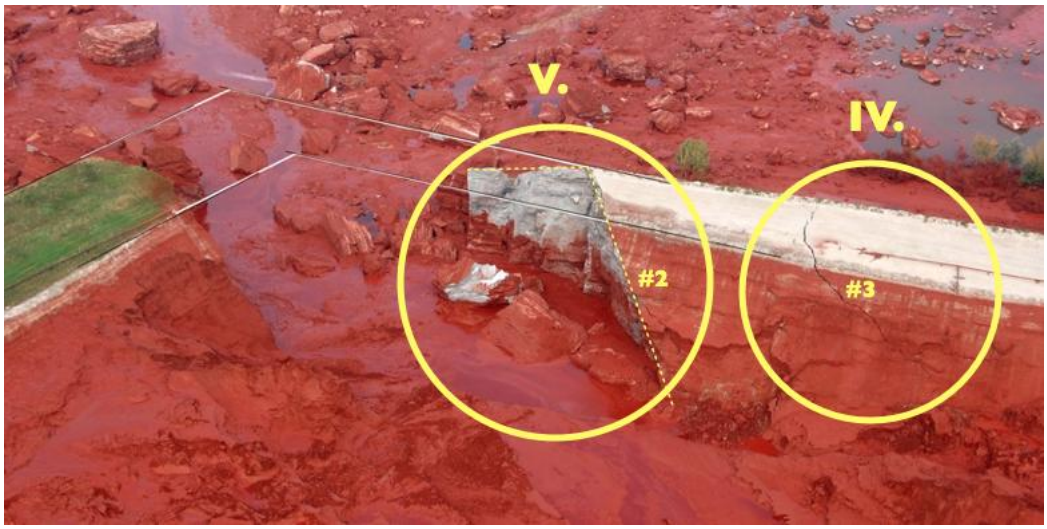
The fracture pattern of these sites shows hybrid failure (Figure 17).

Figure 17*. The fractures at Locations IV and V are hybrid fractures caused by the outflowing pressure of the red sludge and the additional settlement. These fractures occurred after the breach of the dam and they have no relevance to the failing of the dam. (Source: https://commons.wikimedia.org/wiki/File:Ajka_accident_d7df9fea08_b.jpg.)*

If the fractures at Locations IV and V existed before the breach, then the transformation of the force and the torque would be very limited beyond these locations. Elimination of the torque would not allow the development of the angular distortion beyond Location IV or V. Thus, these fractures at Locations IV and V were formed after the breach. The mark of the red sludge on the surface of fracture 2 also shows that this failing occurred after the breach when the level of the red sludge was reduced from its original elevation (Figure 8). The widening of fracture 3 towards the top of the dam indicates that additional angular distortion in the vertical direction occurred, most likely resulting from the outflow of the sludge, which washed out the soil below the dam section at the opening. The settlement of the dam section led to the development of the extension fracture 4. All fractures at Locations IV and V had been developing after the breach of the dam; therefore, these fractures have no relevance to the breach. The list of all the fractures, as well as the type and the cause of the respective failure, is given in Table 1.
