# Geological Engineering Reconnaissance of Damage Caused by the October 15, 2006 Hawaii Earthquakes

**Edmund W. Medley**, Senior Consultant, Geosyntec Consultants Inc., Oakland, CA, USA, Email: [emedley@geosyntec.com](mailto:emedley@geosyntec.com)

**ABSTRACT:** Two strong earthquakes shook the Island of Hawaii, Hawaii on the morning of October 15, 2006. Peak Ground Accelerations reached 1.2g, and earthquake felt intensity of MMI VIII. Earthquake damage of public and private property totaled about \$200 million, with no fatalities. Geological engineering reconnaissance of earthquake damage resulting from the earthquakes focused on the apparent relationships between the observed geology and the damage. Some roadway embankments failed causing temporary closure of Island highways. Landslides were common at steep coastal cliffs. Liquefaction and lateral spreading occurred in coralline fill at Kawaihae Harbor. There were extensive road cut failures, in which the performance of road cuts in soil slopes was generally better than that of rock slopes. Where a'a clinker underlay massive a'a basalt blocks in road cut slopes, the loose clinker dislodged thereby undermining the blocks, and cau

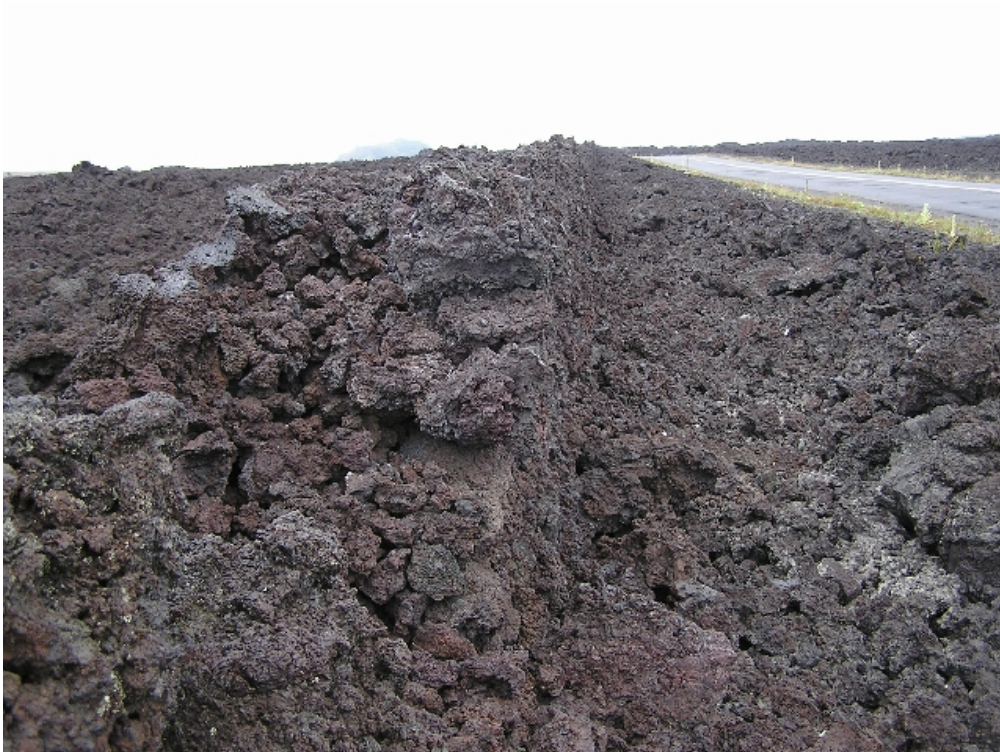
| Sta. | Location | Lat.<br>(N degs) | Long.<br>(W degs) | Feature | Comments |
|---|---|---|---|---|---|
| 11 | Saddle Road (Hwy 200) near intersection w/ | 19.6931 | -155.4929 | Rock wall (intact) | Intact rock walls built of loosely stacked a'a clinker blocks, across extensive a'a |

*Figure 9. Location 11, Saddle Road (Hwy 200). Lava flow of a'a clinker and dry stacked wall of clinker composed of a'a blocks.*

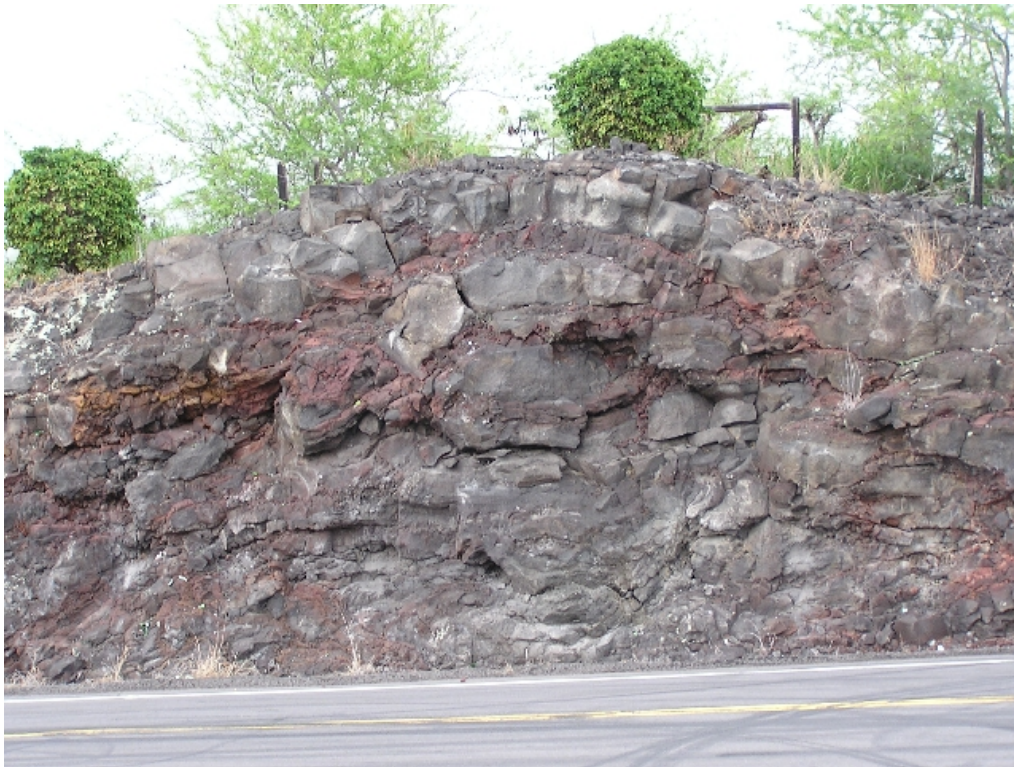
| Sta. | Location | Lat. (N degs) | Long. (W degs) | Feature | Comments |
|---|---|---|---|---|---|
| 37 | Hwy 160, near City of Refuge | 19.4229 | -155.8996 | Intact slopes | Intact slopes in pāhoehoe; rock wall under construction. |

*Figure 20. Location 37, Hwy 160. Pāhoehoe in road cut.*

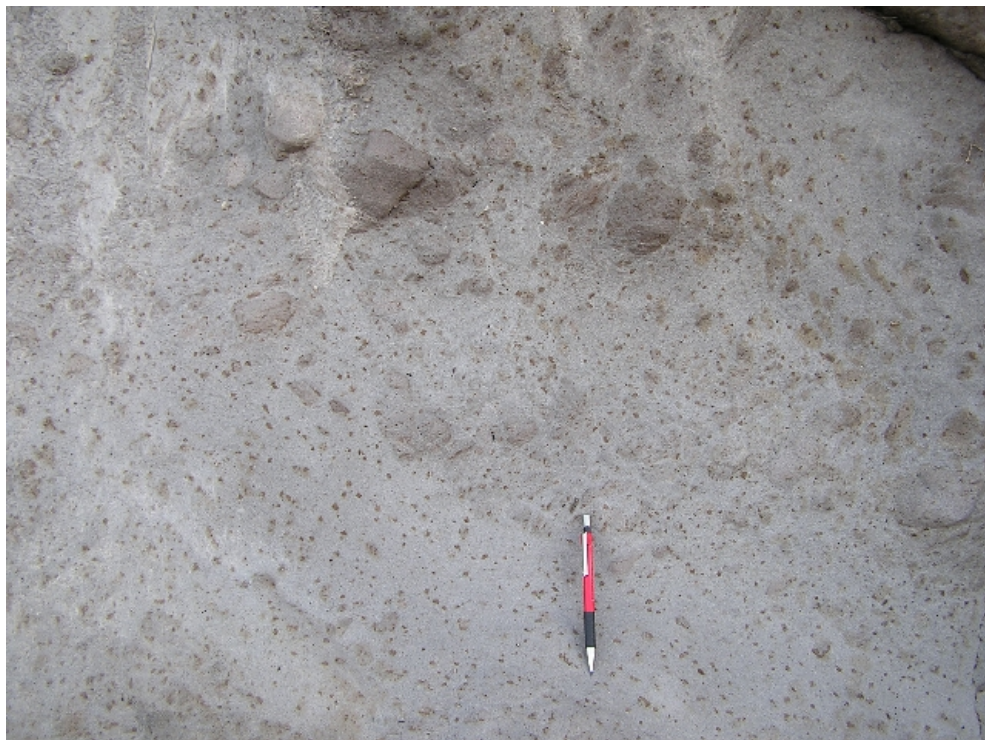
*Figure 22. Location 13, Milepost 8, Hwy 250. Road cut in a pyroclastic assemblage of ash and other volcanic debris.*

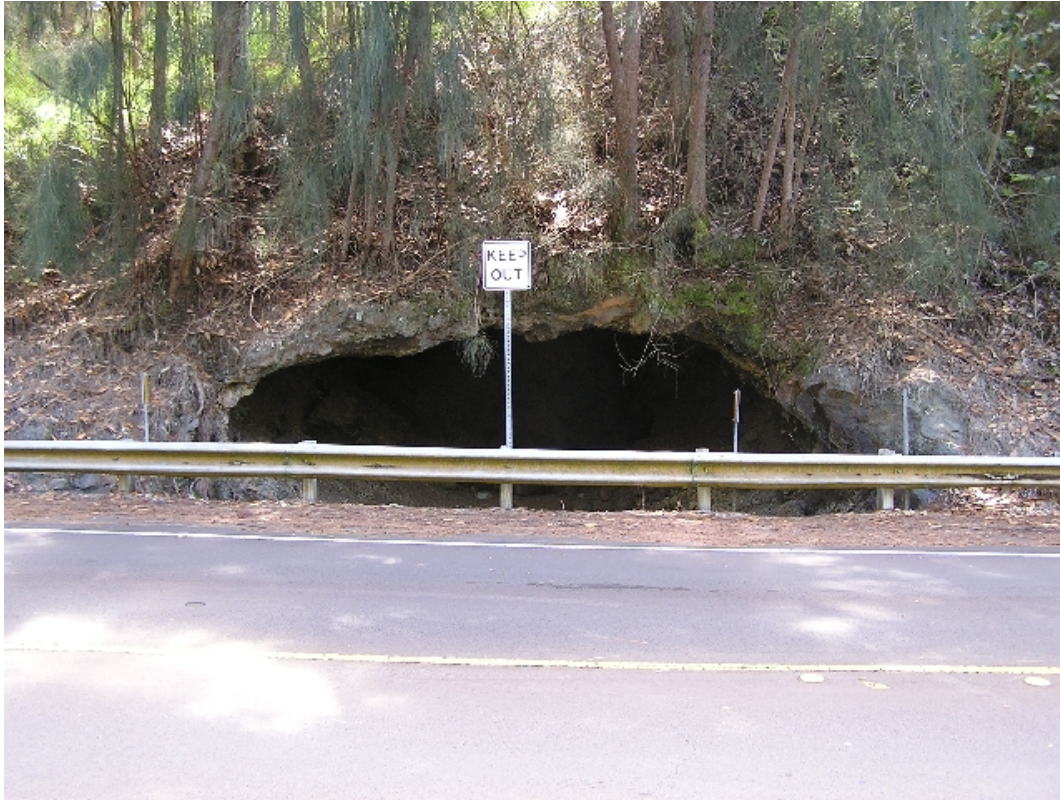
| Sta. | Location | Lat.<br>(N degs) | Long.<br>(W degs) | Feature | Comments |
|---|---|---|---|---|---|
| 7 | Near Kupalena, Hwy 240, Honoka'a-Waipio road | 20.1067 | -155.5373 | Lava tube | Little rock fall within cave despite 10m wide roof span, 5 m high roof and abundant fractured rock exposed at cave surfaces. |

*Figure 23. Location 7, Hwy 240, near Kapulena, north of Honokaa. Lava tube with apparently little rock fall from roof and walls.*

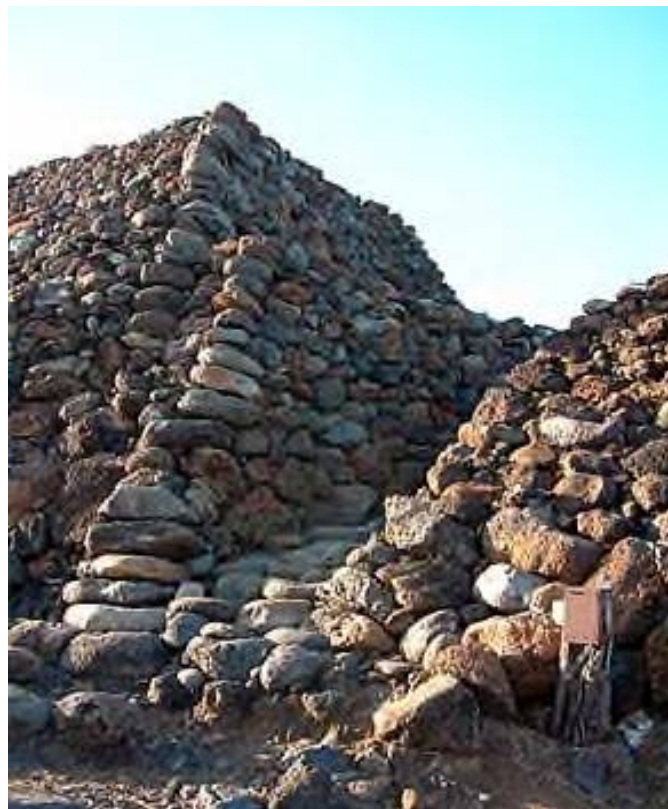
The heiaus were badly damaged by the earthquakes. The hill top location of the heiaus may have focused seismic shaking, although no details about site response are available. The worst damage at the Pu'ukoholā Heiau was to high retaining walls bounding the sole access passage (Figure 48 and Figure 49). At the Mailekini heiau, much of the interior face of the east wall slumped and raveled (Figure 50 and Figure 51).

*Figure 48. Pre-earthquake view of entrance passageway into Pu'ukoholā (Location 29)  
(Medley and Zekkos, 2007; original photo from [www.pacificworlds.com/kawaihae](http://www.pacificworlds.com/kawaihae)).*

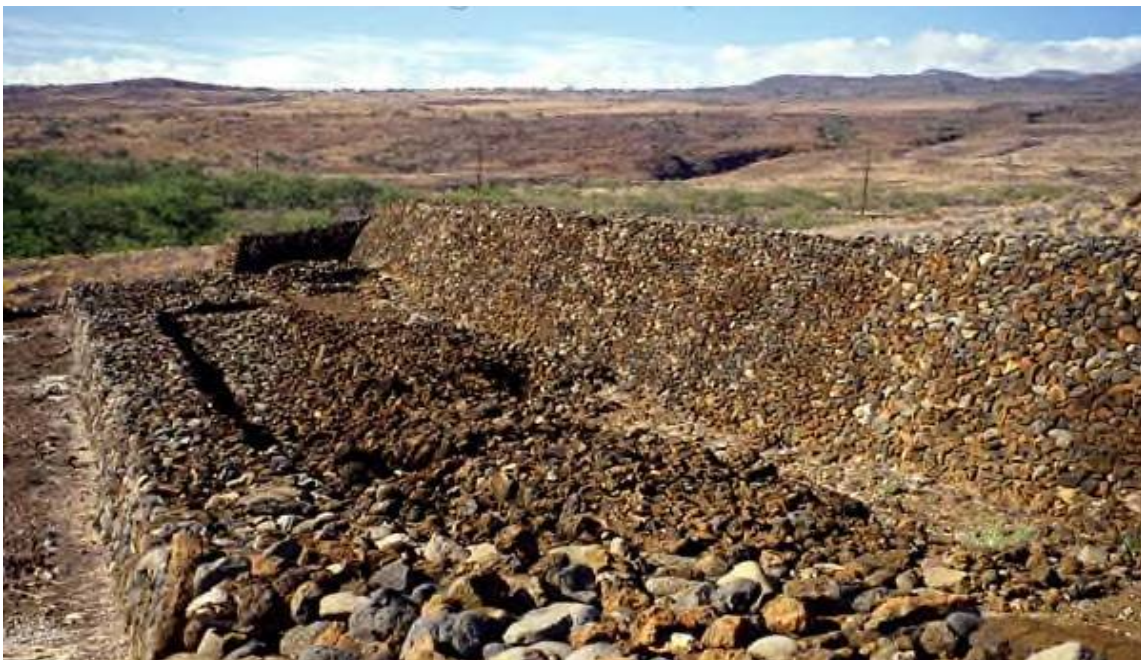
Figure 50. Location 29. Pre-earthquake view of Mailekini Heiau (Medley and Zekkos, 2007; original photo from [www.pacificworlds.com/kawaihae](http://www.pacificworlds.com/kawaihae)).

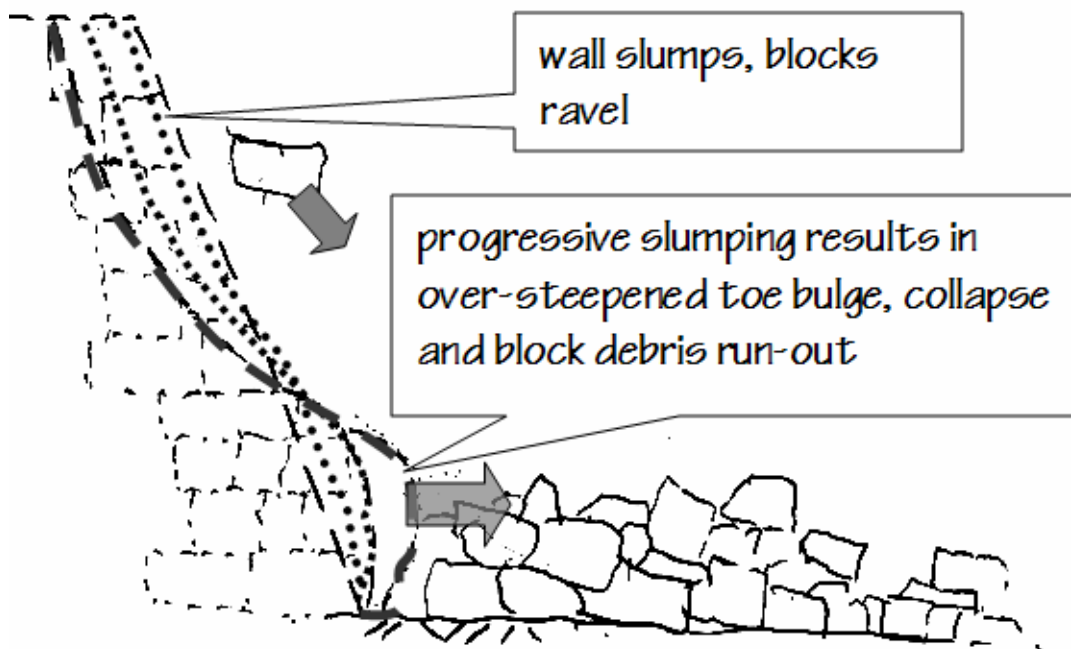
figure 58 and stereo Figure 59). The slumps apparently occurred in much the same fashion as sketched in Figure 60. The angle of repose for the slumps was about 30 degrees, with run-outs extending to more than 5 m from the original toes of the walls (Figure 52 and Figure 56).

Figure 60. Raveling, bulging and slumping of the face of a rock block edifice (Medley and Zekkos, 2007).
