# Lack of Maintenance Compromises Tunnel Structural Safety

**ABSTRACT:** *The Chekka tunnels represent a critical section of the Northern Lebanon Highway. The approximately 350-m long twin tunnels are the most important tunnels in the country. They are used by regular and freight traffic and are a vital link to the capital, Beirut. The tunnels were completed in the early 1970s on the eve of the Lebanon civil war. Given the state of affairs in the country for about two decades of strife, the tunnels were not maintained nor did they undergo any regular inspection. This unique condition of near-abandonment continued up until recently, when the first signs of distress were documented. These consisted of severe and extensive cracking, particularly in the portal approach of the southbound tunnel, along with significant deterioration of the tunnel lining and radial section joints. The danger to traffic and, potentially, to the structure itself was evident. In this paper, the results of an extensive site inspection and evaluation program are presented. The underlying causes of the observed damage are analyzed and discussed using a modeling approach of the progressive loading conditions. R

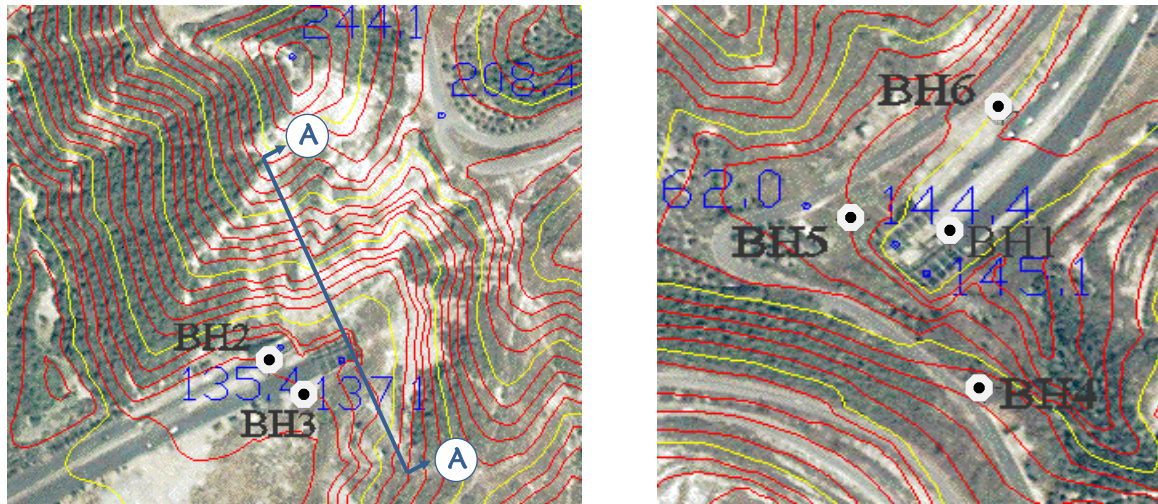
Figure 7. Location of Exploration Boreholes BH-1 Through BH-6.

A total of six boreholes, approximately 10 m deep, were drilled in addition to a number of shallow pits. The locations of the boreholes were restricted to accessible areas and are indicated in Fig. 7. The exploration pits complemented the boreholes and were located primarily above the southern entrance/exit points.
