# Reconstruction of Konstantinovsky Palace in a Suburb of Saint Petersburg

**ABSTRACT:** *This article describes a complex approach to the condition survey and design executed as part of the remedial works on Konstantinovsky palace in the suburb of Strelna (Saint Petersburg)--one of the most beautiful historic monuments of 18th century Russia. The palace was almost completely destroyed in the 1940s. In 2000 the decision was made to reconstruct the palace, and the project for palace reconstruction was developed. The project was completed in 2003. The following important stages of the project are discussed in this paper: palace condition survey and site investigations, analyses of the palace retaining structures, design project of palace reconstruction, and phases of the remedial works.*

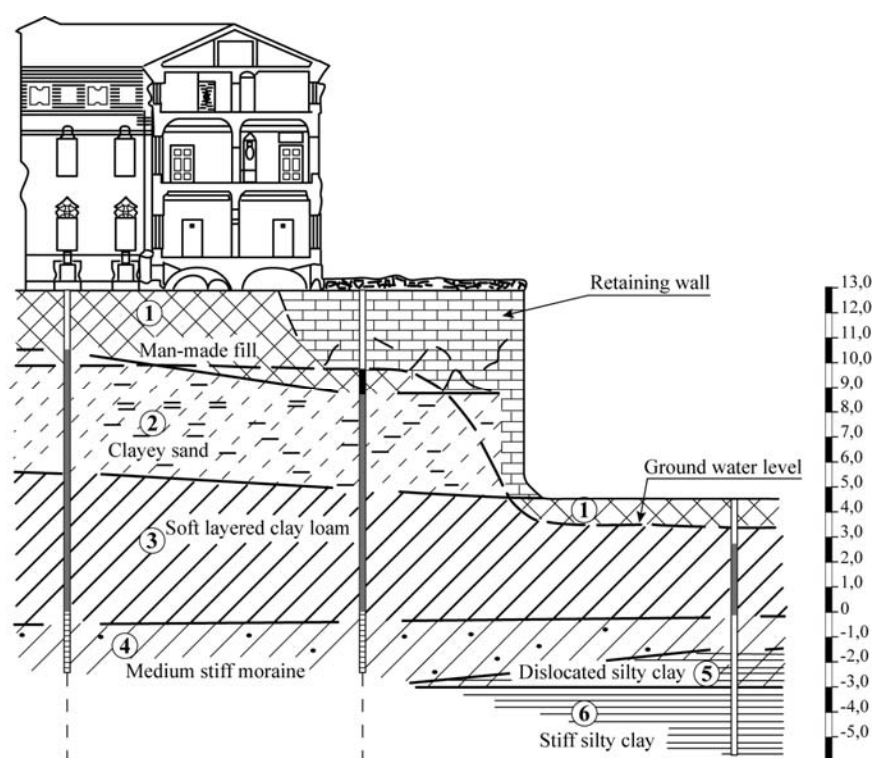
Figure 8. Cross-section of the palace and subsoil profile: 1. Made-up fill, 2. Clayey sand, 3. Soft varved clay loam, 4. Medium-stiff moraine clay loam, 5. Dislocated stiff Cambrian silty clay, 6. Stiff silty Cambrian clay.

As attested by site investigation in the park, underneath 1 m of fill there is a 3-m layer of soft varved clay loam, underlain by medium stiff moraine clay loam (Fig. 8). Still deeper, at the level of around 14.0 m (absolute – 1.3 m), there are medium stiff and stiff deep Cambrian clays.

not be entirely ruled out that the discovered brickwork is demonstrative of a bond between the courtyard foundations and the retaining structure. Above the clayey sand there is a layer of man-made ground about 3 m thick (Fig. 8, layer 1).

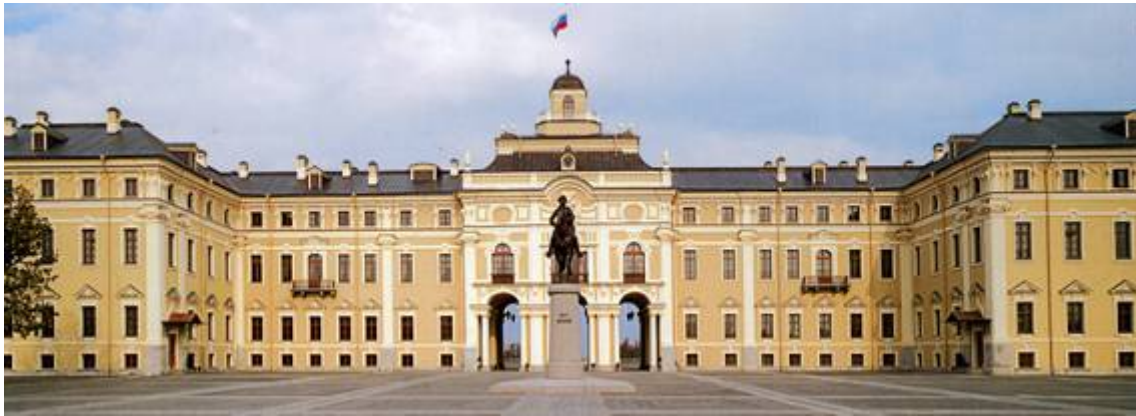
Figure 21. Konstantinovsky Palace, south façade. View after a final reconstruction stage (July 2003).
