# Rockfall and Subsidence on Mumbai-Pune Expressway

**ABSTRACT:** *Mumbai-Pune, India's first expressway, which crosses the mountainous and rugged Deccan Trap Province, suffered from a large amount of rockfall and major landslides in 2003 and 2004. A significant number of accidents and fatalities have occurred on the expressway as a result of such events. On the basis of frequency and magnitude of the recorded incidences of rockfall, seventeen critical areas of the road have been deemed in need of investigations and mitigation. One of the problematic areas that suffered from rockfall and subsidence is at km 41 on the expressway, adjacent to a tunnel (Adoshi). This location has been chosen for detailed study. This area extends for 500 m along the expressway, and the embankment has subsided by 2 to 3 m along the entire length. Based on the geological, geomorphologic and geotechnical investigations, causative factors for rockfall and subsidence at this location have been established. This paper presents the field investigations, probable causes, stability analysis and remedial measures for controlling the subsidence and rock fall.*

investigations carried out to assess the probable c

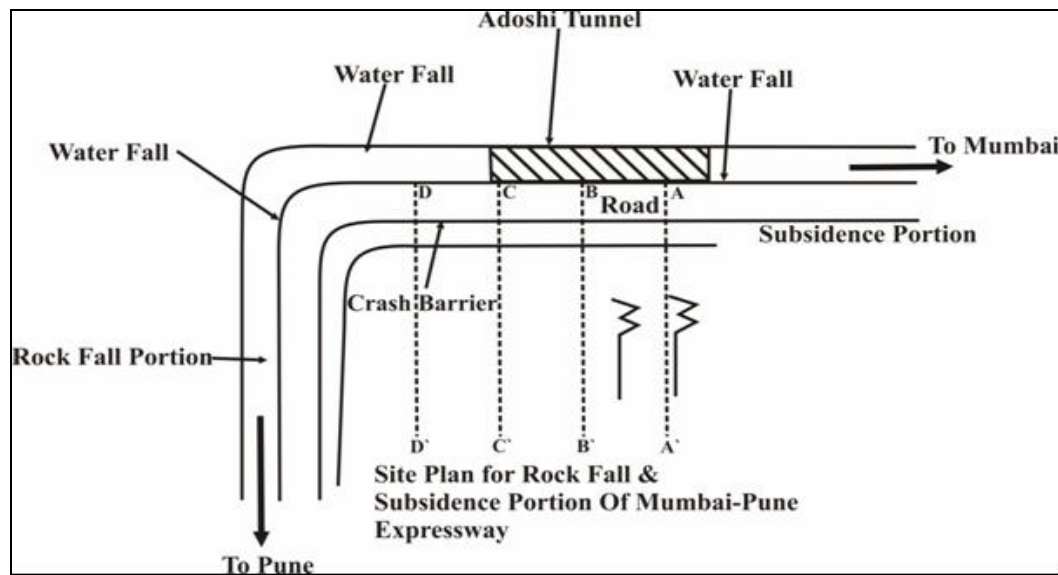
Soil samples were collected from the field. In-situ density of the embankment was measured using the core cutter method. The bulk density of the embankment is  $17 \text{ kN/m}^3$ . The shear strength parameters of the embankment soil are  $c'=3 \text{ kPa}$  and  $\phi'=30^\circ$ . The subsidence portion is around 500 m in length. The cross sections A – A, B – B, C – C and D – D were chosen for every 125 m as shown in Figure 18. Stability analysis of the embankment slope was analyzed by using GEO 4 software (Figure 19). The factor of safety of the embankment was analyzed using Bishop's and Peterson's methods. These results are presented in Table 1. The factor of safety at cross sections A – A and B – B is less than 1.25, which is considered critical by both the code of Indian standards and the US Army Corps of Engineers (IRC: 75, 1979 and EM 1110- 2-1902, 2003).

Figure 18. Location of cross sections for stability analysis.
