## Mississippi River Levee Failures: June 2008 Flood

**ABSTRACT:** During the spring and summer of 2008, record rainfall in the Midwest United States led to severe flooding as water overtopped the levees bordering the Mississippi River and its tributaries. The erosion associated with the overtopping resulted in levee breaches in many places. After the flooding, a field reconnaissance team was sent to collect time-sensitive data and provide a comprehensive overview of the performance of the levees during the flooding.

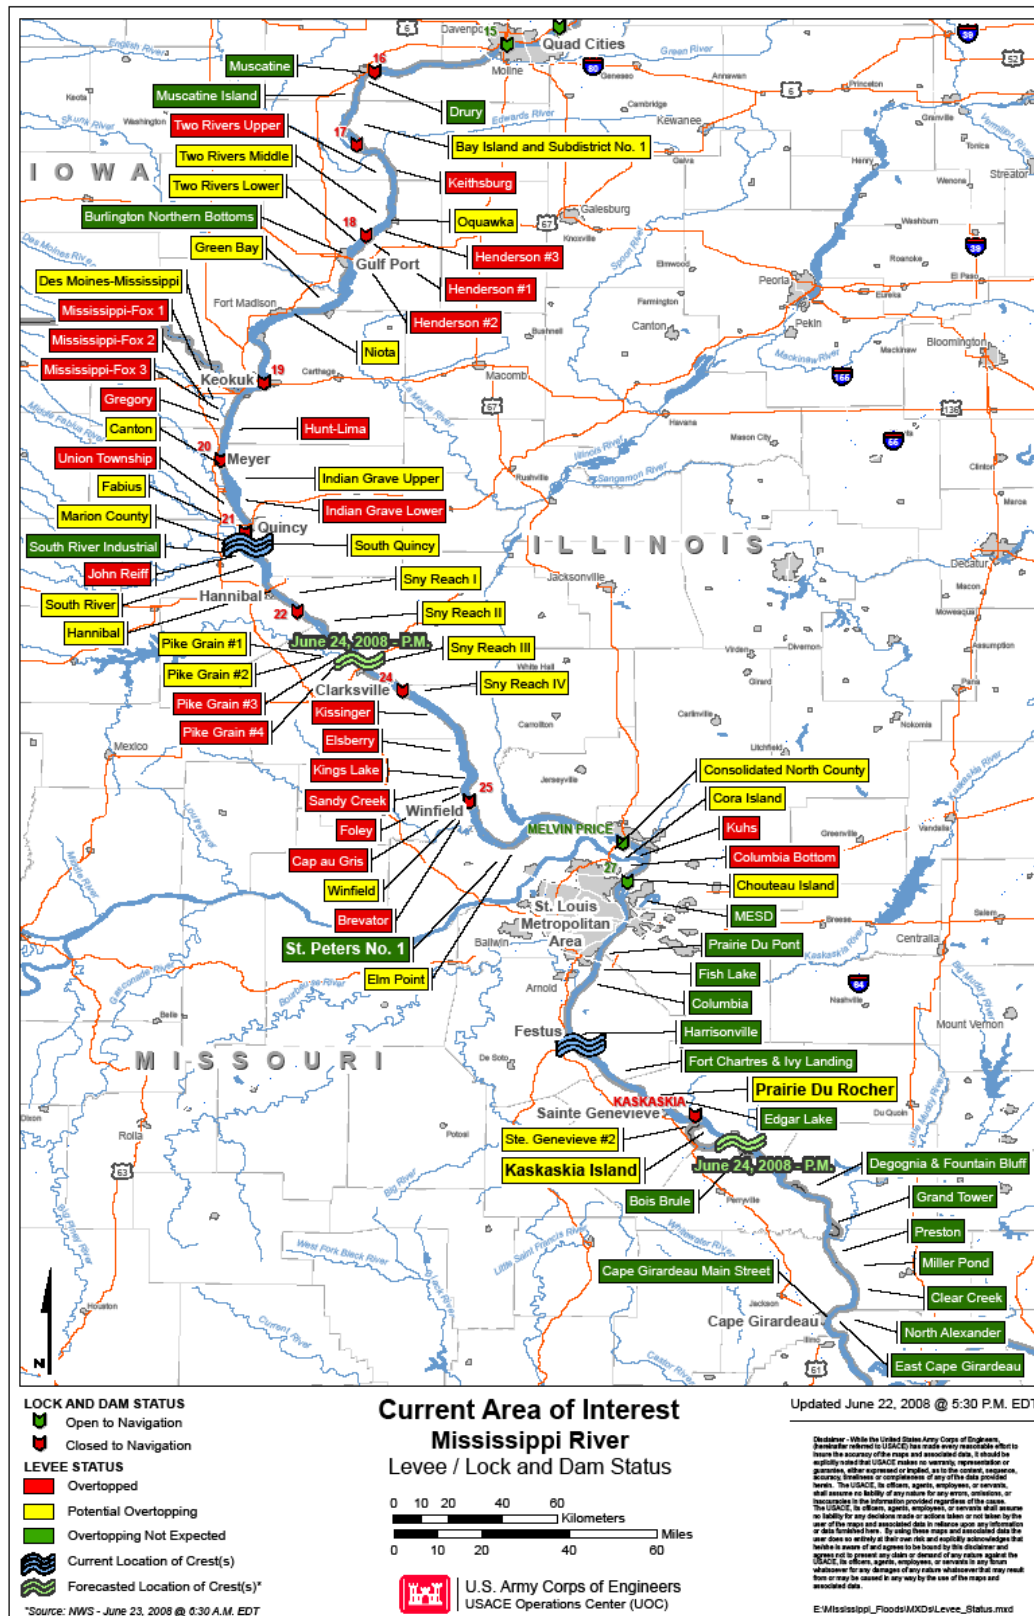
Figure 10. Overtopping status of Upper Mississippi River System (USACE 2008).

Figure 10 shows the US Army Corps of Engineers map of each particular levee system along the Upper Mississippi River System and the corresponding overtopping status during the flooding events as reported on 22 June 2008. The areas tagged in red had already been overtopped while the areas tagged in yellow show levee sections that were still in danger of being overtopped at that date.

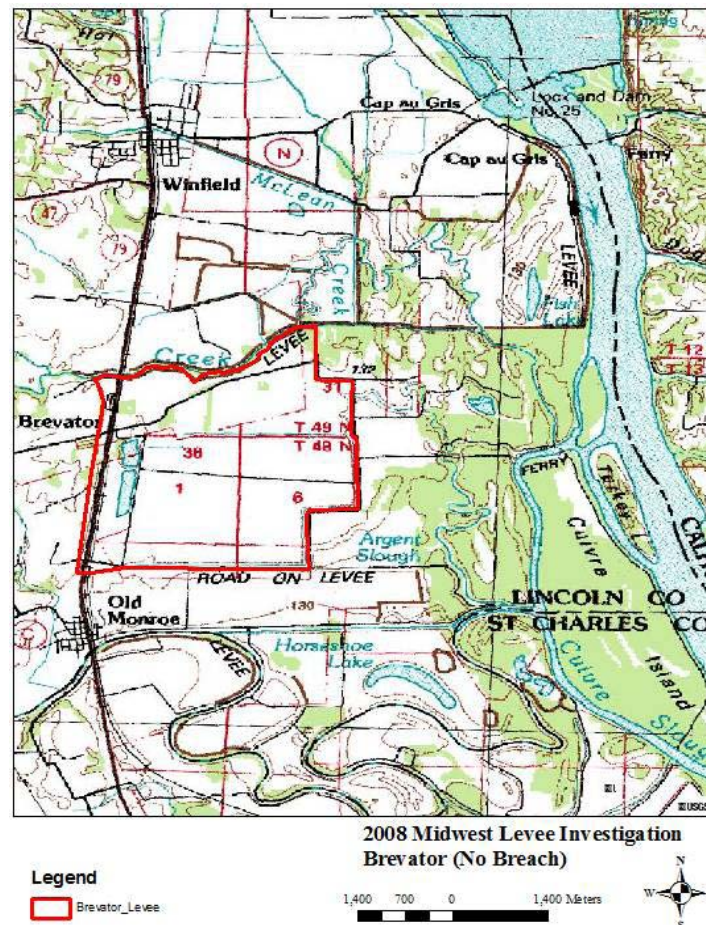
Figure 19. Brevator levee system (Storesund 2009).

This site was unique in the fact that there was no breach in 2008. The only sign of erosion was at a box culvert that was cracked allowing water and soil to seep through. A local resident (Mr. James Pieper) informed the team that the levee was overtopped by nearly 1 m of water for three days and never failed. Four samples were collected from various locations along the levee. Because there was no actual breach, only surficial samples were taken. These samples were much harder to obtain and the soil seemed to be much stiffer than at the previous sites as can be seen by the higher Pocket Penetrometer values (Table 6) obtained at this site compared to the Winfield site. Figure 20 shows the boring locations and Table 6 presents the sample logs for this site.

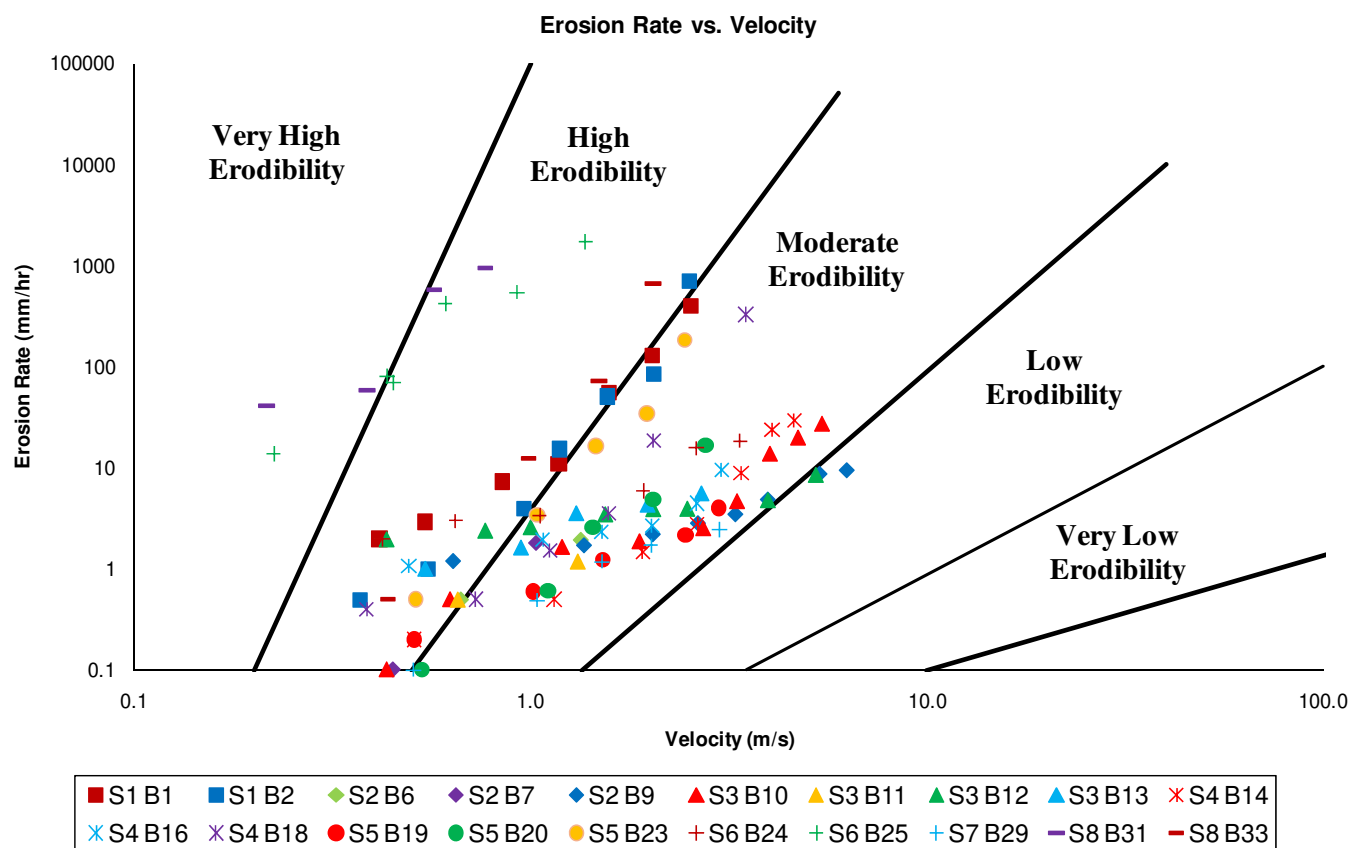
Figure 23. Erosion rate versus velocity for the Midwest Levee samples.

The EFA was used to obtain the erosion functions for 20 Midwest Levee samples. The samples tested were chosen in an effort to encompass a variety of material types, locations within the levee, and erosion performance. In order to compare the erosion functions of the samples, the data points were all plotted on the same graph (Figure 23). This graph also shows the erosion categories developed from previous studies (Briaud 2008). Most of the soils tested show moderate erosion at higher velocity. Please refer to Table 2 for the site identification nomenclature.

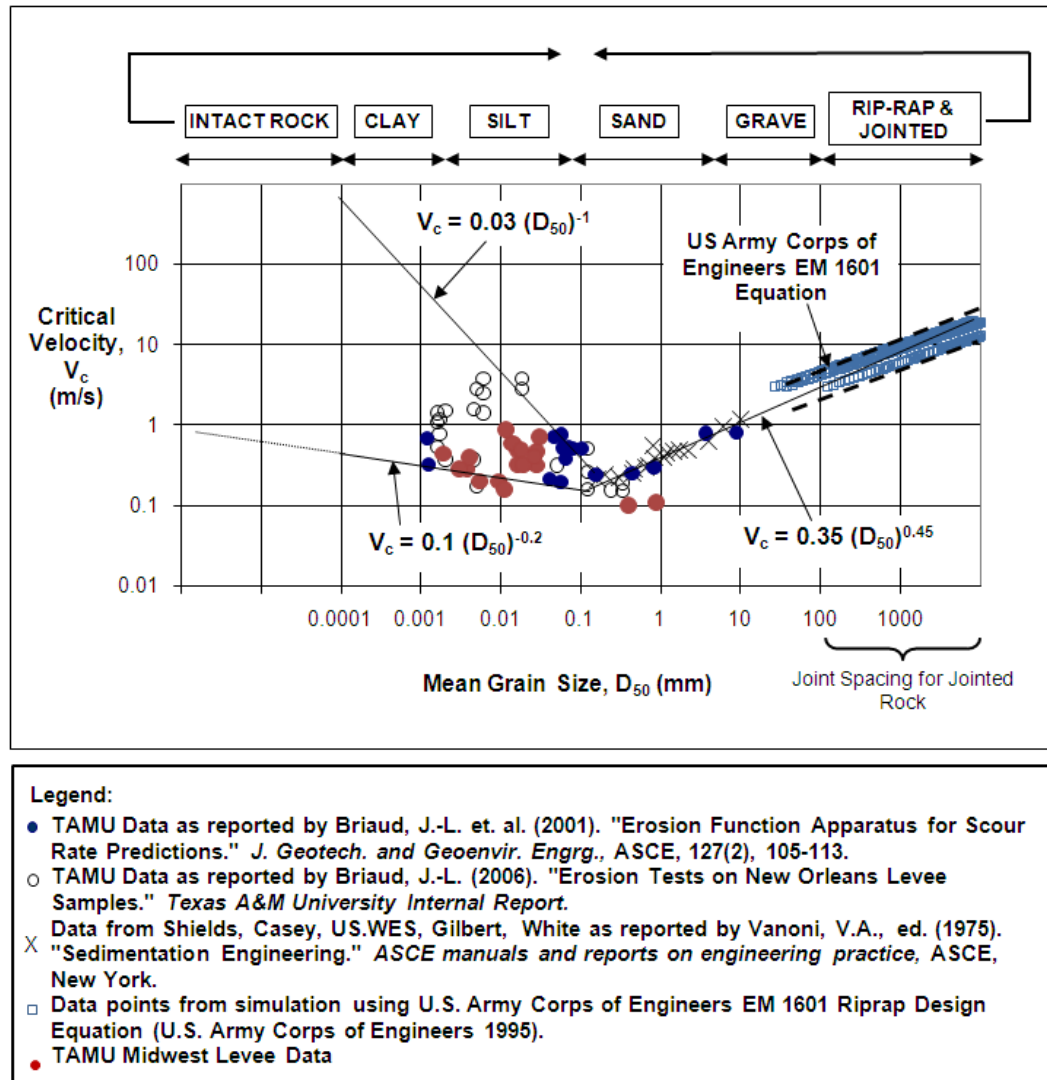
Figure 24. Critical velocity vs.  $D_{50}$  combined results.

The critical velocity is defined as the maximum velocity that the soil can resist without erosion. This erosion threshold is considered to correspond to an erosion rate of 0.1 mm/hr. Previous comparisons (Briaud 2008) have been made between critical velocity and  $D_{50}$  (average particle diameter). Figure 24 shows the Midwest Levee values plotted with values obtained from previous testing. The values follow the trend set by the previous data.

This plot shows that most of the Midwest levee soils tested have  $D_{50}$  values in the silt size range and critical velocities between 0.1 and 1 m/s. Since the levees have heights of 3 to 5 m, the velocity at the bottom of the levee can reach 10 m/s. This can be estimated by equating energies:

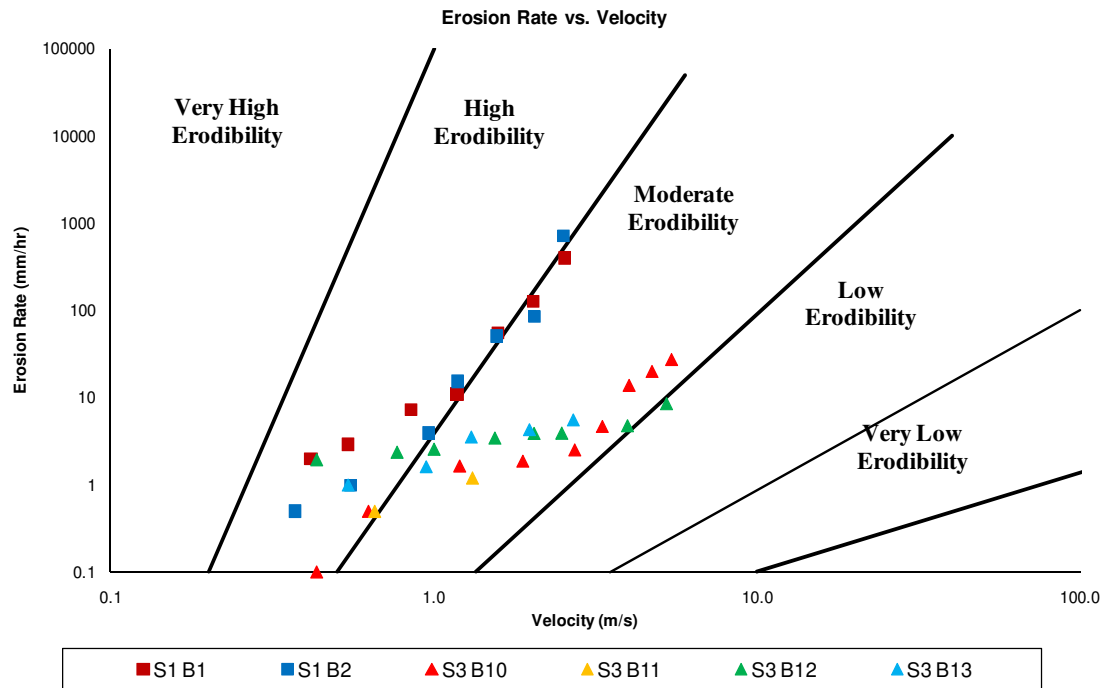
Figure 25. EFA results for Winfield-Pin Oak – S1 and Brevator – S3.

An attempt was made to correlate the erosion resistance with the index properties of the soils tested. The difference in erosion resistance between the two selected sites is clearly seen in Figure 25. Soils from the Brevator site are much more erosion resistant than those from the Winfield-Pin Oak site.

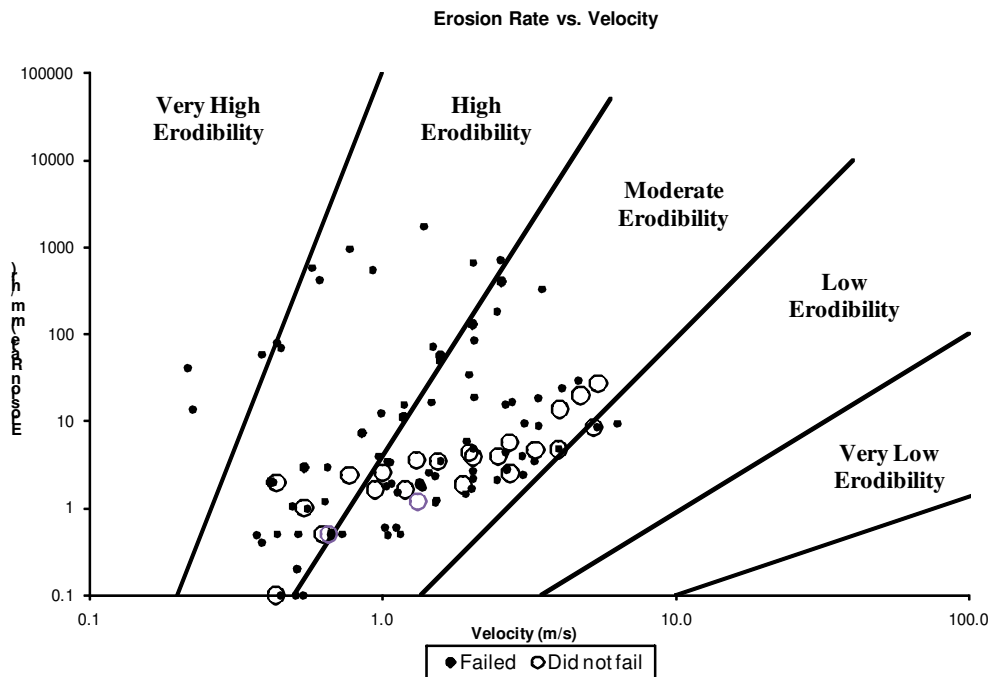
Figure 34. Overtopping comparison of pass vs. fail.

In an attempt to determine a dividing line between the soils that failed due to overtopping and those that passed, the EFA results were plotted with open circles for samples from levees that did not fail and solid circles for samples from levees that failed (Figure 34). Note that the Brevator site was the only site considered to have not failed.

Overall there is no clear division between the two sets of points like what was seen in the Katrina data (Figure 35) given in Briaud et al. (2008). The soils from the Brevator site are among some of the more resistant soils tested; however, there are several sites where the samples are just as resistant yet the sites failed. Comparing the sites that failed to the sites that did not fail based on the plotted points is somewhat deceptive because the EFA tests were limited to the bare soil and did not

account for any of the site conditions, such as vegetation or other variables that may have influenced the sites performance. The strong vegetative cover at the Brevator site would increase the resistance and effectively shift the erosion function towards the low to very low erodibility categories.
