# Quarry-Induced Slope Instability at a Broadcasting Transmission Plant near Valcava, Lombardia, Italy

**ABSTRACT:** *Since 2006, a broadcasting tower and ancillary buildings on the top of a hill adjacent to a large, active limestone quarry, in northern Italy near the village of Valcava, has been heavily damaged by ground deformation due to slope instability. In 2005, the quarry began to work the slope toward the broadcasting plant, releasing bedding planes that affected the tower site: a number of fractures occurred in the warehouse and in the ground around it, that grew particularly during significant rainfalls. In October 2006 a landslide occurred in the quarry area, close to the broadcasting site. In order to understand what induced the fracture process in the buildings and define a support system to stabilize the broadcasting site, a detailed geotechnical survey and a number of numerical slope stability analyses were carried out. One of the main goals of the paper is to underline the effectiveness of the numerical analyses to understand the instability phenomena when they are particularly complex. Furthermore, by using a reliable numerical model with a good understanding of s

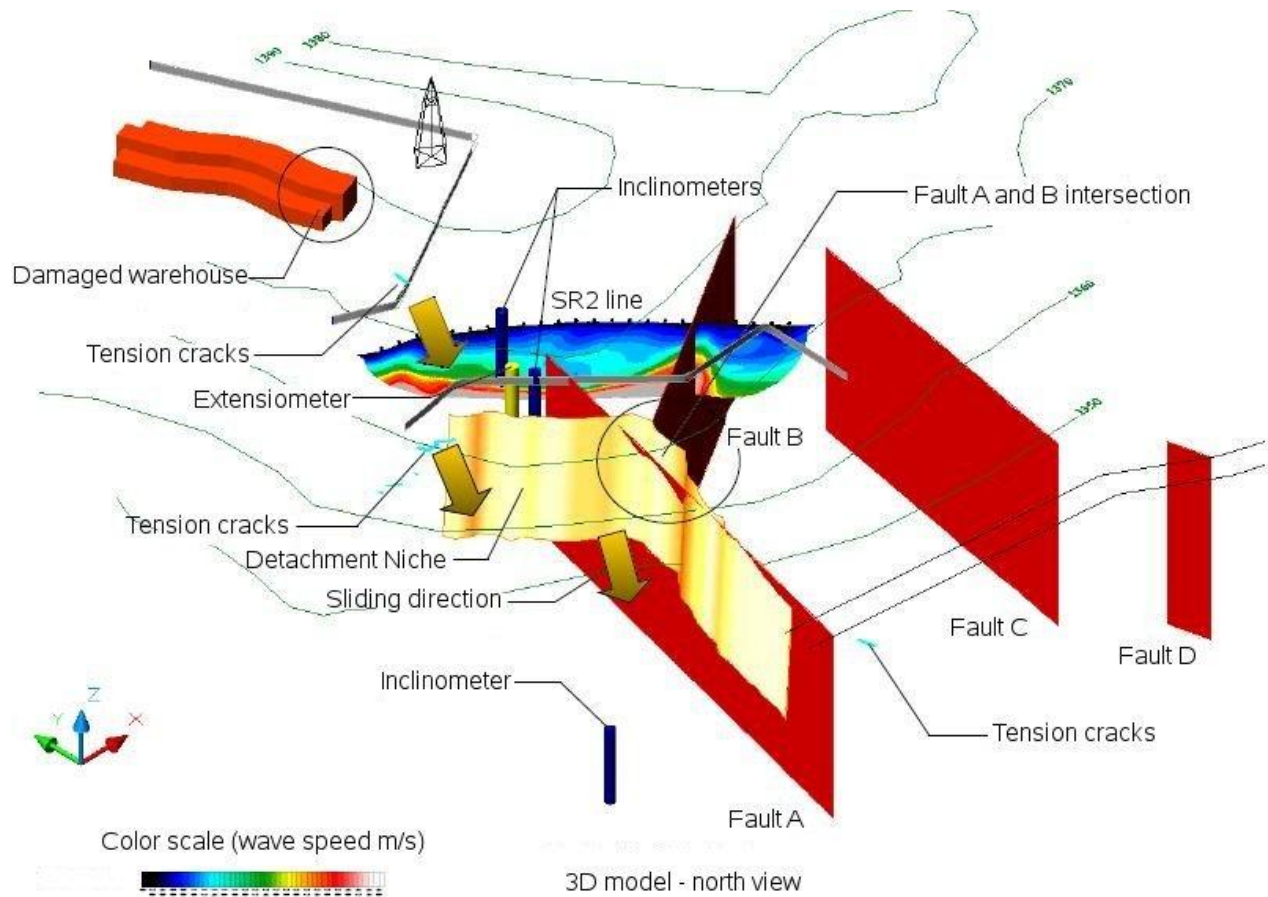
Figure 7. Three dimensional model for the seismic and geo-electrical survey.

One seismic refraction and two geo-electrical soundings were located near the warehouse on the unstable slope, toward the pit. Another pair of seismic and geo-electrical outlines was located close to the broadcasting tower base (Figures 6 and 7). The data were processed with tomographic technique (Hampson & Russel, 1984; Olsen, 1989) and then interpreted considering the conventional exploration with core-drilling data. Similar results were generated in the slope and in the tower area. Upslope of the warehouse, in the tower area, there is a superficial layer of fill about 3 m deep, underlain by a layer of fractured limestone overlying apparently intact bedrock at a depth of about 16 m, as shown in Figure 8. Near the warehouse, upslope from the landslide, a pit showed the same stratigraphic sequence is observed in the tower area, as well as evidence of the two main faults A and B (Figure 9). Because of fault B, the apparently intact limestone is found at a depth of more than 20 m. The seismic survey thus confirmed the likelihood that the sliding surface was located above a depth of 20 m.

The results of the field surveys have shown that many natural weakness elements affect the site. Fault A marks the east boundary of the landslide. Its intersection with fault B (Figures 6 and 7) induces heavy fracturing in the limestone to significant depths contributing to the instability of the area. The downslope dipping bedding planes predispose the slope to sliding and the two sub-vertical sets of discontinuities can become preferential paths for water percolation. These favorable to sliding conditions, however, do not result in movement of the instable mass, as no cracks or damage occurred in the broadcasting plant before the pit activities initiated towards the plant. Quarrying activities caused relaxation of the rock along the bedding planes in the excavation area, progressively inducing the landslide. The instability involved also the broadcasting area inducing tension cracks and fractures in the soil and in the warehouse. The tension cracks became preferential paths for the water, so the stability of the area got worse with heavy rainfalls during the spring and the autumn 2006 until the collapse in October 2006. This event mobilized the slope slide in the broadcasting site and the growth of the fractures openings was observed. However, quarrying activities did not damage the buildings located in the broadcasting site neighbourhood and the broadcasting tower did not exhibit any displacements or rotations. In fact, no changes in the broadcasting signal occurred in that period. These facts allowed ruling out that the landslide was induced by a larger, deep-seated, landslide.

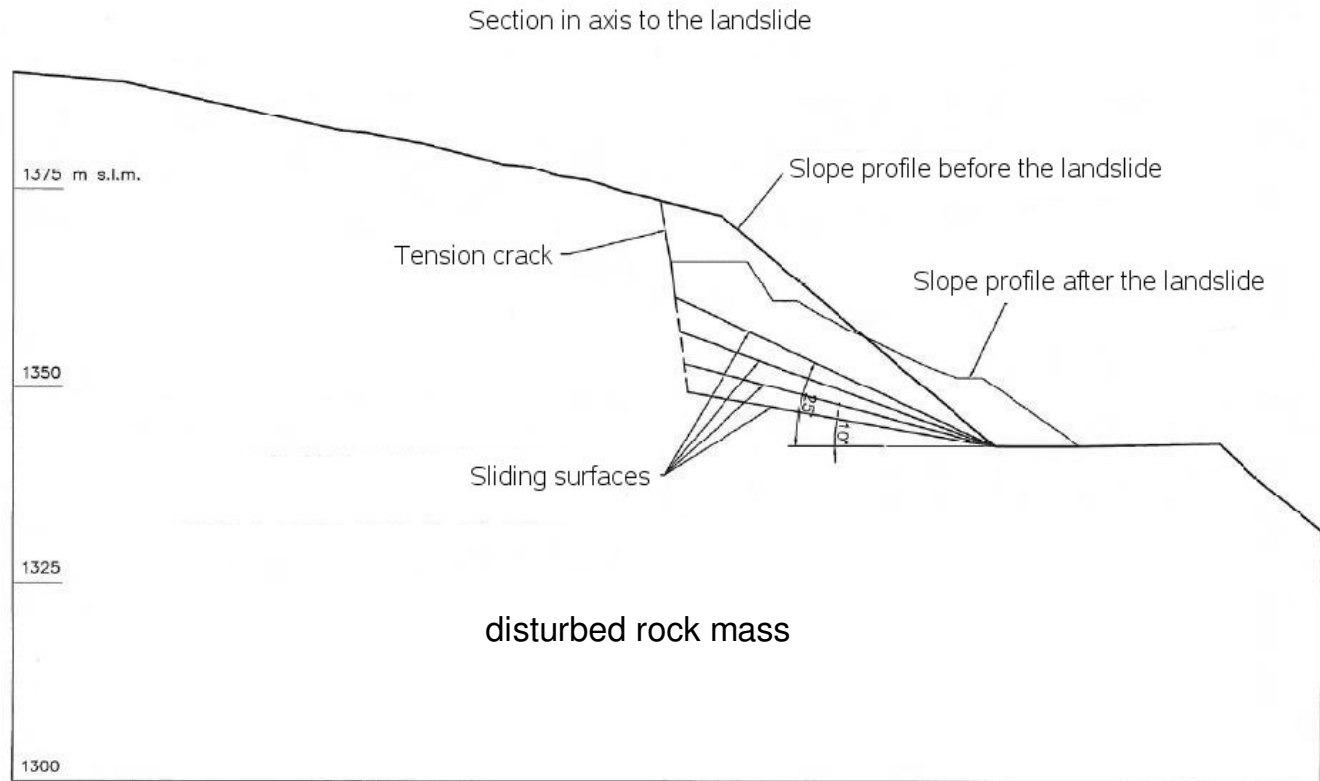
Figure 10. Slope section used for the limit equilibrium analyses (Slope-W).

An assumption had to be made for the discontinuity parameters, for which no experimental measurement was available. In order to confirm the suitability of the geotechnical characterization, a back-analysis of the landslide which occurred in October 2006 in the pit area was carried out, using the limit equilibrium method (LEM). The landslide involved an area of about 1750 m<sup>2</sup>, between 1345 and 1375 m over sea level. It was assumed that the movement occurred along a bedding plane. The detachment crown was located along a sub-vertical joint, according to in situ observations. The precipitation data showed that medium-high intensity rain occurred in the area for two days before the landslide. It was assumed that quarrying released the bedding planes and induced tension cracks to propagate, allowing more rainwater to seep in, which

triggered the landslide. An example of a model of rainfall-induced initiation model is presented by Salciarini et al. (2006). A case of a landslide related to prolonged rainfall patterns is studied by Ibsen and Casagli (2004). The stability analyses were carried out by using the limit equilibrium method (Janbu solution) implemented in SLOPE-W (Geo-Slope International, 1998). A section in the middle of the landslide was considered for the analyses (Figure 10). The model is constituted by a single material, characterized by disturbed rock mass mechanical parameters. The anisotropic function was used to introduce Mohr-Coulomb parameters, obtained by the linearization of the Barton-Bandis criterion, along the sliding surfaces. The parameters listed in Table 4 have been considered.
