## Embankment Failure in Residual Soils at Nivsar, Ratnagiri

**ABSTRACT:** The Nivsar Yard embankment was constructed by the Konkan Railways in 1994. Near the station building, the 22m high embankment runs parallel to the Kajali River for a stretch of about 100m. This stretch has experienced failure and settlement related problems since the record-breaking July 2005 rainfall. Corrective ground improvement measures were implemented immediately after the monsoon. However, these measures were inadequate because the failure surface reappeared during the following monsoon. The failure surface mirrored the shape and size of the failure observed in 2005. Since then after nearly every monsoon, the embankment has moved despite precautionary measures taken by the railway to arrest the movement. The hydrogeological and geotechnical properties which affect slope stability are first discussed. The stability of the embankment is then evaluated at 5 sections drawn along the slope. Two cases are considered. In the first case, the stability of the unreinforced slope is calculated. In the second case, calculations are done using the slope reinforced with soil nails and micropiles installed in 2005

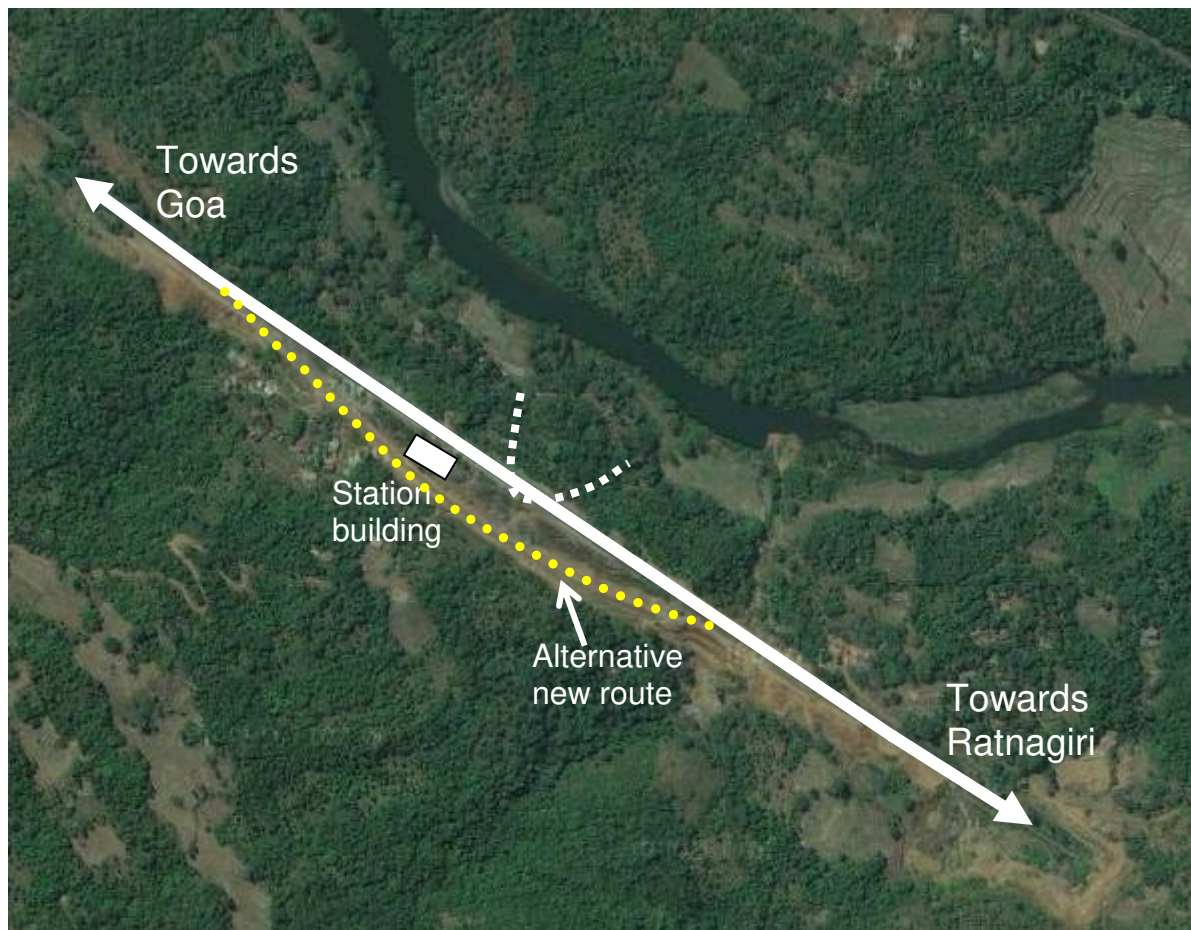
Nivsar is located in Ratnagiri district of Maharashtra at latitude  $16.95^{\circ}$  N and longitude  $73.45^{\circ}$  E. Most of the rain in this region falls during the monsoon which lasts from mid-June to mid-September. Konkan Railways pass through this district and has a station located at Nivsar. Figure 1 shows the location of the station building. A portion of the approach earthfill embankment (shown by broken line in the figure) has experienced failure and settlement related problems since the 2005 monsoon. The failure surface at the embankment follows the shape of an inverted parabola and encompasses all the rail tracks and the station platform. The slip circle appears to pass through the toe of the embankment and terminates close to the road, where transverse cracks are observed.

*Figure 1. Nivsar Station in Ratnagiri District of Maharashtra (Source: Google earth). Note: The dashed line shows the approximate location of the embankment failure .*

In 2010, the rail track was realigned to bypass the failure surface. This arrangement provided immediate relief to the rail-traffic. Figure 1 also shows the new alternate route used by the Konkan Railways. Since then, three other lines have been realigned to follow this alternate route. Irrespective of the above change in the rail alignment, Figure 3 also shows that the rate of settlement of the embankment has reduced since the 2009 monsoon. It is plausible to assume that the slump accumulated at the toe has reduced the gradient and hence affected the soil movement over this period (Figure 5). The site was re-investigated in 2010. The results of the re-investigation are part of this present study. The objective of this paper is to investigate the slope failure at Nivsar as recorded since the year 2005. Stability of the embankment before and after the ground improvement works is discussed. Railway loads from the old as well as the new rail alignment were used in the analysis. The critical failure circle for each case is shown to be affected by the geometry of the slope and the hydrogeological conditions at the site.

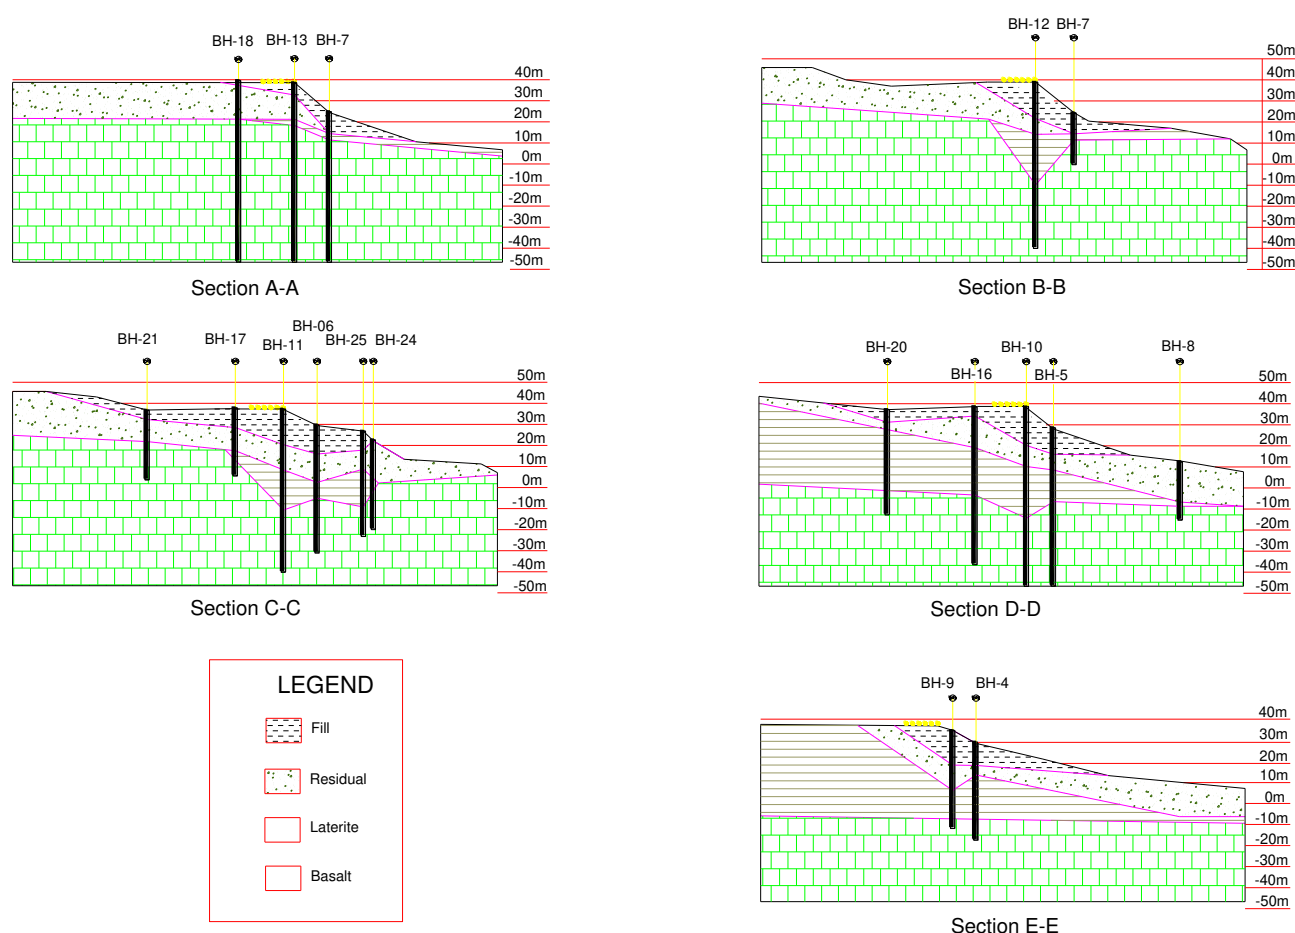
Figure 9. Subsurface profile at the site. Location of sections A-A to E-E are as per Figure 7.

Using the borehole data, five cross-sections were drawn to interpret the subsurface profile of the site. The five sections are marked as A-A to E-E in Figure 7 and are shown in Figure 9. Sections B-B to D-D were chosen to represent the edges and centre of the failure zone. Laterites were nearly absent in section A-A and had the maximum presence in section D-D. The average geotechnical properties at each section are shown in Table 4. The material properties in Table 4 were obtained from the field and laboratory testing programme monitored jointly by Konkan Railways and IIT Bombay. Direct shear tests were conducted to obtain  $c'$  and  $\phi'$ . Unconsolidated undrained (UU) triaxial tests were conducted to obtain  $c_u$ . The secant Young's modulus,  $E$ , of selected samples was obtained from stress-strain curves on UU samples confined with 50 to 200 kN/m<sup>2</sup> mean stress. Unconfined compression tests were conducted to obtain the  $c_u$  of laterites and basalt.

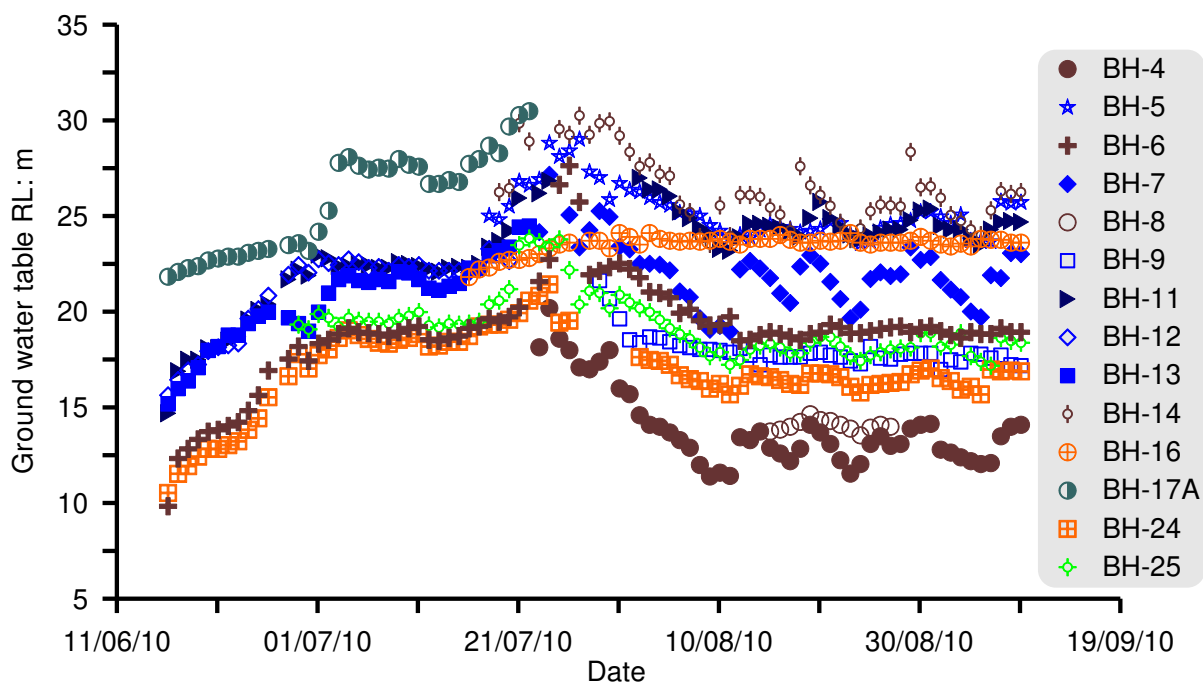
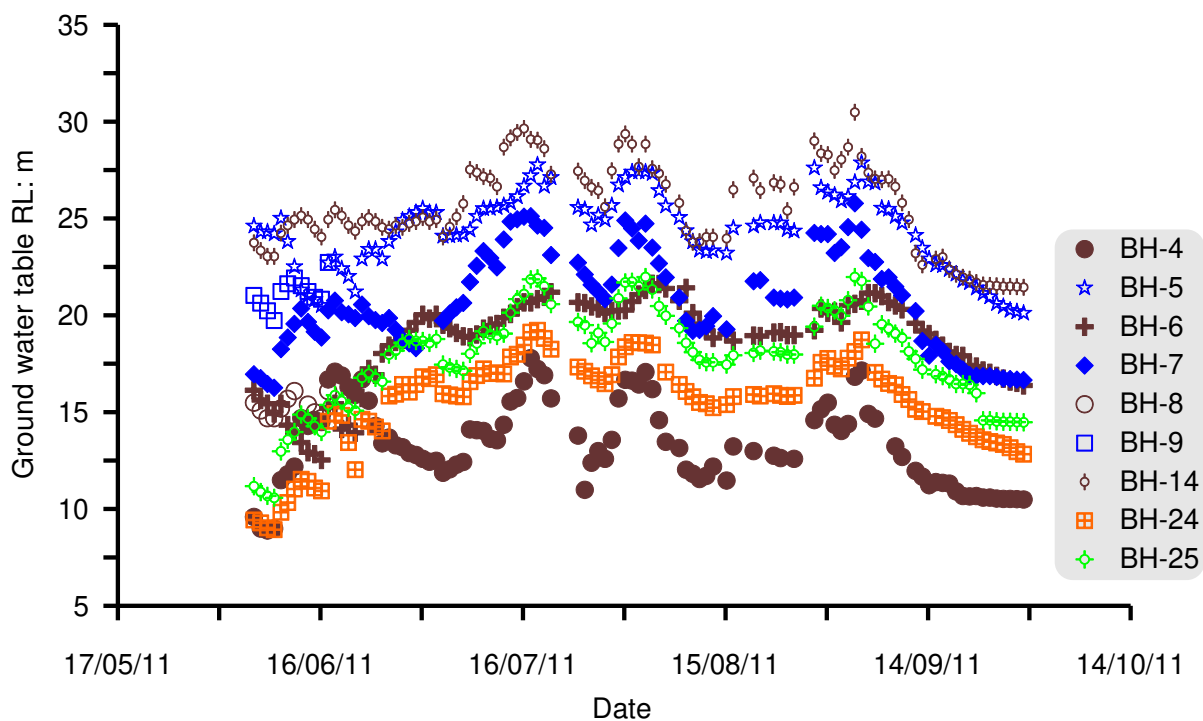
Figures 10a-b. Water table in standpipes: (a) In 2010; and (b) In 2011.

Standpipes were installed in the boreholes after the completion of the drilling. Ground water depths were occasionally recorded in these standpipes for about two years. Figures 10a and 10b show the water table recorded in 2010 and 2011, respectively. The slope movement during the 2010 and 2011 monsoons, sheared-off some of the standpipes. As a result a complete record of ground water data is not available over the monitoring period at these locations. The maximum and minimum water table depths are summarised in Table 5. A few observations may be made from Figures 10a-b and Table 5. First, the water table changed from 12.5m to 20m over the monitoring period in boreholes which were drilled along the centre-line of the failure surface. This variation in the water level possibly created a large pressure gradient. Second, the seasonal variation in the water level was more than 9m in boreholes drilled within the failure zone. There was significant variation in the water level even outside the failure surface. For example, the pressure head difference between boreholes BH-7 and BH-12 was more than 17m although the boreholes were only about 35m apart. Inevitably, these large pressure head difference caused large groundwater flow and significant seepage forces.
