## The July 10 2000 Payatas Landfill Slope Failure

**ABSTRACT:** *This paper presents an investigation of the slope failure in the Payatas landfill in Quezon City, Philippines. This failure, which killed at least 330 persons, occurred July 10<sup>th</sup> 2000 after two weeks of heavy rain from two typhoons. Slope stability analyses indicate that the raised leachate level, existence of landfill gas created by natural aerobic and anaerobic degradation, and a significantly over-steepened slope contributed to the slope failure. The Hydrologic Evaluation of Landfill Performance (HELP) model was used to predict the location of the leachate level in the waste at the time of the slope failure for analysis purposes. This paper presents a description of the geological and environmental conditions, identification of the critical failure surface, and slope stability analyses to better understand the failure and present recommendations for other landfills in tropical areas. In addition, this case history is used to evaluate uncertainty in parameters used in back-analysis of a landfill slope failure.*

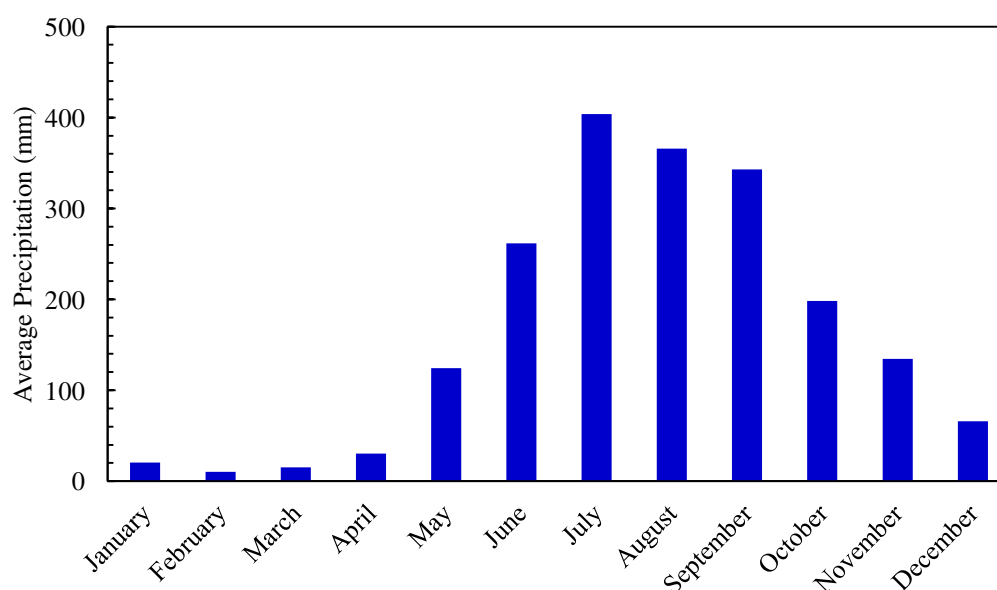
The precipitation database in the HELP model does not provide historical precipitation data for Quezon City, so recorded rainfall data from 1 May through 31 July 2000, was obtained from the Quezon City weather station and imported into HELP. This provides a reasonable simulation of the two months of precipitation immediately preceding the slope failure. Replicating approximate initial moisture conditions before May 1<sup>st</sup> 2000 involved executing the HELP model for several years prior to the failure. As a result, weather and climate conditions similar to Quezon City were required because this data is not available from the Quezon City weather station. Quezon City, located at 14° latitude, is closer to the equator than the United States and hence, has different climate conditions. Quezon City weather is dominated by high humidity, precipitation, and warm conditions year round. Table 7 presents a summary of the key weather conditions for Quezon City. The HELP program can also generate daily precipitation data using a synthetic weather generator. By entering the normal mean monthly precipitation values of Manila, Philippines shown in Figure 13, HELP generated synthetic precipitation records for 10 years preceding the failure. This synthetic record was used until May 1<sup>st</sup> of the 10<sup>th</sup> year, so that the water content and saturation levels reached a reasonable steady state value before applying the recorded data from the Quezon City weather station. From May 1<sup>st</sup> to July 31<sup>st</sup>, recorded precipitation values from the Quezon City station (Canty and Associates LLC, 2004) were input to HELP.

*Figure 13. Average monthly precipitation for Manila, Philippines from Quezon City weather station (data from [www.weather.com](http://www.weather.com)).*
