## A High Rock Cut Stabilization in Muscat City, Oman

**ABSTRACT:** A large road box cut was constructed in hilly terrain of Muscat city, Oman, in an area underlain by the geologically complex Sahtan and Mahil formations comprising of limestone, dolomite, sandstone and siltstone with interbedded soft calcareous mudstone. The rockmass contains a large number of small scale faults, shear zones, minor folds and solution cavities. The maximum height of the cut was 50 m with slope angle of 1V:0.25H, and intermediate benches generally 3 m wide. To control vibrations in the urban neighborhood located nearby and avoid damage to the rockmass, a very cautious and time consuming excavation approach was adopted using rock breakers. The excavation work was completed in 2010. Oman has a hyper-arid environment with scarce rainfall for many months. However, occasionally the area is hit by intense rainstorms. During Cyclone Phet and accompanying rains in June 2010, part of the cut slope failed with a downslope movement of about 800 m<sup>3</sup> of massive rock. This necessitated a post-excavation re-evaluation of the cut slope, which culminated in design modifications, and construction of long te

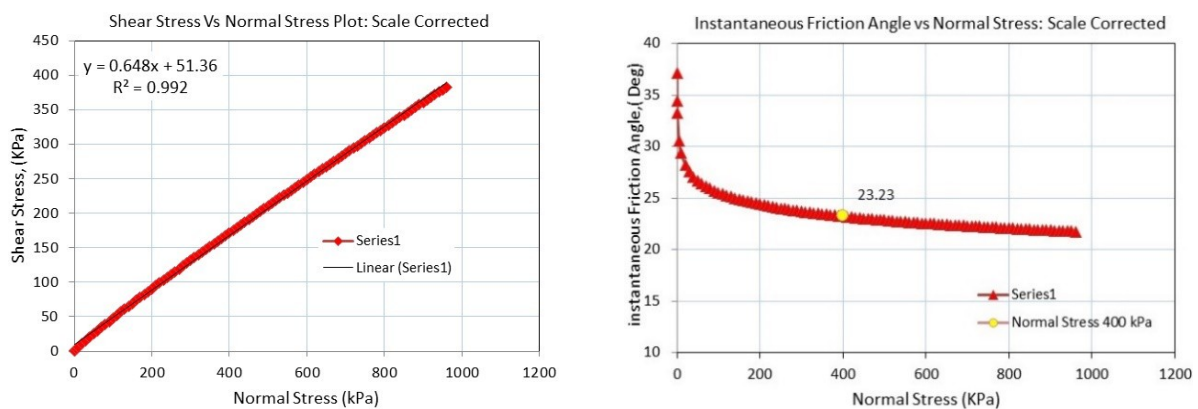
Figure 7. Friction angle at various stress levels for a deep seated sliding plane.

Figure 7 shows the spreadsheet results of  $\phi_L$  at various normal stress levels for deep seated failures.

The average normal stress range was found to be about 400 kPa. Considering this, the corresponding friction angle ( $\phi_L$ ) was selected as  $23.2^\circ$  from Figure 7. In addition, based on site observations of intact rock bridges and test results, a cohesion value of 80 kPa was selected for analysis in deep seated failures. Similarly, for small scale failure, the  $\phi_L$  value was calculated as  $28^\circ$  and zero cohesion was assumed in this case.

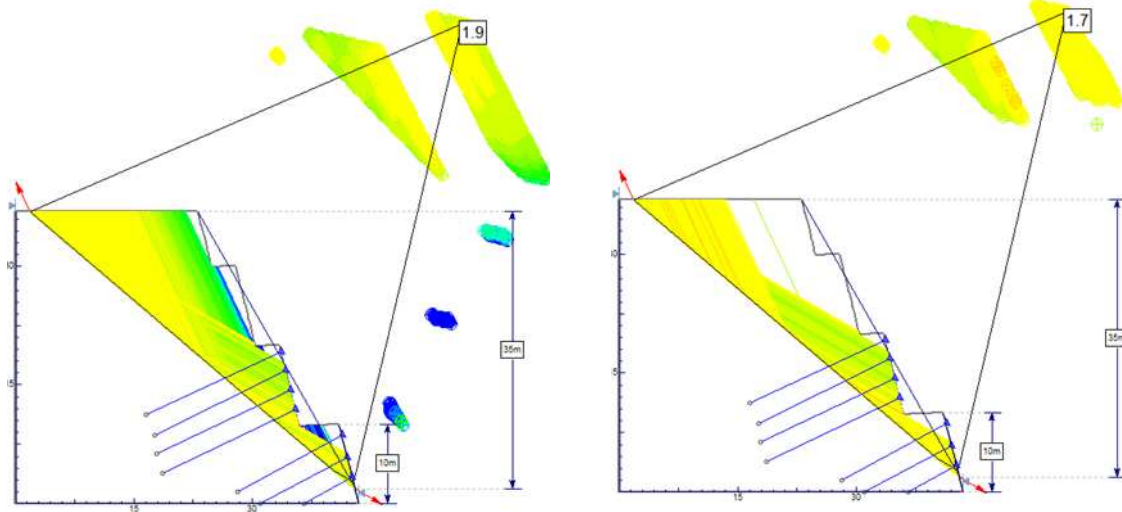
Figure 14. FOS with 7 x 1200 KN anchors in dry condition using Bishop (left) and Morgenstern-Price (right) methods.
