# Geotechnical Damage Caused by the 2016 Kumamoto Earthquake, Japan

**ABSTRACT:** On the 16<sup>th</sup> of April 2016, the Kumamoto earthquake ( $M_w$  7.0) hit the Central Kyushu Region, Japan, following a  $M_w$  6.2 shock on the 14<sup>th</sup> of April. The earthquake sequences caused severe damage in Kumamoto Prefecture. This paper presents quick reconnaissance results focusing on geotechnical damage features, which were observed during field investigations immediately after, one, and two weeks after the main shock. The damage surveys were carried out in southern Kumamoto City, Mashiki Town, Aso Caldera area and their suburbs. In southern Kumamoto City, evidence of liquefaction was found at many locations, and some buildings and river levees suffered from significant settlement and deformation; damage to an embankment of Kyushu Highway also seemed to be the result of liquefaction. The majority of the damaged residential houses were found in Mashiki Town and its suburbs, which may be linked to intense earthquake motions associated with the seismic fault location. In Aso Caldera area, a number of moderate to large scale landslides and their significant impact to structures wer

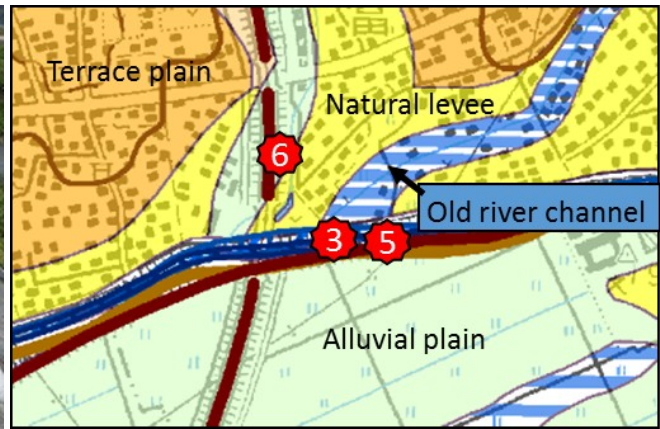
Figure 7. Landform classification map and location of the damaged sites (Modified from GSI's map).

Figure 6 shows the typical liquefaction-induced damage to a river levee (site 3). Large settlement and lateral deformation was found at the levee along Akitsukawa-River. According to a landform classification map for flood control, provided by Geospatial Information Authority of Japan (GSI) shown in Fig. 7, the damaged levee is located at the old river channel, which suggests that a shallow soft deposit liquefied, inducing lateral spreading toward the river. Kyushu Regional Development Bureau of MLIT (2016) reported damage of variable severity to the levees of the Midorikawa-River and Shirakawa-River. They identified a total of 171 sites, however, their emergency restoration was almost completed as of middle of May. The settlement of levees, for example, caused a large gap between the embankment and bridge girders leading to a transportation problem (Figure 8, site 4). As of the end of April, such problems have occurred at many locations, however, they have been temporally solved by the installation of a filled slope (Figure 9, site 5). Although the locations of liquefaction are widespread in Kumamoto City (Wakamatsu et al., 2016), there have been no official report of serious liquefaction-induced damage; there are neither collapse of buildings nor washout of levees due to liquefaction.
