# Uplift of an Underground Tank in Northern Malabar Region, India

**ABSTRACT:** An underground reinforced concrete tank was constructed for a project in the southwest region of India. The tank was 90 m x 35 m in plan and 7.3 m deep resting on partly filled-up and partly native soil. During the peak monsoon, a sudden uplifting of the base slab by about 300 mm and subsequent failure of the foundation raft and a partition wall was observed. Laboratory testing was executed and hydrogeological survey was carried out using ground penetrating radar, seismic refraction and infiltrometer testing, and an analytical study was carried out to identify the root cause of the tank uplifting. Based on this study, it was observed that the uplifting and structural failure was essentially due to the peculiar land terrain and soil properties and the development of excess hydraulic head below the bottom of the tank. After considering different options, the rectification measures were carried out by provision of dewatering wells along the tank periphery to release the excess hydrostatic pressure and stabilize the foundation raft. The structural repair of the top of the foundation raft and partition wall

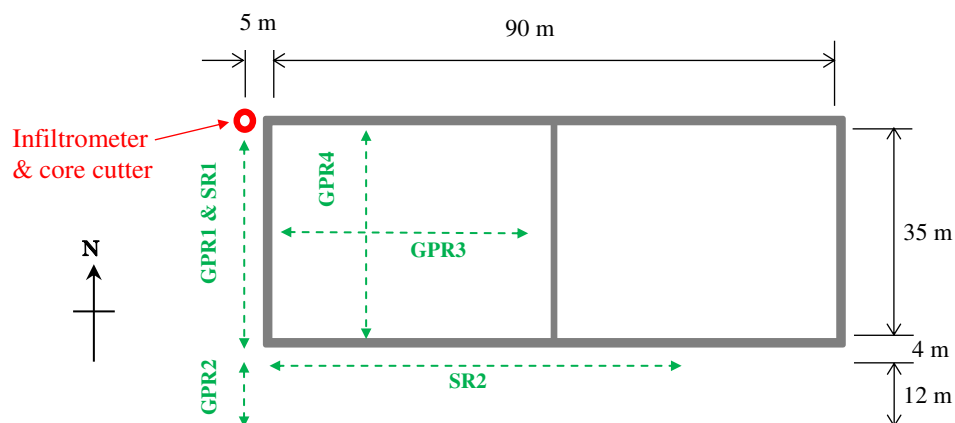
Figure 5. The schematic plan illustrating the location of GPR profiles, seismic refraction (SR) survey profiles and soil samples (see also Table 2).

The investigation was focused on the west and south periphery of the tank, where the ground was submerged. It shall also be noted that historically there was a perennial water well near the southwest corner of the tank which was filled up with soil and boulders during construction. The water from this well was used for household purposes by the local villagers. The concrete slab was also cast on top of this well during construction. The area on north and east of the tank was observed to be relatively dry.

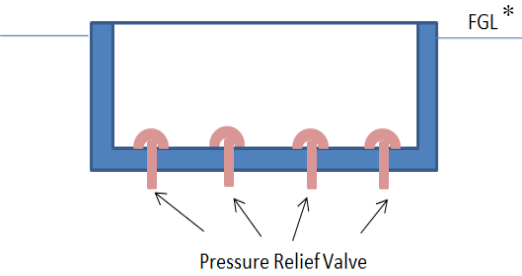
| Option 3 | <p><b>NON-RETURN PRESSURE RELIEF VALVES:</b></p> <p>Provision of non-return pressure relief valves on the bottom slab to release groundwater pressure, by allowing the groundwater to enter the tank through these valves.</p> | | <p>There is a chance of groundwater contamination in case of malfunctioning of the non-return valve. This was not acceptable from an operation point of view.</p> |

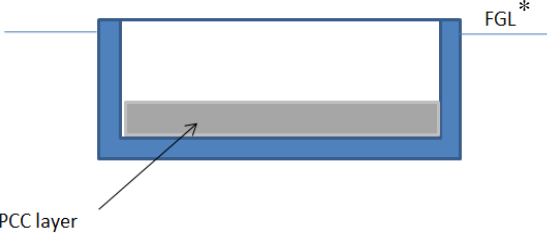
| Option 4 | <p><b>DEAD WEIGHT:</b></p> <p>Provision of dead weight in terms of 1.2 m thick layer of plain cement concrete (PCC) on top of the foundation raft inside the tank. This would increase the dead weight of the tank and would counterbalance the uplifting due to groundwater pressure.</p> | | <p>Provision of PCC would also reduce the volume and ultimate capacity of the tank which was not acceptable from an operation point of view. Very high cost involved in this option.</p> |

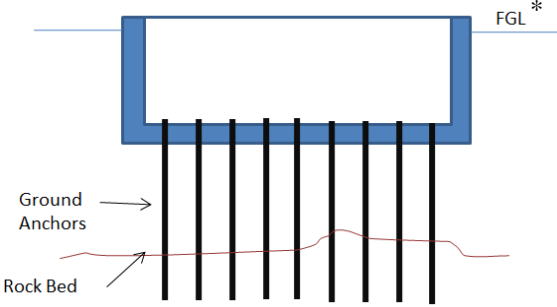
| Option 5 | <p><b>GROUND ANCHORS:</b></p> <p>Provision of ground anchors to hold the tank against uplifting.</p> | | <p>During execution of ground anchors from inside the tank, dewatering of tank is required and has a risk of tank uplifting and cracking after dewatering. Else the groundwater level has to be temporarily lowered during anchoring by means of a well point system. Very high cost involved in this option.</p> |
