# Lessons Learned from Dike Failures in Recent Decades

**ABSTRACT:** *The paper describes five different dike failures that occurred in recent decades. The case histories were located on different rivers and involved different loading conditions. The observed failure mechanisms involved erosion and stability problems. The types of erosion observed were both internal erosion due to extreme groundwater flow and external erosion caused by the river flow and wave action. The case involving instability was caused by uplift, i.e., increased hydraulic head led to a sharp reduction in maximum shear strength between subsoil layers. Two cases demonstrate the importance of dike management and maintenance. Despite the variations in the loading conditions and failure mechanisms, all the cases show that the strength of a dike depends not only on the material used to build the dike but also on the strength of the subsoil.*

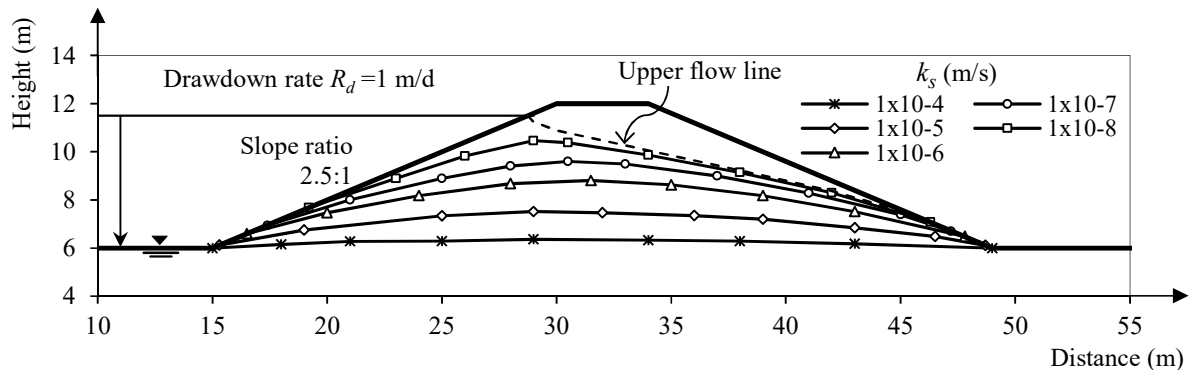
Figure 7. Phreatic surfaces (desaturation lines) at the end of the water drawdown stage in a dike with variable hydraulic conductivities  $k_s$ , (López-Acosta et al. 2015)

These analyses evaluated several homogeneous and isotropic dikes with a 2.5(H):1(V) slope and total dewatering head of 5.5 m for different hydraulic conductivities. Figure 7 shows the upper flow line for the initial steady-state condition and desaturation lines at the end of water drawdown in dikes with different hydraulic conductivities  $k_s$  for the transient-state condition and assuming a constant drawdown rate of  $R_d = 1$  m/d. As can be seen from this figure, where  $k_s = 1 \times 10^{-8}$  m/s, the desaturation line remains practically in the same position as the upper flow line, which is associated with the *fully rapid drawdown mode*. In this case, it can be assumed that the soil behaves undrained. For  $k_s = 1 \times 10^{-4}$  m/s, the desaturation line inside the dike drops down almost in line with the reservoir water level, which is associated with the *fully slow drawdown mode*. In this case, it can be assumed that the soil behaves drained. It can also be assumed that the desaturation lines between these two extreme modes represent the *transient drawdown mode* in which a curvilinear water line is generated in the soil structure, the position of which depends on the drawdown rate and the constitutive material properties. The remaining pore pressure in the dike is therefore transient, it varies as a function of time, but also with the soil's ability to retain water. Several authors have recognised the three water drawdown modes described here (examples being Lane & Griffiths, 2000 and Berilgen, 2007).

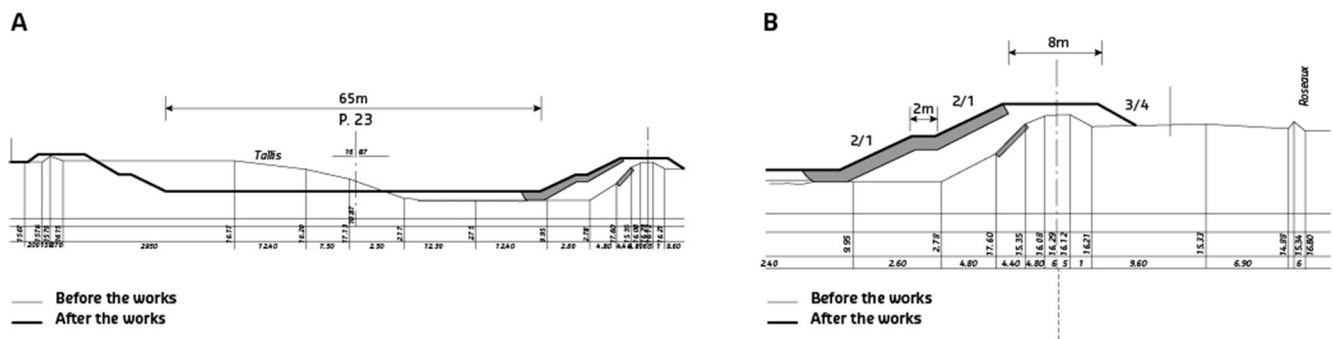
When the river was re-profiled in 1970, the bed was widened to 65-70 m. The dikes generally were constructed to an elevation of 2-3 m, 8 m wide at the crest, with 1V/2H slopes, see Figure 12 and were built using local material. Thus, the materials used vary along the dikes and may consist of loam and sandy loam or even gravel. There is riprap toe protection on the river side, and armour protection over the full height on the concave side of curved sections, as shown in Figure 12b.

Figure 12. a) Re-profiling of the river and construction of the dikes, b) armouring of the river side of the dikes in concave sections

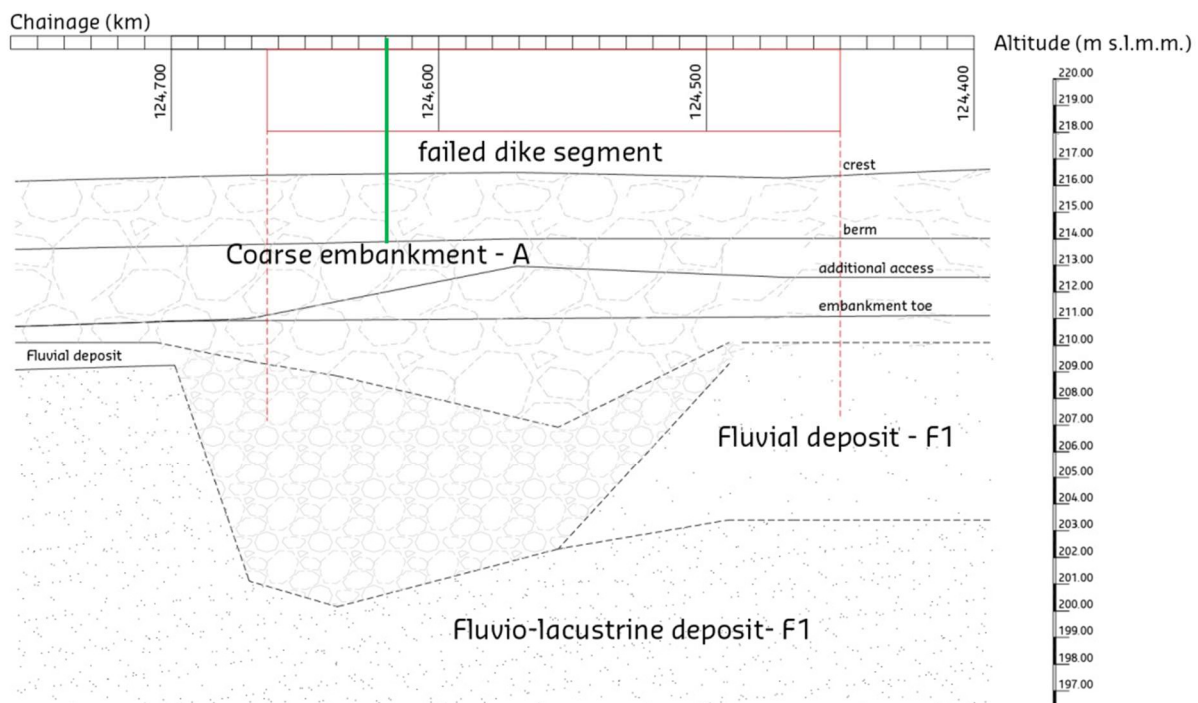
Figure 20. Longitudinal soil profile of the dike segment in Laag that includes the section breached in 1981. The location of the representative cross-section is indicated by the green line.

Figure 20 shows the longitudinal soil profile that includes the segment of the dike in Laag breached in 1981 and then reconstructed after 1981. The dip in the interface between the coarse-grained embankment and the ancient river bed is attributable to the excavation of the ancient river bed material after the dike was breached. During the flood, the embankment was patrolled frequently (a few times a day) and no evidence of sand boiling was detected. It is not possible to exclude that

sand boiling was occurring between one visual inspection and another. However, it would appear that failure was mainly caused by underseepage rather than erosion triggered by uplift pressures at the landside toe of the embankment.

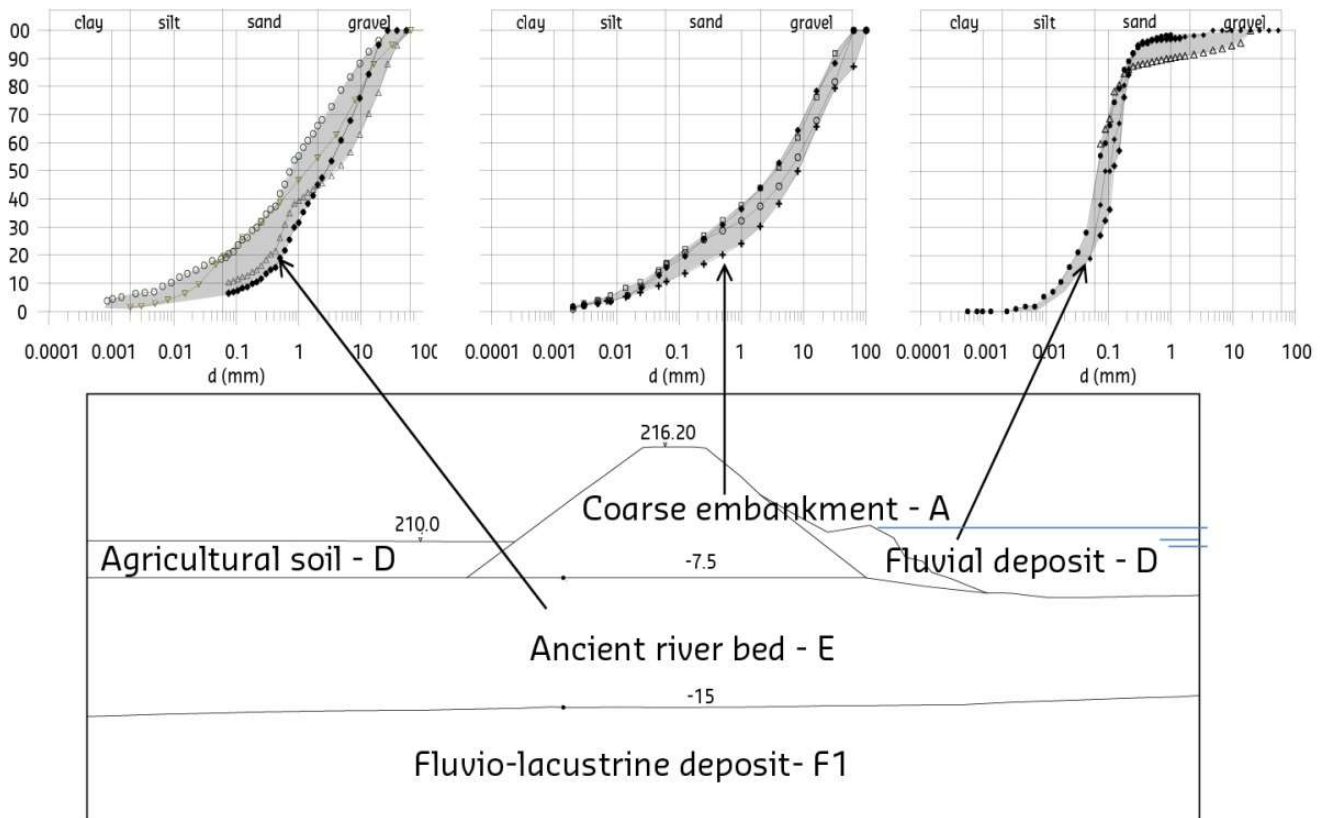
The cross-section at chainage 124.620 km was selected to analyze the hydro-mechanical response of the embankment (Figure 21). Figure 22 shows the longitudinal soil profile that includes the segment of the dike in St Florian affected by instability in 1981 (scarp of about 50 cm). The cross-section at chainage 122.248 km was selected to analyze the hydro-mechanical response of the embankment (Figure 23).

Figure 21. Soil profile for the cross-section representative of the dike segment in Laag breached in 1981 (chainage 124.620 km)

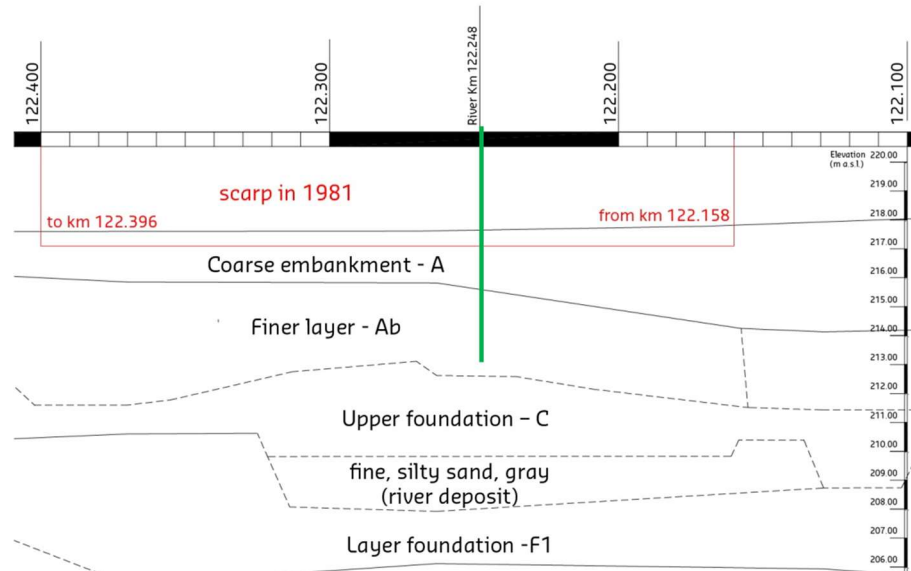
Figure 22. Longitudinal soil profile of the dike segment in St Florian that includes the portion affected by instability in 1981. The location of the representative cross-section is indicated by the green line.

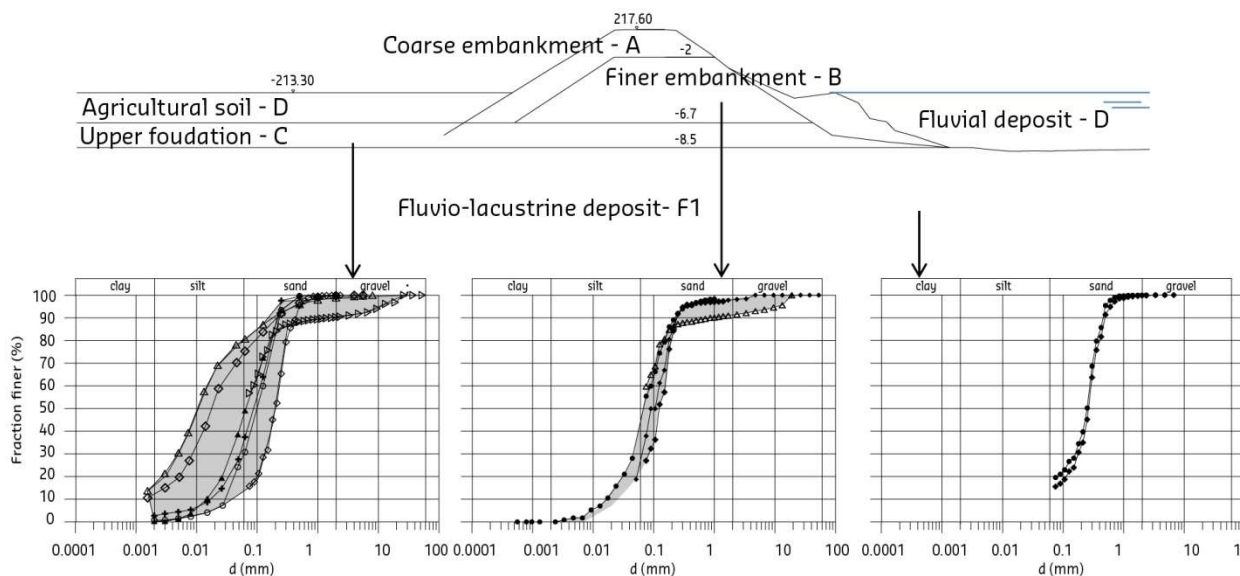
Figure 23. Soil profile for the cross-section representative of the dike segment in St Florian affected by instability in 1981 (chainage 122.248)

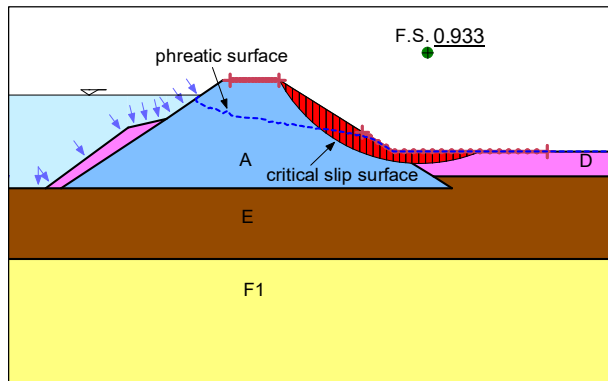
Figure 24. Stability analysis and relevant soil parameters at flood peak and transient flow condition of the section at km 124.62 in Laag;  $c' = 0 \text{ kN/m}^2$

where  $\sigma_n$  is the normal stress,  $\theta_w$  is the volumetric water content,  $\theta_s$  is the saturated volumetric water content and  $\theta_r$  is the residual volumetric water content. The results of the stability analyses at flood peak for the two cross-sections based on transient flow conditions are shown in Figures 24 and 25. The stability analysis consistently returns factors of safety  $< 1$  for these sections, which proved to be unstable in 1981.

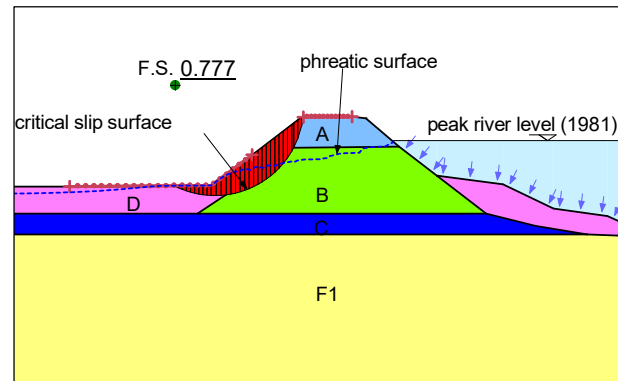
Figure 25. Stability analysis and relevant soil parameters at flood peak and transient flow conditions of the section at km 122.248 in St. Florian;  $c' = 0 \text{ kN/m}^2$ .

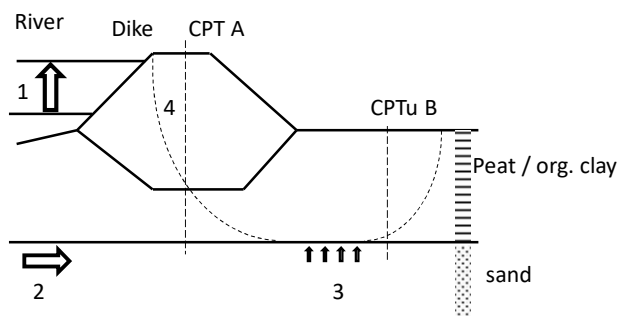
A typical failure mechanism for dikes in this area is loss of stability due to uplift of the soft soil layers at the toe. Figure 28 explains the failure mechanism. There is a hydraulic connection between the river and the Pleistocene sand layer. A rise in the river level (1) results in an increase in the hydraulic head in the Pleistocene sand layers (2) until the pore pressure equals the weight of the Holocene layers on top (3). The shear strength at the transition between the Holocene clay and peat layers on the one hand and the Pleistocene sand deposit on the other is drastically reduced, creating the conditions for a long, deep, slip plane (4). The uplift phenomenon is described in further detail by Cooling & Marsland (1953), Marsland (1961), Bauduin et al. (1989) and Van (2001). Observations of stability loss due to uplift are scarce and it was decided to study the uplift phenomenon at the Bergambacht test site.

Figure 28. Impression of the uplift failure mechanism, 1: river level rise, 2: hydraulic connection to sand layer, 3: pore pressure rise until uplift top layer, 4: failure plane.

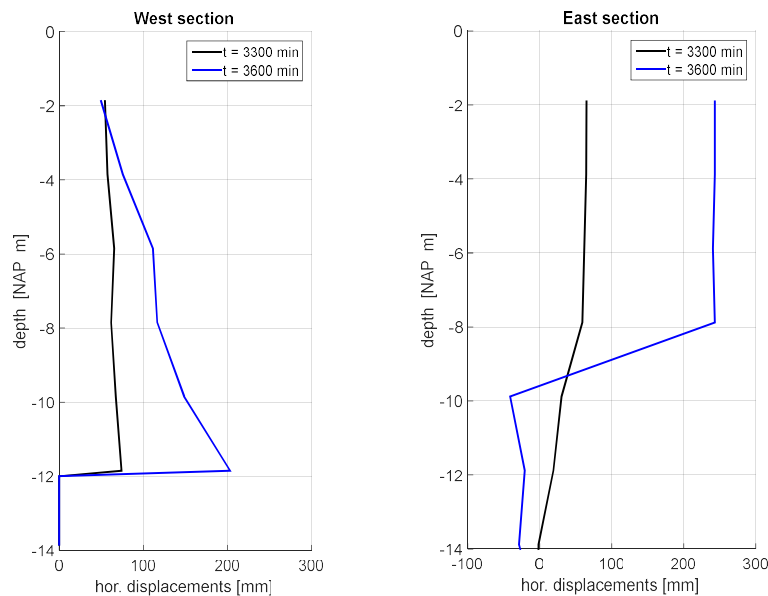
Figure 33 shows the horizontal displacements measured at the toe in the eastern and western sections at  $t = 3300$  min (55 h) and  $t = 3600$  min (60 hours). Note that there was no inclinometer in the central section. The maximum displacement was found at the transition between the Pleistocene and Holocene layers, which was not at the same depth in both sections. Figure 34 shows the development of the maximum displacement for both sections. In the western section, horizontal displacements started to develop as soon as infiltration began. At approximately  $t = 1500$  min, infiltration was suspended temporarily and no further deformation was observed until  $t = 2500$  min, when infiltration resumed. Soon after, horizontal displacement developed in the eastern section as well. Infiltration was suspended for a second time, and horizontal displacement stopped again. Soon after infiltration resumed, displacement accelerated until the dike failed at  $t = 3450$  min (57.5 hours) after the start of the test.

Figure 33. Horizontal displacement at the toe (both polder-side west respectively east of the central section as shown in Figure 27a)

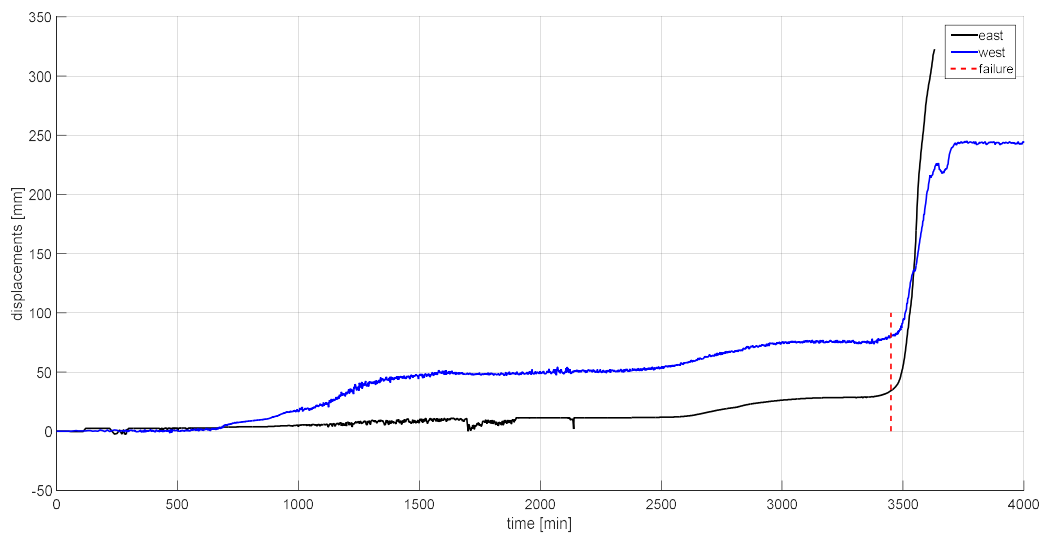
Figure 34. Development of maximum horizontal displacement during the test

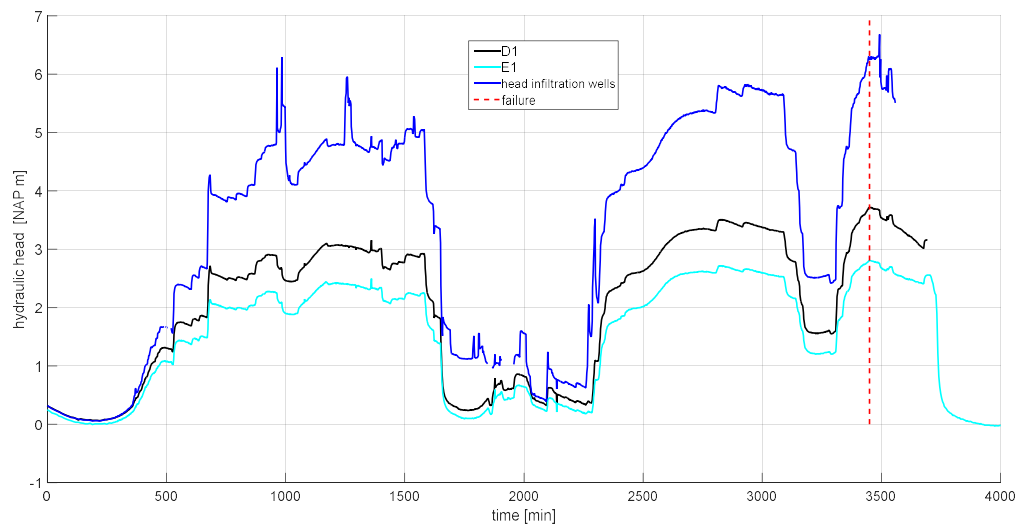
Figure 35. Hydraulic head in Pleistocene sand layer, locations D1 and E1 (see Figure 29)

Figure 35 shows the hydraulic head observed in the Pleistocene sand layer at distances of 21 and 42 m from the infiltration wells. The effect of infiltration declined with increasing distance from the well; the hydraulic head at D1 was lower than in the infiltration wells and a further reduction in maximum head was observed in E1.

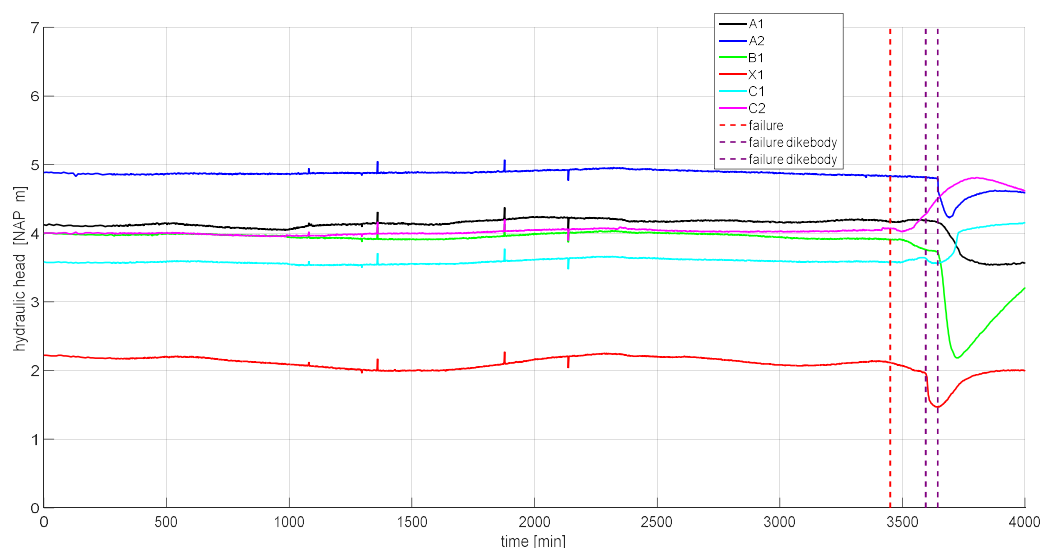
Figure 36 shows how hydraulic head developed inside the dike body. Prior to failure there was no significant fluctuation in hydraulic head. The range in hydraulic heads measured by the different transducers can probably be explained by suction forces at the top of the dike. With the exception of C2, there was a sharp drop indicating failure. Close inspection shows that, inside the dike body, the response to failure was later than given by the observed horizontal displacement at the toe,  $t = 3450$  min at which only the pore pressure at location C2 shows a response. There was a minor initial response at B1 and C1 shortly after  $t = 3450$  min. The sharp drop in hydraulic head was observed later. The drop at X1 and C1 was observed at  $t = 3595$  min, or 145 min (2.4 hours) later. At  $t = 3644$  min (50 minutes later) the hydraulic head at B1 and A2 dropped significantly. The time differences for local failure found at different locations shows the propagation of the failure plane, starting deep in the subsoil and moving towards the crest. It should be noted that the development of the failure plane resulted in breakage of the infiltration wells. When infiltration ceased, the uplift conditions were no longer in place and sliding along the slip plane as indicated by Figure 28 stopped.

Figure 36. Hydraulic head in the dike body for locations A1 to C2 (see Figure 29)

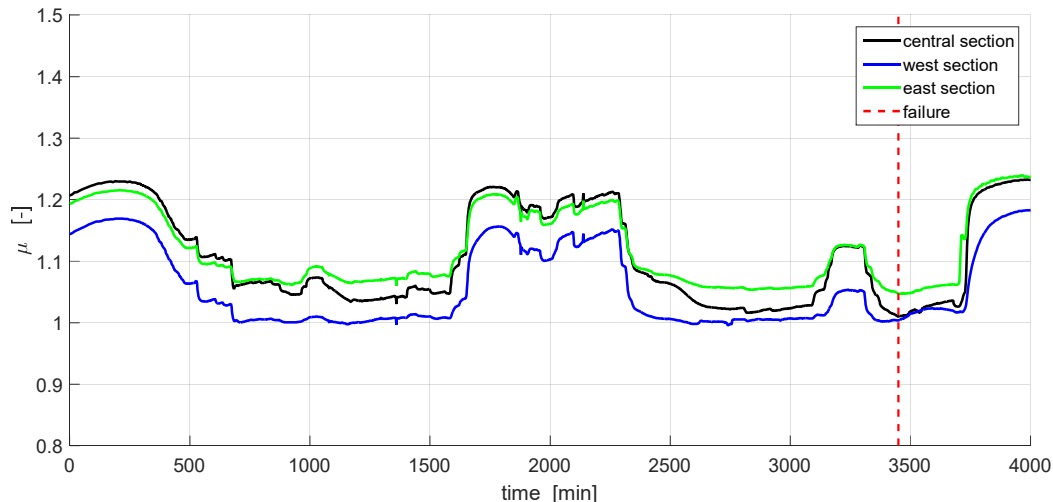
Figure 37. Ratio of total overburden pressure to pore pressure,  $\mu$ , during the test

To check on the uplift conditions during the test, the ratio,  $\mu$ , of the weight of the Holocene layer to pore pressure in the Pleistocene sand layer was determined for each of the transducers in the Pleistocene sand layer. Figure 37 shows the ratio,  $\mu$ , during the test for the transducers placed at 46 m from the crest of the dike in the central, eastern and western sections. Initially,  $\mu = 1.2$ . When infiltration began, this value reduced, as expected. Due to differences in the subsoil layer,  $\mu$  varied for the different sections, with the lowest value in the western section, where the value remained approximately 1. In the central and eastern sections,  $\mu$  seemed to reduce slightly during the test. This corresponds to the slight increase in infiltration pressure during the test, as shown in Figure 35. The value did not drop significantly below 1.0. This could be explained by the pumping capacity, which does not allow for any further increase in pore pressure in the sand layer at the toe of the dike. It can also be hypothesized that when the pore pressure in the sand layer starts to exceed the weight of the clay and peat layers above it, a gap is created which is filled with pore water from the sand layer until a new equilibrium is attained. When pumping capacity is further increased, the gap may be widened, maintaining the equilibrium in vertical forces. In this hypothesis,  $\mu = 1.0$  could be a physical boundary that will have prevented any further decline in the  $\mu$  value in the western section during the test. It should be noted that, at larger distances from the dike, the Pleistocene hydraulic head decreased, causing an increase in  $\mu$ . Close to the dike,  $\mu$  is affected by the weight of the dike body.

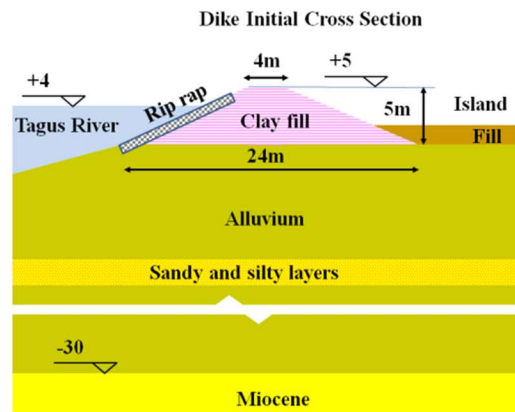
Given the location of the island in the Tagus River delta, one of the widest estuaries in Europe, the geological scenario is very complex: alluvium deposits, mainly very soft clays, with  $S_u$  not greater than 20 kPa, sometimes interbedded with silty and sandy layers, with an overall depth of approximately 30 m (Figure 39). The alluvium rests on the bedrock of Miocene sandstone.

The main failure mechanism is related to the erosion of the clay fill due to water inflow and the mechanical action of the waves on the outer face of the dike. Failure originated with the erosion of the riprap revetment (Figure 39). The presence of a permeable sandy layer below the dike foundations also contributed to the failure mechanism. The actual dike failure began during the severe winter of 2015 - 2016 and involved a section with an overall length of approximately 30 m. When the failure occurred, the water level in the Tagus River was approximately Mean Sea Level, MSL, +4.20 m. In October 2016, the overall length of the dike failure line had increased to approximately 80 m.

Figure 39. Initial dike cross-section and geotechnical profile.
