# Reconnaissance of the New Orleans Hurricane and Storm Damage Risk Reduction System after Hurricane Gustav

**ABSTRACT:** On October 2 and 3, 2008, a group of civil engineers sponsored by the National Science Foundation (NSF) and organized by the Geoengineering Extreme Events Reconnaissance (GEER) Association, visited the New Orleans area to assess levee performance during hurricane Gustav. This paper summarizes the team's observations and understanding of the state of the New Orleans Hurricane and Storm Damage Risk Reduction System (HSDRRS) in the fall of 2008 and the performance of elements of the HSDRRS during Hurricane Gustav. The fundamental conclusion was that the HSDRRS performed well under the surge and wave stresses generated by Gustav. The team's observations led to lessons about dangers to floodwalls from boats and barges, the importance of timely preparation for hurricanes, erosion resistance of clay levees, and the need for continued emphasis on evacuation for life protection.

Reference: Wooten R. L., Gilbert R. B., Marcuson, III W. F., Harder, Jr. L. F., and Nicholson P. G. (2020).

Reconnaissance of the New Orleans Hurricane and Storm Damage Risk Reduction System a

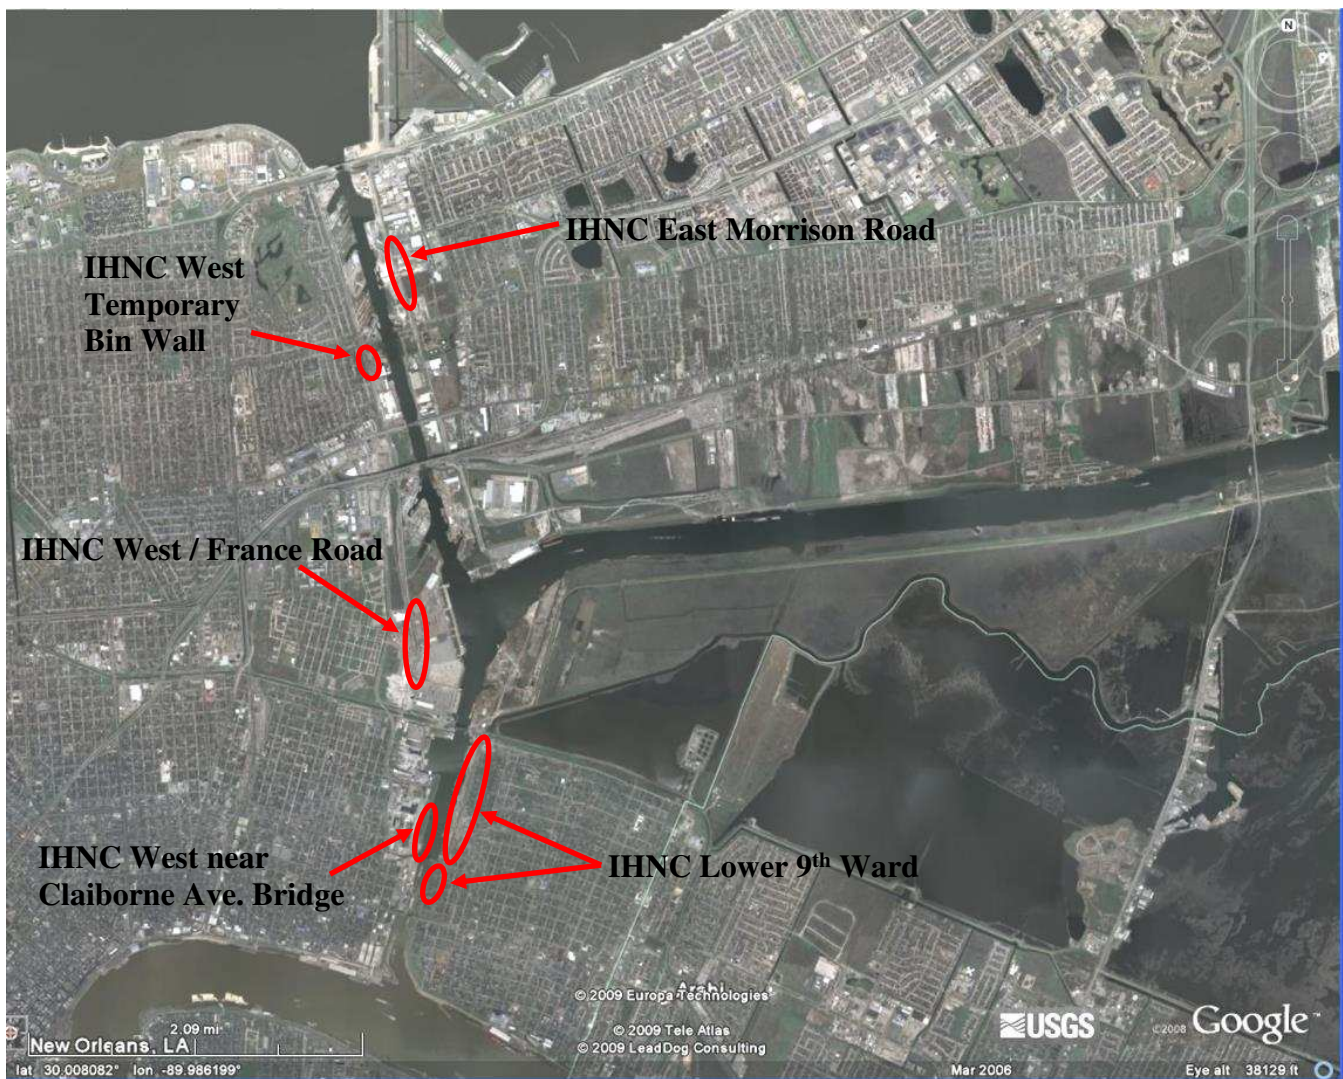
The storm surge from Hurricane Gustav in the metro New Orleans area was most dramatic along the IHNC, where several previous floodwall and levee failures resulted in catastrophic damage during Hurricane Katrina. Waves from Gustav overtopped the floodwalls at some locations along the western side of the IHNC. Figure 15 shows the locations of our reconnaissance along the IHNC.

Figure 15. Areas of reconnaissance along IHNC. (Google Earth Image)

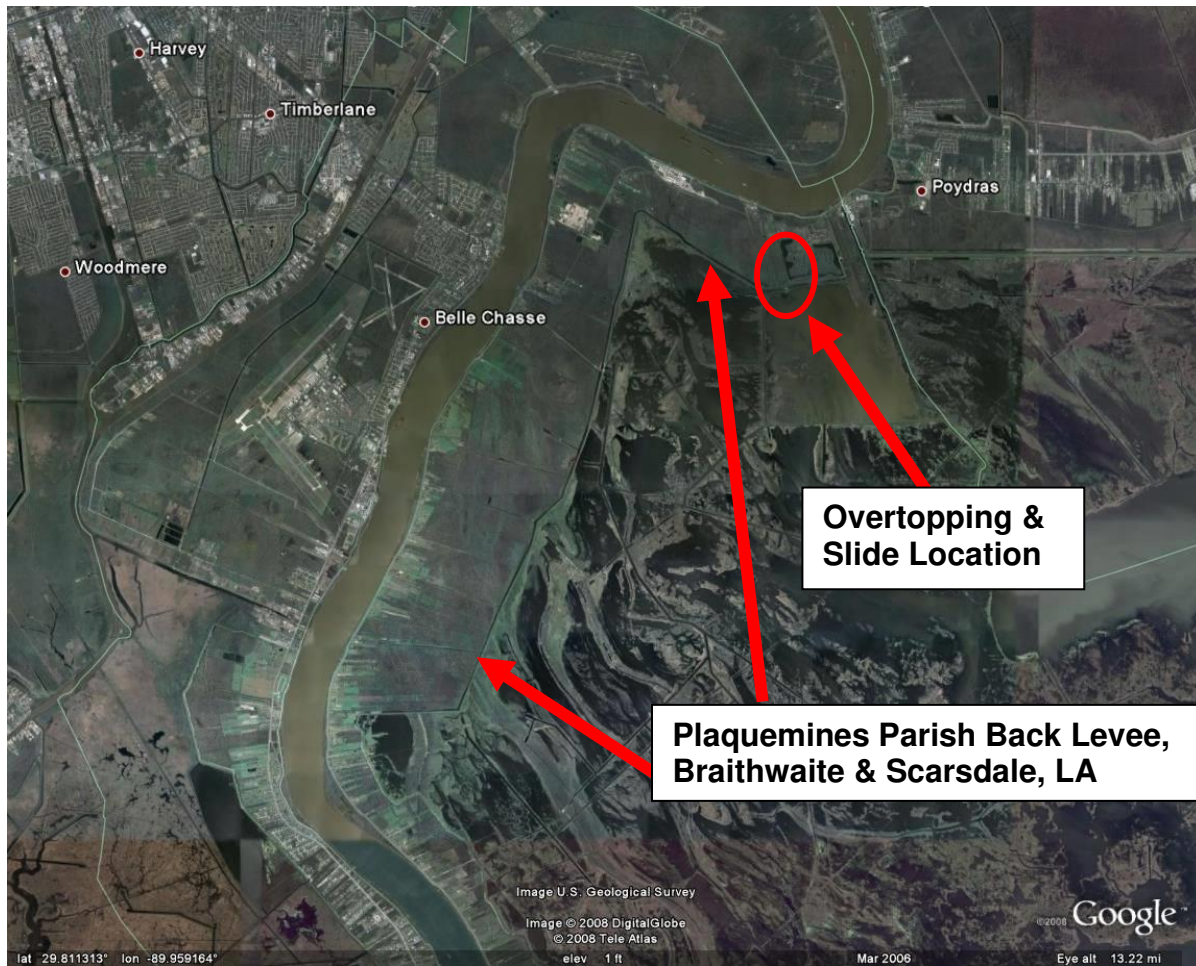
At the time of our visit, multiple sections of the levee crest were still covered with a slit-film woven geotextile, held in place with a continuous sand bag berm on the flood side and by intermittent sand bags on the protected side of the crest. Based on our observations and on interviews with a pump station operator, it appears that much of the back levee was overtopped and that a slope slide or slough had occurred on the protected side of the levee along one ~90-m- (~300-ft-) long levee section as shown in Figure 35. Figure 36 shows a part of the scarp for that slough. The team also observed that desiccation cracks were prevalent along parts of the levee. The desiccation cracks may have contributed to the slide by allowing overtopping water pressures into embankment zones critical to slope stability. The placement water content, compaction, and organic content of the back-levee soils were not known and may be factors in the susceptibility of the levee soils to desiccation cracks and erosion.

Along more southerly sections of the levee, the team observed signs of overtopping with less dramatic effects. Debris from overtopping and erosion gullies, often covered with sand bags, was prevalent along all sections of the levee.

Figure 34. Plaquemines Parish back levee near Braithwaite and Scarsdale, LA. (Google Earth / USGS Imagery)
