# Images Collected from the Internet Reveal the Failing Mechanism of the Tailing Dam Breach at Kolontar, Hungary

**ABSTRACT:** The failure of the red sludge tailing dam at Kolontar in 2010 was the most severe environmental disaster in the history of Hungary. The official investigations are confidential because the legal case has not been closed. The publicly accessible information from the breach of the dam are the photographs taken by the media and news agencies. Collecting these images and analyzing the recorded fractures and displacements of the dam reveal the failing mechanism. The breach of the dam resulted from failing to sliding, which had been developed in three stages. This conclusion is consistent with the observed movements of the dam deduced from a persistent scattered radar interferometry deformation analysis conducted between 2003 and 2010.

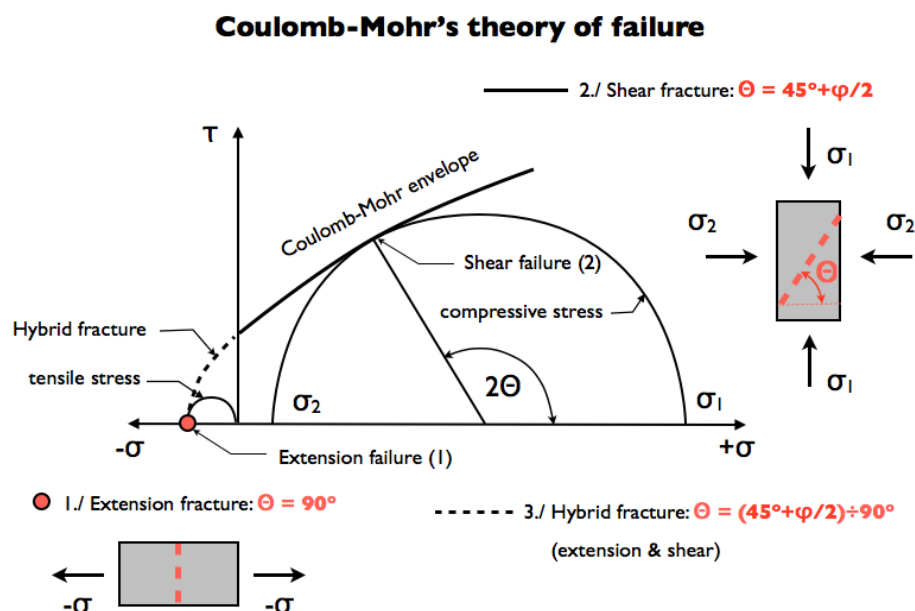
**Figure 4.** The two types of fractures are extension and shear. The dashed line shows the area where hybrid fractures occur, resulting from the transformation from extension to shear failure (Ramsey & Chester, 2004). The angles of the failed surface or fractures are given in relation to the principal stresses for the different failures.

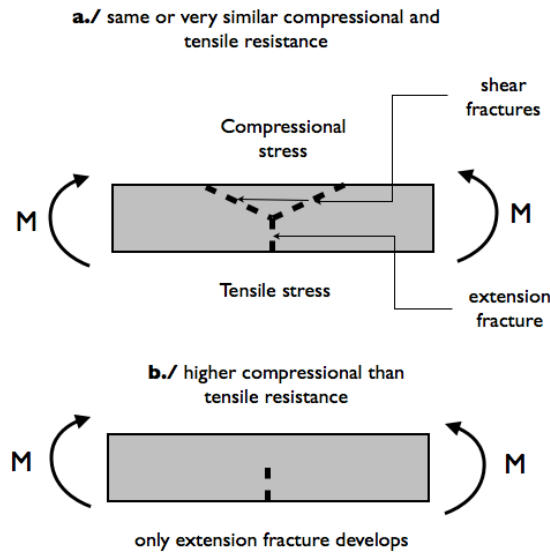
**Figure 5.** The fracture pattern of pure bending is shown. The tensile and compression stresses are on the opposite sides of the beam, developing extension and shear fracture respectively: (a) If the compression and tensile resistances of the substance are the same or similar to each other, then both shear and extension fractures are developing; (b) If the compression resistance of the substance is higher than the tensile resistance, then primarily extension fracture develops.

If the tensile strength of the substance is weaker than the compression, like rocks and concrete, then the tensile resistance of the substance is first exhausted and extension fracture develops (Figure 5b). If the bending is accompanied with shear stress, like a beam loaded in the middle, then a hybrid fracture pattern should develop (Melvin, 1993), as shown in Figure 6.

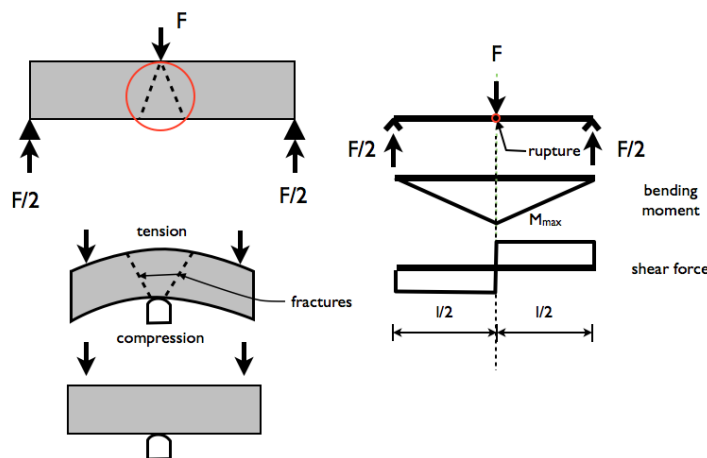
**Figure 6.** Combined extension and shear stress occurs in a beam when the load acts in the middle. This “bending force” produces hybrid fractures, resulting in a triangular or trapezoidal fracture shape (Melvin, 1993).
