# Leaning Tower of Pisa: Behaviour after Stabilization Operations

**ABSTRACT:** It is well known that the foundations of the Leaning Tower of Pisa were stabilised using the method of underexcavation to reduce the southward inclination of the Tower by about 10 percent in combination with controlling the seasonally fluctuating water table beneath the north side. Having been closed to the public since early in 1990, the Tower was re-opened in December 2001. The paper summarises the response of the Tower during the period of implementation of the stabilisation works. Monitoring of the movements of the Tower has been continuing and the observations obtained since 2001 are presented. It is shown that over the six years between 2003 and 2008 the induced rate of northward rotation of the Tower has been steadily reducing to less than 0.2 arc seconds per year. Similarly the rate of induced settlement of the centre of the foundation has been steadily reducing and is approaching the background rate of settlement of the Piazza. Piezometer measurements close to the north side of the foundation shows that the drainage system has been successful in stabilising the groundwater levels beneath the n

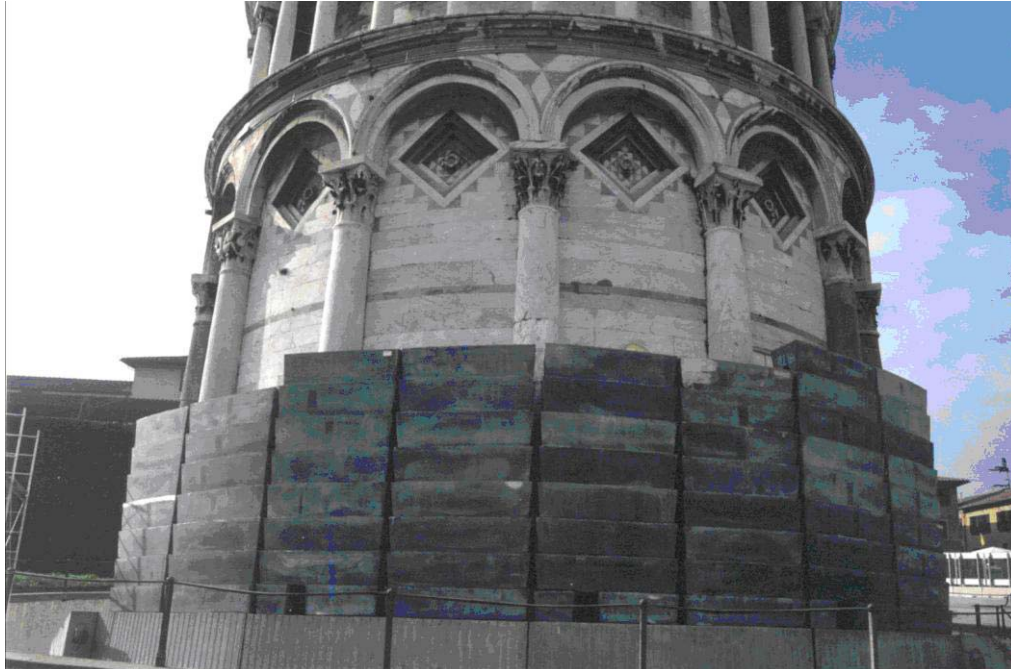
*Figure 7. Lead counterweight on the North Side.*

Temporary stabilisation of the foundation was achieved during the second half of 1993 by the application of 600t of lead weights on the north side of the foundations via a post-tensioned removable concrete ring cast around the base of the Tower at plinth level, see Fig. 7. This caused a reduction in inclination of about one minute of arc and, more importantly, reduced the overturning moment by about ten percent. In September 1995 the load was increased to 900t in order to control the accelerating southward movements of the Tower during an unsuccessful attempt to replace the unsightly lead weights with temporary ground anchors. This difficult period during the Committee's activity has been called "Black September" and is referred to in Fig.16.

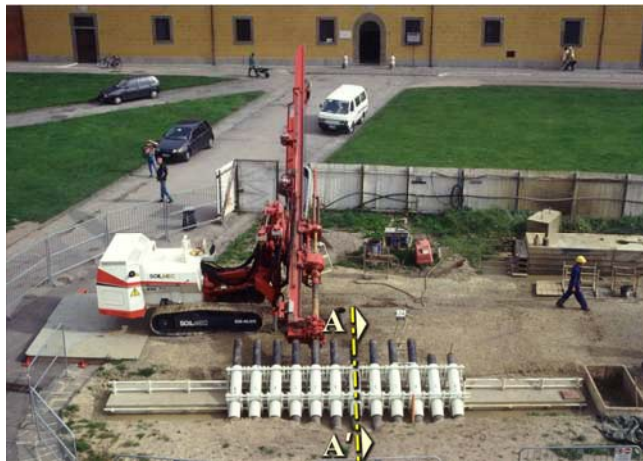
### Preliminary underexcavation Extraction hole - Section A-A'

Figure 9. Holes for preliminary underexcavation.

In August 1998 the Committee agreed to carry out limited soil extraction from beneath the Tower with a view to observing its response. This preliminary underexcavation was to be carried out over a limited width of 6m north of the Tower using twelve bore holes lined with 219mm diameter casings (Fig. 9). On 9th February 1999, in an atmosphere of great tension, the first soil extraction took place. The Tower slowly began to rotate northwards. When the northward rotation had reached about 80 arc seconds by early June 1999 the preliminary soil extraction was stopped. Northward rotation continued at a decreasing rate until October 1999.
