# Reclamation and Safety of High Cantilever Strong Box Pipe Pile Seawall in Marine Clay

**ABSTRACT:** A high cantilever seawall was constructed in soft clay of 15 m to 32 m thickness and the enclosed water between the shoreline and the seawall was reclaimed. The area was 7 hectare and the reclamation height ranged from 10 m to 20 m. The reclamation methods were controlled and not intended to cause additional incremental deflection to the already high design deflection of -385 mm or 0.89% of H ( $H = 44$  m is defined as rotating and not cantilever height). However the different methods of reclamation had a significant influence on the slurry clay flows and thus caused additional incremental deflection. The slurry clay flows pushed the deflection of seawall to an additional maximum magnitude of -353 mm or 0.80% of H. The maximum seawall deflection of -526 mm or 1.20% of H was based on inclinometer IW1903 readings. At such high seawall movement, the inclinometer deflection profiles indicate safety in the design and the long term deflection is stable. This reclamation experience indicates that it is difficult to control slurry clay flows in future high reclamation filling of 10 m to

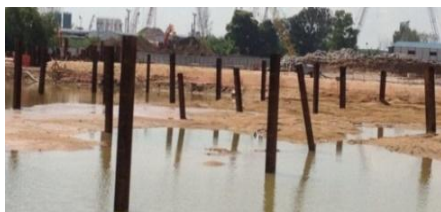
Pond A  
Controlled filling layout with kingposts in progression of 0.5 m thick sand layer at every 10 m x 10 m grid.

Figure 12. Photograph showing controlled filling method C for stage 3 reclamation.

Reclamation by controlled filling method C for filling into ponds B, A and C is shown in Figure 12. This control filling of 0.5 m thickness with Grade A material was enforced for the clay slurry ponds A, B and C. For pond A, a grid pattern of 10 m x 10 m was set up for the filling that was carried out in progression. At each step of progression, the fill thickness was

not exceeding 0.5 m. Even with such stringent control filling, some of the kingposts were noted to tilt. The method of reclamation was extremely slow and may cause clay squeezing of thickness less than 0.5 m. Similar layering reclamation filling in 0.5 m thickness was carried out for ponds B and C.

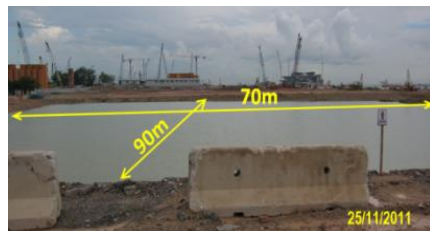
(a) Photograph of pond A (90 m x 70 m x 5.5 m) with slurry clay heaved from RL94.5 m to RL100 m.

The clay slurry ponds B and C were observed on 25 Nov 2011 as shown in Figure 13, when the clay slurry was pushed sideways and upward to the pond water level RL102.0 m. Pond A was still submerged in water and the clay slurry thickness was determined by chain sounding.

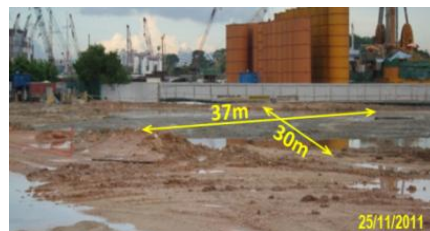
(c) Photograph of pond C. (37 m x 30 m x 7.5 m) with slurry clay heaved from RL94.5 m to RL102 m.

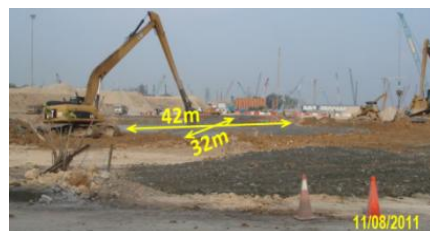
(d) Photograph of pond D (42 m x 32 m x 5.5 m) with slurry clay heaved from RL96.5 m to RL102 m.
