# Geotechnical and Structural Challenges over an Active Landslide

**ABSTRACT:** The construction of the steel arched Tsakona Bridge, designed to overpass an active landslide, required several temporary projects. Auxiliary steel towers were used for the erection and welding of the arch segments. Most of them had to be founded in the body of the sliding mass. An automated instrumentation and monitoring system was installed on site providing early warning to the engineers in charge in case large displacements were measured. The real-time recording data provided valuable information about the landslide movements. These monitoring results defined the geotechnical and structural design criteria for the deep foundation of the temporary towers. Several 2D and 3D geotechnical and structural models were created to evaluate the sliding effect on the foundation components, finalize their dimensioning and calculate the required reinforcement. The procedure followed for the design of the temporary deep foundation is described based on the criteria devised using the monitoring system, emphasizing on the continuous feedback between the geotechnical and structural design teams. Several key structu

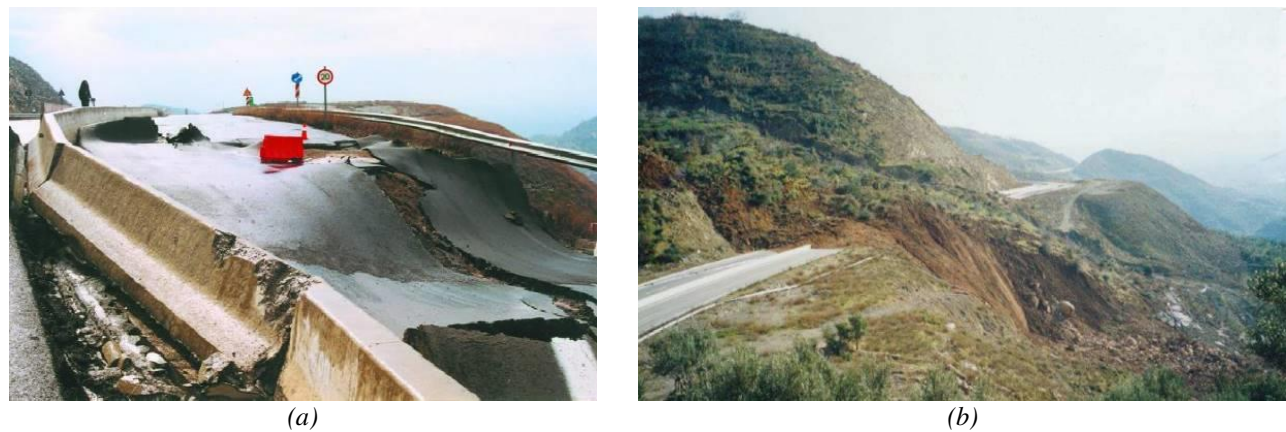
Figure 1. The Tsakona landslide (February 2003) (EMEK S.A (2015)) (a) large settlements on the road pavement (b) massive soil movement (Fikiris et al. (2001)).

The highway to the city of Kalamata in southern Peloponnese crossed through an old landslide, which was reactivated in January 2003 after a period of heavy rainfalls, leading to a major catastrophic slide. The triggered landslide is one of the largest that have occurred in Greece, the consequences of which are shown in Figure 1. Horizontal and vertical displacements of the sliding mass up to 100 m and 40 m, respectively, were measured, causing a soil mass movement of about 6,000,000 m<sup>3</sup> of flysch colluvia and manmade deposits, extended in a large area of 400 m upslope and 700 m downslope of the highway (Belokas 2013, Belokas and Dounias 2016). Among several options studied for the rehabilitation of the National Highway, bridging over the landslide was selected as the most cost-efficient and technically feasible solution (Fikiris et al. 2011). The steel arched Tsakona Bridge, sketched in Figure 2, was decided to be constructed over the sliding mass, which moved downslope at an average rate of about 1.5-2.0 mm/month. This rate was increasing significantly during the periods of intense rainfalls, exceeding for short periods of time the value of 30 mm/month (projected rate of movement).

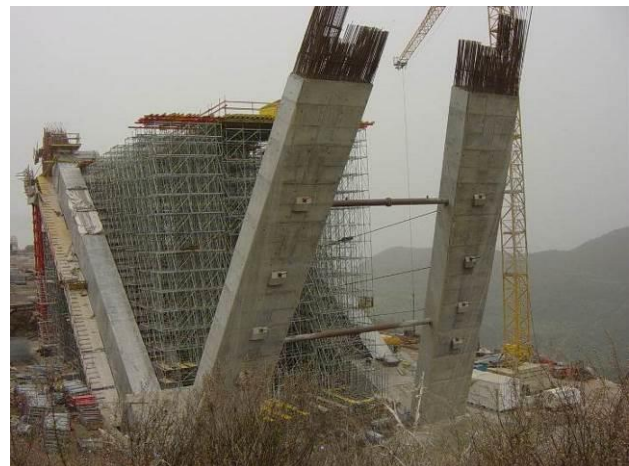
Figure 9. Construction of the (a) curved struts and (b) straight struts of the bridge pier.

The main body of the V-shaped pier consisted of two pairs of supporting struts. The southern struts were curved, following the parabolic geometry of the arch. The northern ones were designed as straight elements on the same inclined plane, converging towards each other. For the construction of the curved struts, scaffolding towers were used, anchored on slabs on the ground. For the straight struts a self-climbing formwork system was mobilized. Temporary horizontal bracings along the transverse direction kept the straight struts in place. At the same time, temporary tendons were utilized to suspend these struts from the completed curved ones, providing the necessary stability to the unfinished V-shaped pier (Figure 9). Before the construction of the curved struts, the two MT towers were installed to support their top ends. They were designed to provide bearing capacity of 12000 kN and 16500 kN each, under static and seismic load combination, respectively. Their foundation consisted of pile-groups penetrating the stable bedrock, connected with pile caps. Ground anchors were also foreseen, as mitigation measure to be activated in case large movements were observed during construction (Figure 10). A special arrangement was provided on the top of the MT towers to compensate any contingency movement within the loose soil above the bedrock as well as the elastic deformations of the auxiliary towers and the deformation due to temperature fluctuations. This arrangement included two (2) elastomeric bearings and four (4) lifting jacks for each tower. Continuous accurate surveying of the level of the bearings and vertical adjustments through the jacks were ensuring the fixed vertical position of the support during construction, until the complete functionality of the arch was achieved.

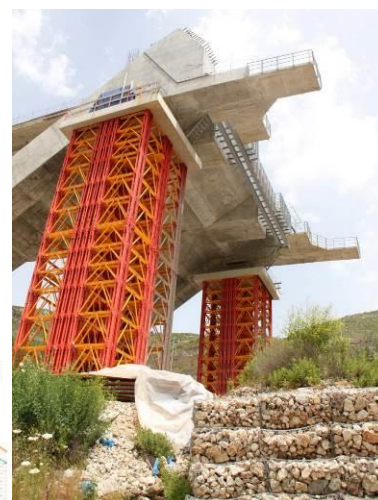
Figure 10. Arrangement of the MT towers beneath the curved struts of the bridge pier.

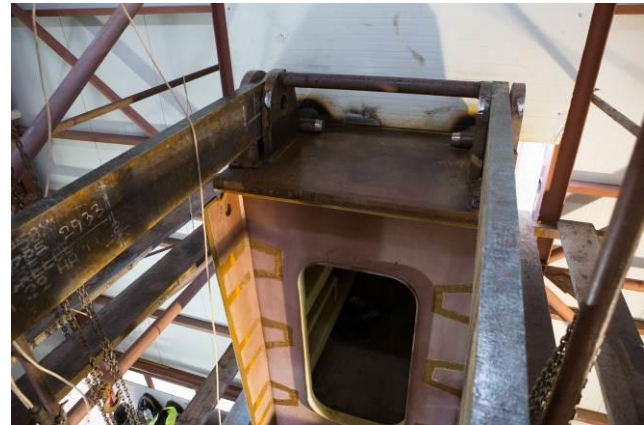
Figure 13. Connection arrangement for fixing the crown gap between the arch parts to weld the key segment (a) drawing (b) implementation.

The length of the crown gap changed during a 24 hours cycle up to 4 cm, because of the high temperature differences, rendering difficult the welding of the key segment. The gap was fixed to a firm distance to allow the welding of the last “tailor made” piece of the arch, using steel plates and pins. Four connections were designed (Figure 13) to sustain a total tensile and compressive force between the constructed parts of the arch equal to 10000 kN, caused by a mean temperature difference of  $\pm 15^{\circ}\text{C}$ .

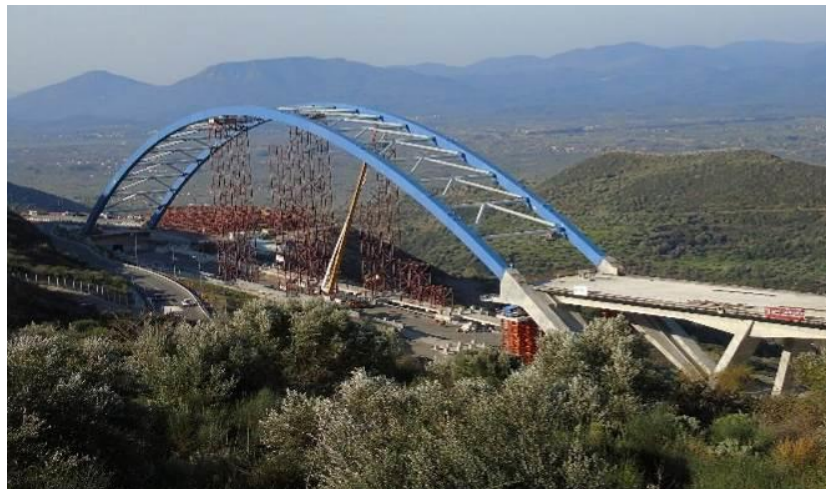
Figure 14. Removal of the temporary towers.

Other crucial issues were related with gradual removal of the arch supporting towers (Figure 14), as well as the total release of the bridge and the removal of the last supporting structure, the MT towers.

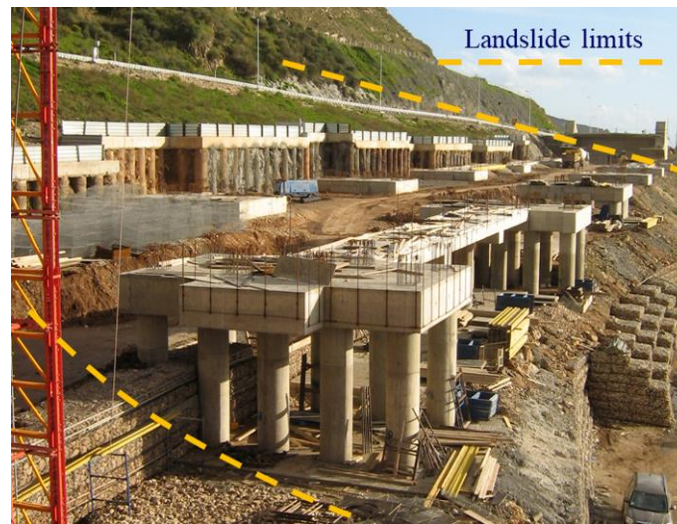
Figure 23. Assembling line of the right branch.

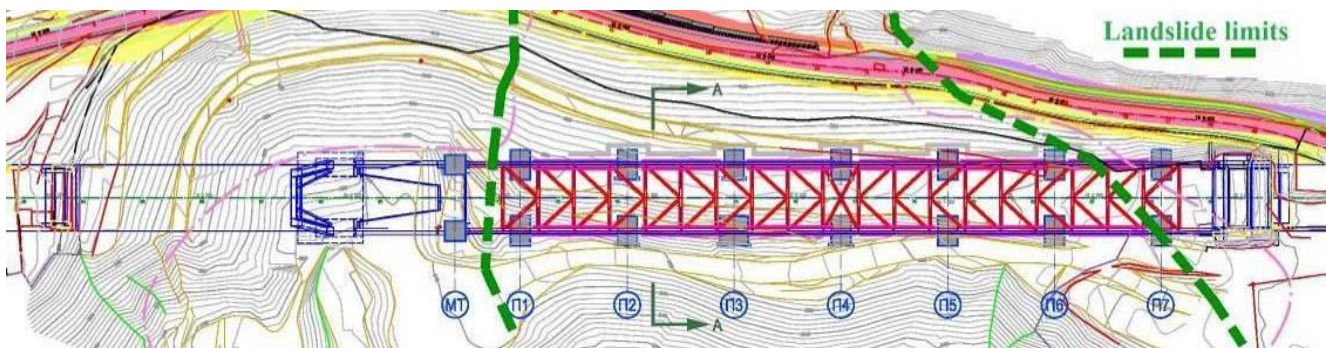
Figure 24. Location in plan view of the characteristic transverse view A-A.
