# Large Diameter TBM Tunnelling Beneath New Reclamation

**ABSTRACT:** The Tuen Mun–Chek Lap Kok Link (TMCLKL) project successfully completed a 14 m diameter slurry mix-shield tunnel boring machine (TBM) tunnelling in Alluvium, beneath a recently reclaimed land. The in situ clayey Marine Deposits and Alluvium were subject to ongoing consolidation and creep settlements as a result of reclamation loading. This posed a challenge to the design of tunnels which needed to achieve a limiting tunnel squat of 1% of tunnel diameter over an operational life of 120 years. An innovative design was conceived by installing barrettes at the tunnel springlines to reduce the tunnel squat in the long term by sustaining the soil arching load around the tunnel. This paper presents the field performance of tunnelling with respect to TBM operational parameters. Although the barrettes were intended to reduce the tunnel squat, the field measurement showed that they also reduced volume loss ratios caused by tunnelling. The measured volume loss ratios were between 1.27% and 2.07% in the seawall area without barrettes, and smaller than 0.54% in the area with barrettes. In the seawall area, post-tunnelling con

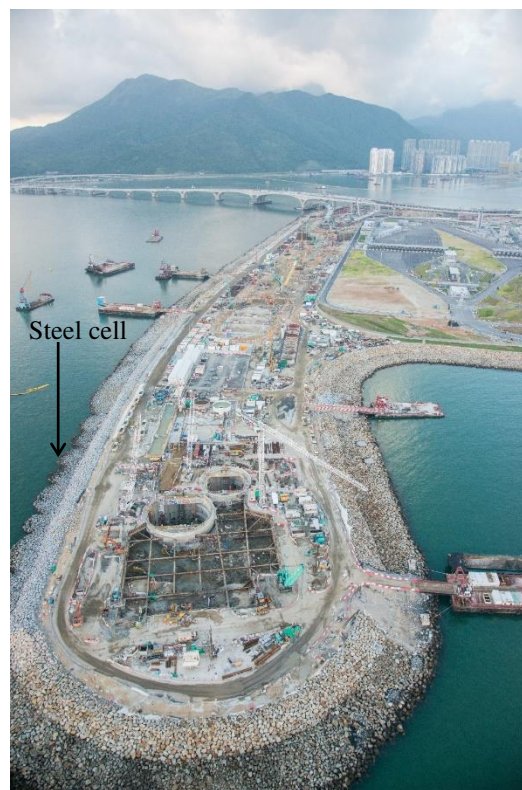
*Figure 7. Southern Landfall reclamation in July 2018.*

Figure 7 shows the SL reclamation in July 2018. The Contract required that the post-handover settlement should not exceed 500 mm for an operational life of 120 years. The SL reclamation included a seawall perimeter which comprised 31 m diameter steel cells extending through the MD and approximately 5 m into the underlying Alluvium. The steel cells were formed by interlocking sheet piles. A sloping rockfill seawall was constructed in front of the seaward side of the steel cells. Stone columns were installed within these steel cells and beneath the sloping rockfill seawall. The steel cells (see Figures 2 and 8), together with the stone columns, created an earth-retaining gravity structure that could temporarily support the reclamation loading whilst the soft clay within the seawall steel cells and beneath the reclaimed land was gaining strength.

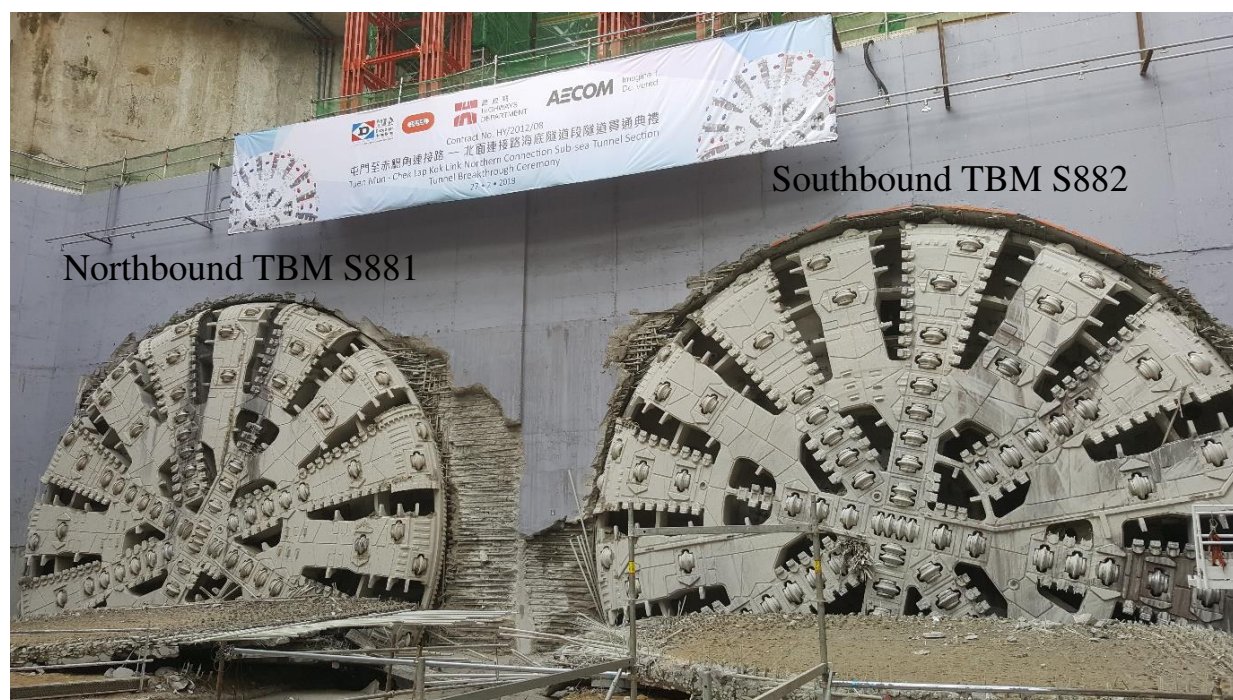
Figure 9. 14 m diameter slurry mix-shield TBMs.

Two slurry mix-shield TBMs, viz. S881 and S882, were deployed to construct the tunnels at SL (see Figure 9). Mix-shield TBMs have been designed for heterogeneous ground conditions encountering clay/sand/gravel and high water pressure up to 15 bars (<https://www.herrenknecht.com/en/products/productdetail/mixshield/>). Precise control of slurry support pressure at the tunnel face was managed by using an automatically controlled air cushion. The TBM allowed for the erection of segmental tunnel linings immediately behind the TBM shield as the permanent ground support. Chan et al. (2021b) presented other special TBM features implemented at the TMCLKL project, such as automated monitoring and replacement of 19-inch disc cutters at cutterhead, hyperbaric intervention by compressed air (up to 4.2 bars) and saturation diving (up to 6 bars), stone crushers, etc.
