# MSE Wall Behavior during Large Truck Impact at High Speed against Barrier on Top of Wall

**Reference:** Briaud J.-L., Bligh R., and Maddah L. (2024). *MSE Wall Behavior during Large Truck Impact at High Speed against Barrier on Top of Wall*. International Journal of Geoengineering Case Histories, Vol. 8, Issue 1, p.1-24. doi: 10.4417/IJGCH-08-01-01

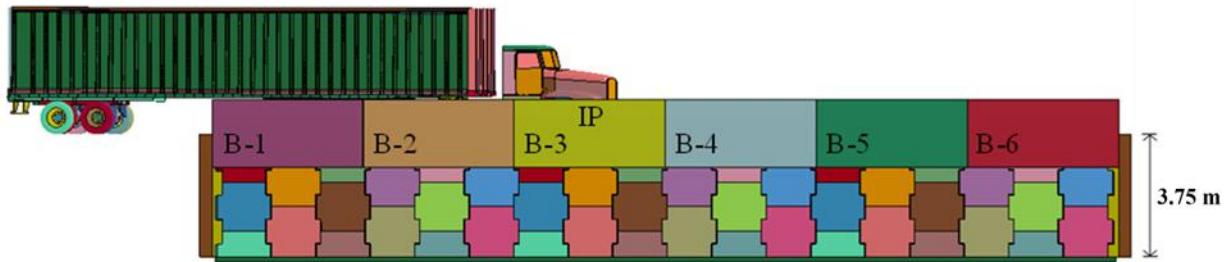
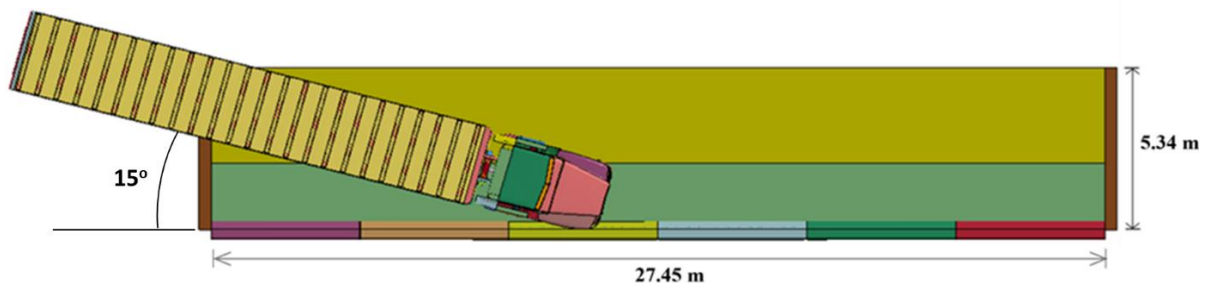
**Figure 1.** Finite element mesh for simulation of barrier-moment slab-MSE wall assembly with truck: (a) cross section of barrier-moment slab-MSE wall assembly with truck, (b) front view of the barrier-moment slab-MSE wall assembly with truck, and (c) plan view of the barrier-moment slab-MSE wall assembly with truck.

The software used for the simulations was LS-DYNA (Hallquist, 2007). The Finite Element Method (FEM) models included the tractor-trailer truck, the L shape barrier and moment slab, and the MSE wall with soil and reinforcement strips (Figure 1).

The dimensions of the model (Figure 1) were 27.45 m in length, 3.75 m in height, and 5.34 m in width. The barrier height from the pavement surface to the top of the barrier was 1.07 m and the width of the moment slab was varied but finally chosen as 2.13 m, measured from the back of the MSE wall panel to the end of the moment slab. The bottom of the moment slab was 1.02 m deep below the pavement surface, and the length of the reinforcement strips was 3.05 m. Referring to Figure 1, the boundary conditions were as follows: all boundaries were free of any constraints except for the vertical boundary at the back of the wall, at the bottom of the wall and on the side-ends of the wall.

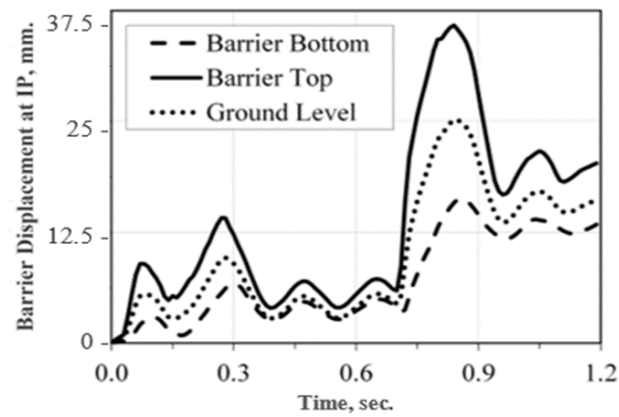
**Figure 4.** Barrier displacement during impact in FEM simulation.

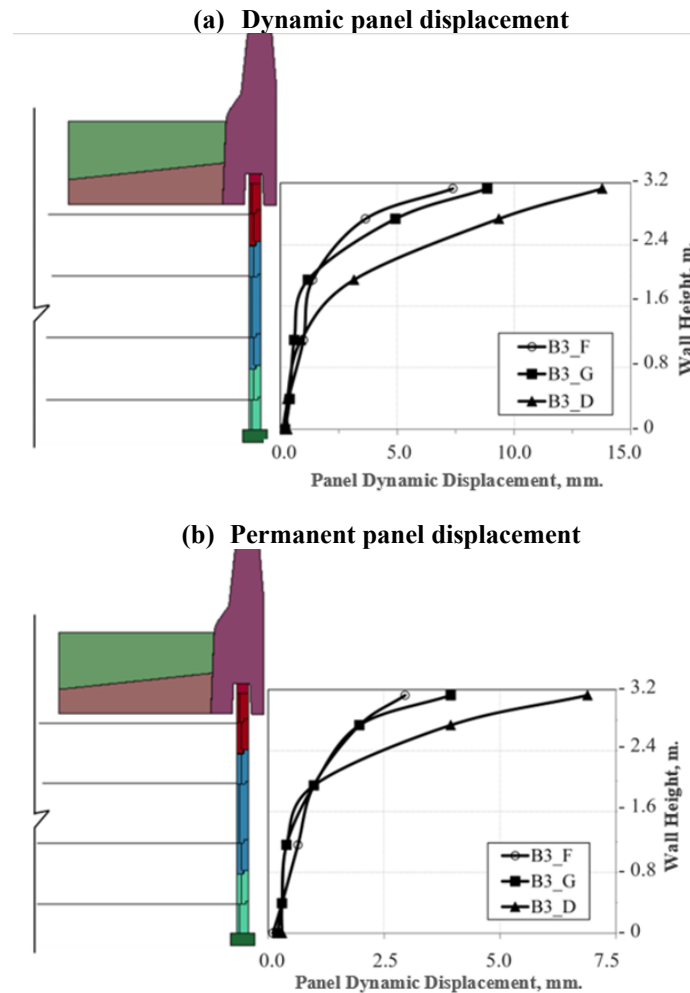
**Figure 8.** Displacement of the MSE wall panel in FEM simulation:  
(a) dynamic panel displacement, and (b) permanent panel displacement.

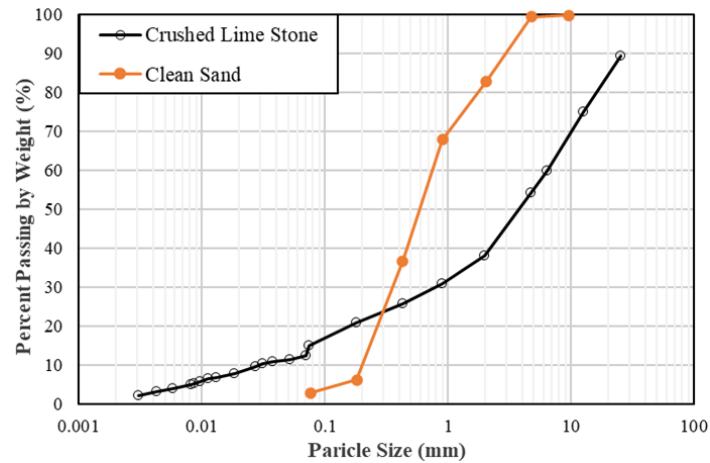
**Figure 10.** Particle size distribution curves for the clean sand and the crushed limestone rock.

The backfill consisted of two soils: the clean sand used to build the wall from the bottom of the excavation to the bottom of the moment slab (1.98 m), and the crushed limestone from the bottom of the moment slab to the pavement surface (1.02 m). The clean sand was a poorly graded sand (SP) with a  $D_{50}$  of 0.51 mm, a coefficient of uniformity of 3.85, a coefficient of curvature of 0.84, and 3.1% passing sieve No. 200 (Figure 10a). The modulus of the sand was 14.8 MPa as measured with the BCD (Briaud et al., 2006), and the direct shear test friction angle was 34 degrees. The crushed limestone rock (also called road base) was a silty gravel with a  $D_{50}$  of 4 mm, a coefficient of uniformity of 216.7, a coefficient of curvature of 3.28, and 15.0 % passing sieve No. 200 (Figure 10b). The modulus of the crushed limestone was 55.2 MPa as measured with the BCD, and a large triaxial cell test gave a friction angle of 45 degrees. The sand was compacted in 150 mm thick lifts to a dry density of 17.4 kN/m<sup>3</sup> (95% of maximum dry density) and 3.03% water content, while the crushed limestone was compacted in lifts of 250 mm to a dry density of 20.1 kN/m<sup>3</sup> (95% of maximum dry density) and 5.81% water content.

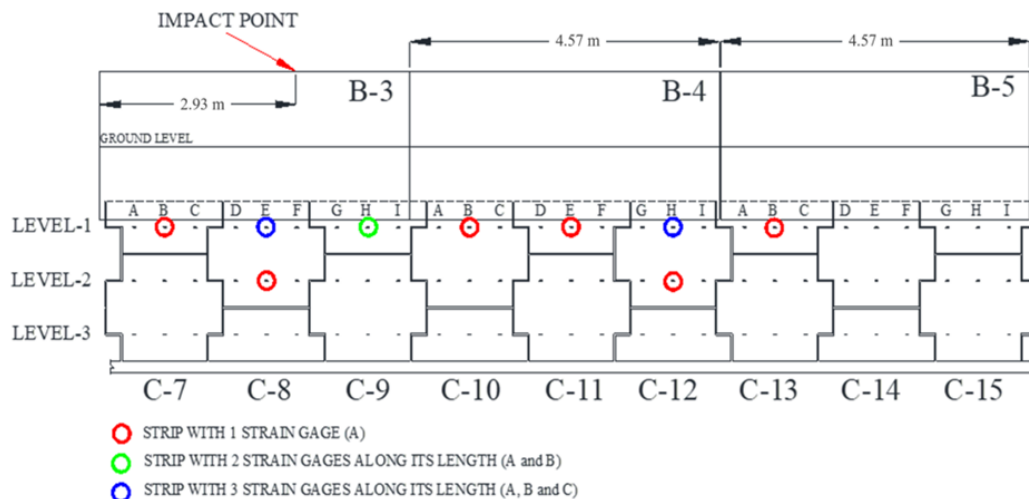
**Figure 11.** Location of the instrumented reinforcing strips.

The location of the MSE wall reinforcing strips that were instrumented is shown in Figure 11. The total load in a strip in this project is defined as the addition of the static load due to the internal stability of the wall under gravity active pressure and the dynamic load induced by the truck impact. The load in the strips was measured 0.178 m behind the strip connection to the panel, and the dynamic load vs. time is shown in Figure 13. The maximum dynamic component of the loads in the strips is listed in Table 1 and the total load in Table 2. The dynamic load in the strips was maximum near the strip-to-panel connection point. As can be seen, the measured static loads are close to those calculated by AASHTO. The sum of the dynamic load and the static load is defined as the total load in the first layer of strips; the total load reaches the calculated ultimate resistance of the strip closest to the impact.

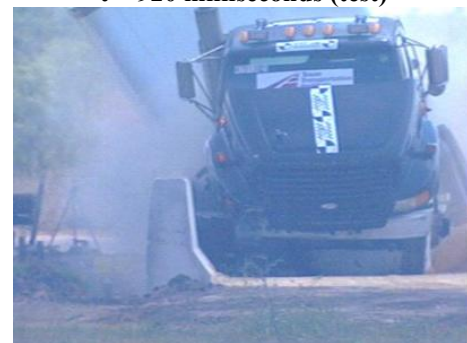
**Figure 14.** Comparison between simulation and test of sequential views of the impact.

Qualitatively, the sequential views of the impact from the simulation and the test compare well, as seen in Figure 14. Quantitatively, the acceleration results were closer for the rear axle of the trailer, which corresponds to the highest load in the impact than for the rear axle of the tractor. Indeed, for the trailer, the longitudinal and lateral accelerations were -2.7 g's and -11.6 g's for the model, and -3.4 g's and -10.8 g's for the test; for the tractor, they were -2.1 g's and -5.3 g's for the longitudinal

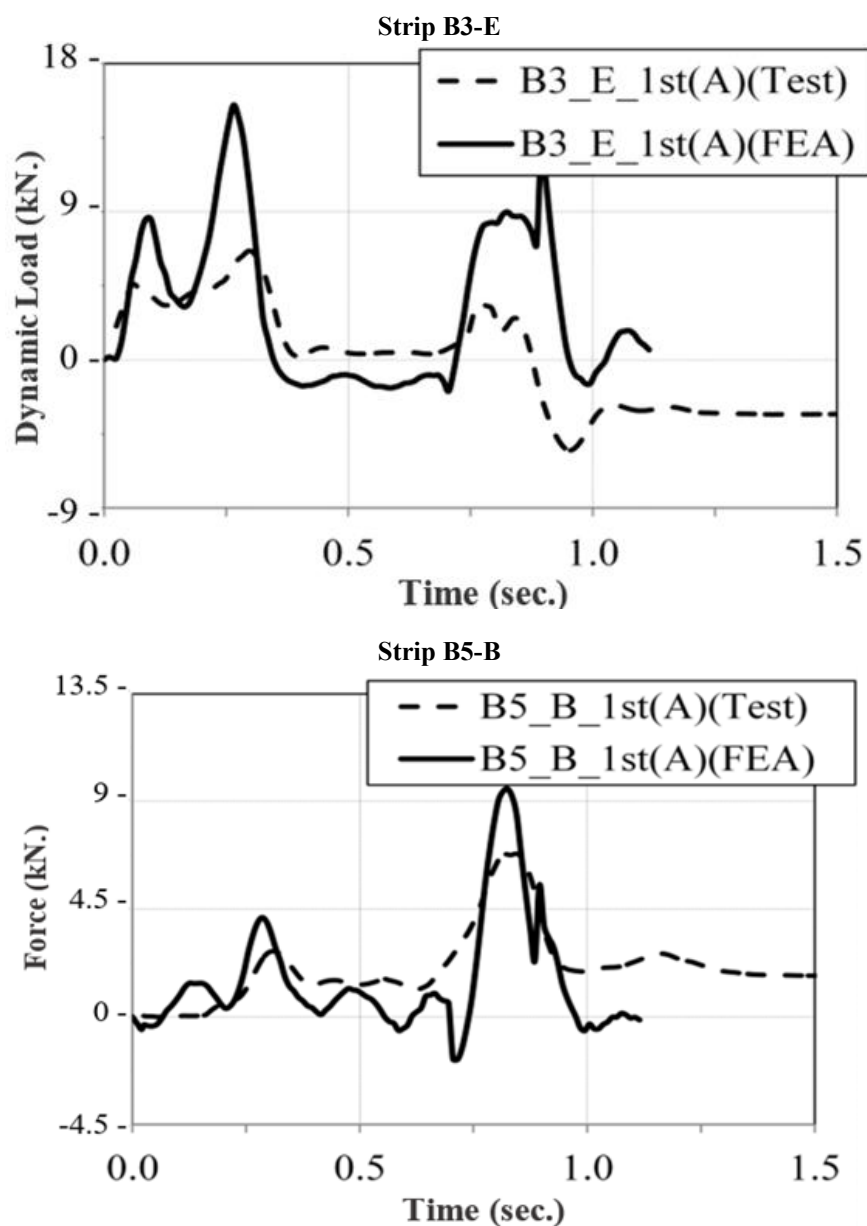
**Figure 15.** Comparison of the dynamic component of the strips' loads in the uppermost layer of soil reinforcement.

and lateral acceleration in the model, and -1.4 g's and -4.4 g's for the test. These acceleration values are 50 msec averages. The simulation predicted reasonably well the permanent displacement of the barrier, as shown in Table 3. The dynamic displacements of the wall panels during the test could not be measured due to problems in the instrumentation. The measured lateral permanent deflections of the wall panels after the test ranged from 0.25 mm to 13.72 mm. The dynamic and permanent deflection determined from the simulation ranged from 0.25 mm to 14.73 mm and from 0.25 mm to 7.11 mm, respectively. The simulation under-predicted the permanent displacement in some wall panels but predicted others reasonably well. In addition, the simulation predicted high bending stresses of the panels located underneath the impact point and, after the test, hairline cracks were observed at those locations. The simulation overpredicted the tension load in the top strips near the point of impact but did better at other locations (Figure 15), particularly in the second row of strips.

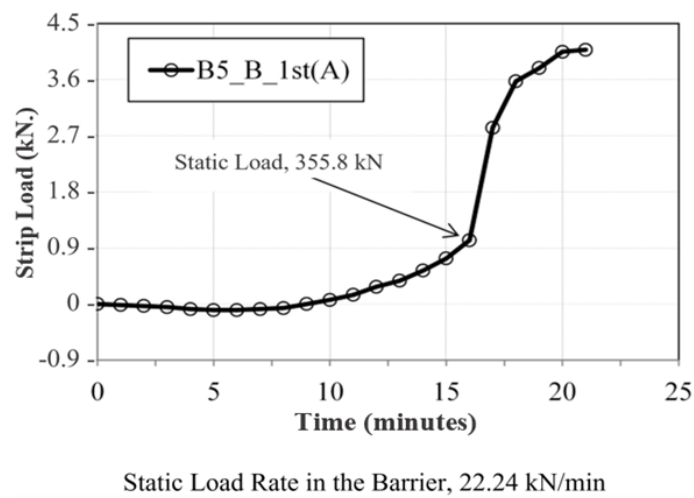
**Figure 18.** Load in top strip below barrier loading point.

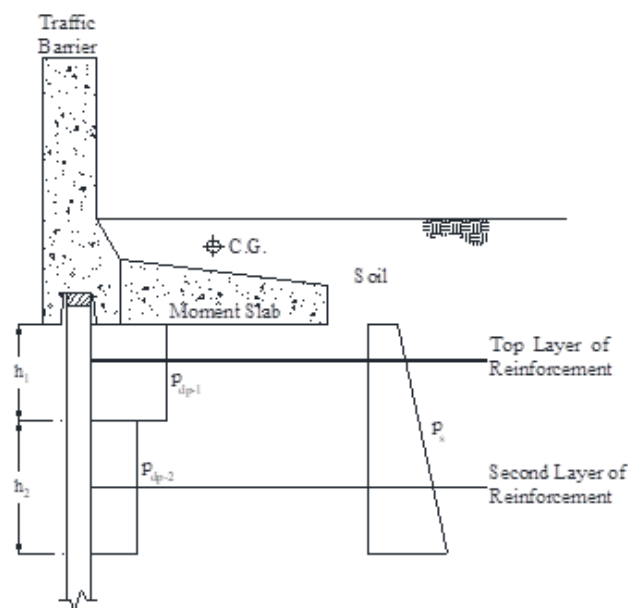
**Figure 19.** Pressure diagram for static and dynamic components to design MSE wall strips for TL5 impact loading.
